PigLet Snuffles Out Pipe Problems

In addition a trail project was started together with the waste water-industry to inspect a 600 meter long HDPE waste water pipeline. Part of this pipe was new laid while the other part consists of a 30 years old section. Prior to the inspection the pipeline was cleaned using a MD-foam pig were after the inspection run was started from the pump station to the septic tank.

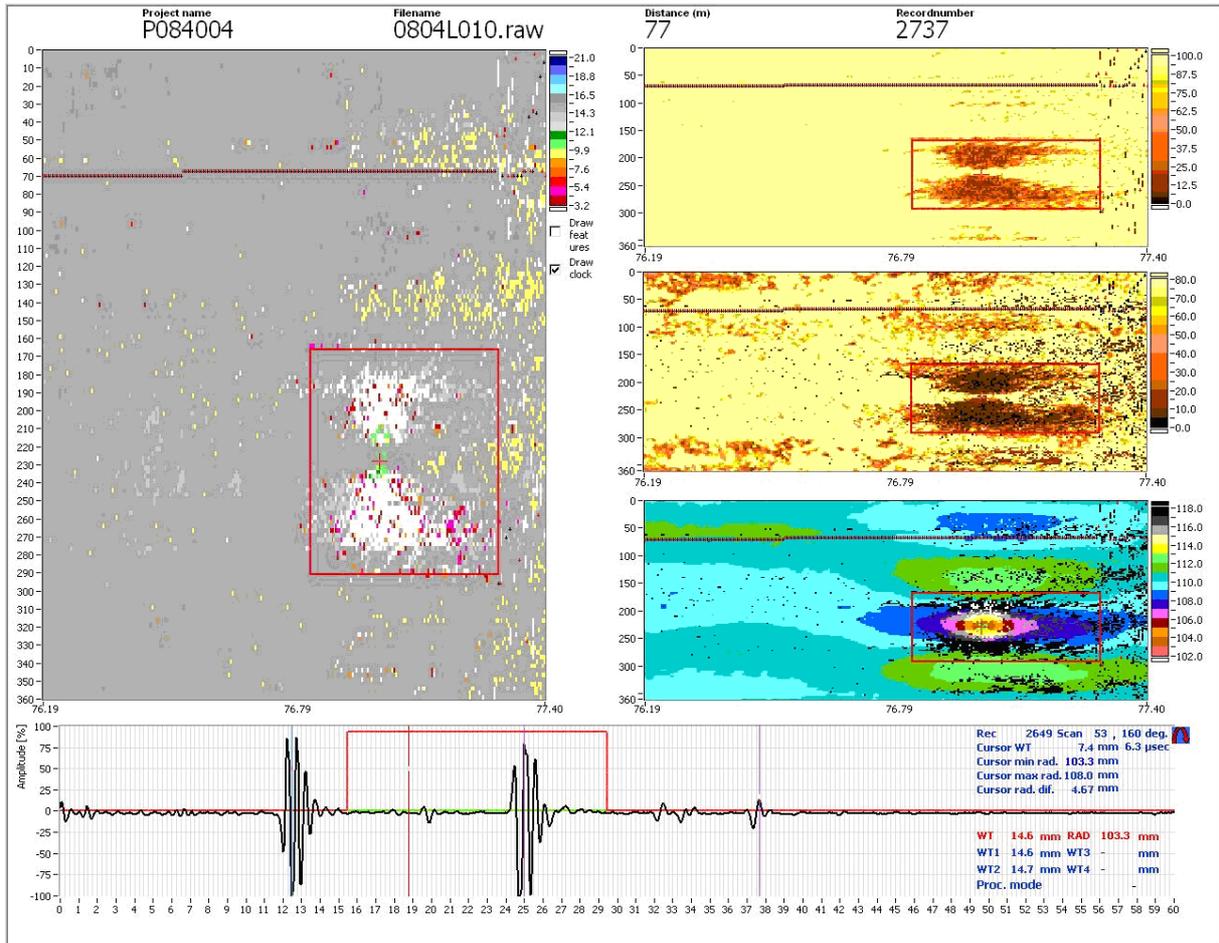
**Example of an Anomaly with identification Dent located during the inspection
Report for Anomaly with identification Dent located at log distance 77.07 m**

During the inspection a few areas were identified with different thicknesses, due to the change in pipe material and the production process. A few areas were ovalities were measured in combinations with some dents. These areas were investigated more closely and dig-up verification was carried out. In one area a gas pipeline was found pushing onto the pipe and causes the ovality and dent at the area. It was expected that in the future this

Anomaly no.	4	Width (mm)	244
Log distance (m)	77.07	Length (mm)	473
Joint no.	150	Remaining t (mm)	-
Average t / joint (mm)	14.6	Mean anomaly depth (%)	-
Average radius / joint (mm)	110.4	Maximum anomaly depth (%)	-
Average percentage of successful measurements / joint (%)	99	Up weld distance (m)	2.18
Average reliability / joint (0-1)	n.a.	Clock position (h:min)	5:20
Joint length (m)	9.95	Reliability (0-1)	n.a.
Feature type	Anomaly	Defect assessment method	ASME-B31.G
Feature identification	Dent	PSafe (MPa)	-
Anomaly dimension class	-	ERF	-
Surface location	Not applicable	Defect assessment comment	-
Comments	9 mm deep.	Feature scan name	S00077_07.jpg;

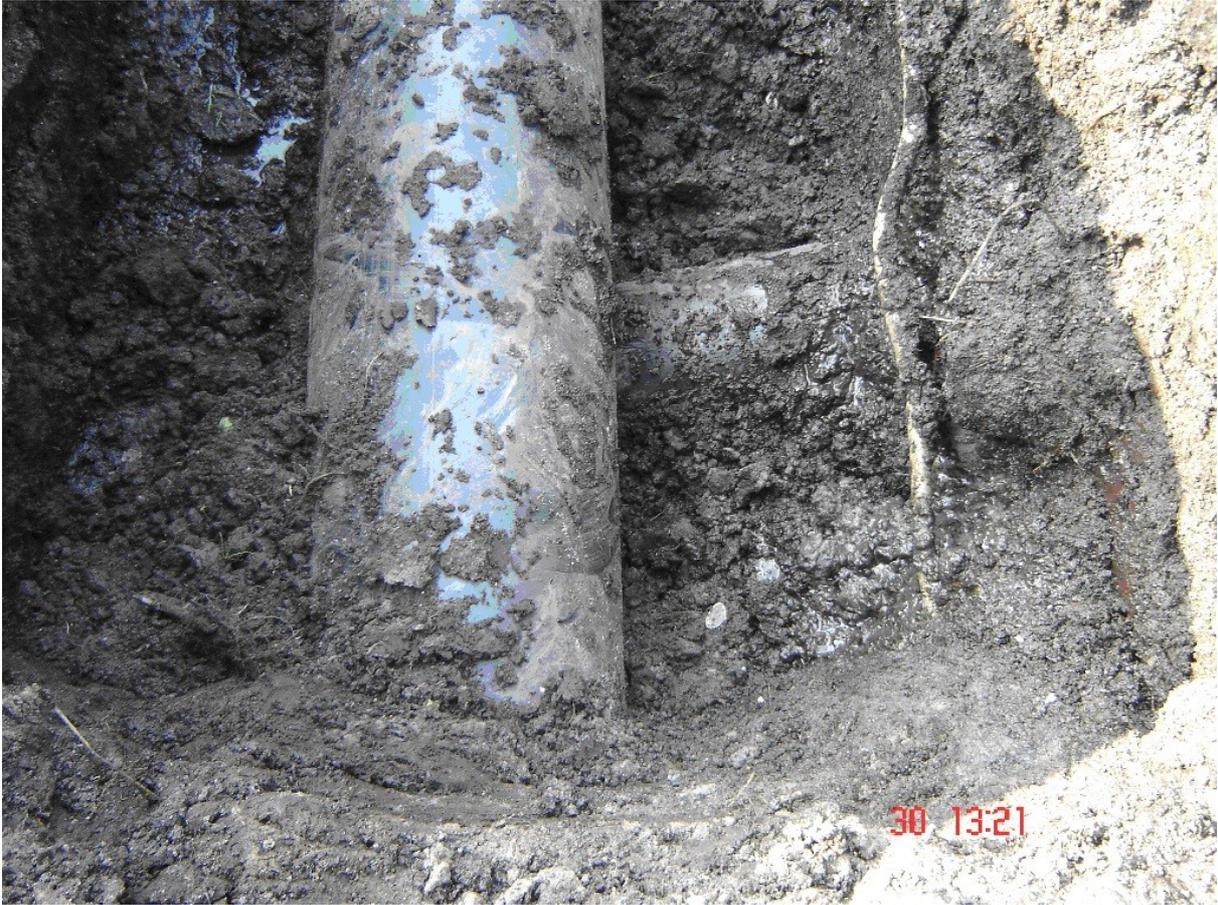
could be a critical leakage, resulting in unwanted shutdown of the pipeline and dangerous situations.

Picture taken of the anomaly detected during the inspection after verification dig-ups. It was found out that the waste water lines has been moved about 20 -25 cm and now rests on a PN160 gasline, which causes the deformation of the HDPE pipeline.
