MULTIDISCIPLINARY PIPELINE INSPECTION PROJECT, DEVELOPMENT OF IN-LINE ULTRASONIC INSPECTION TOOL TO BE ABLE TO PASS MULTIPLE MITRE BENDS AND 1D BACK TO BACK BENDS IN ONE INSPECTION RUN

By: L.J. Gruitroij, A.Hak Industrial Services B.V., The Netherlands

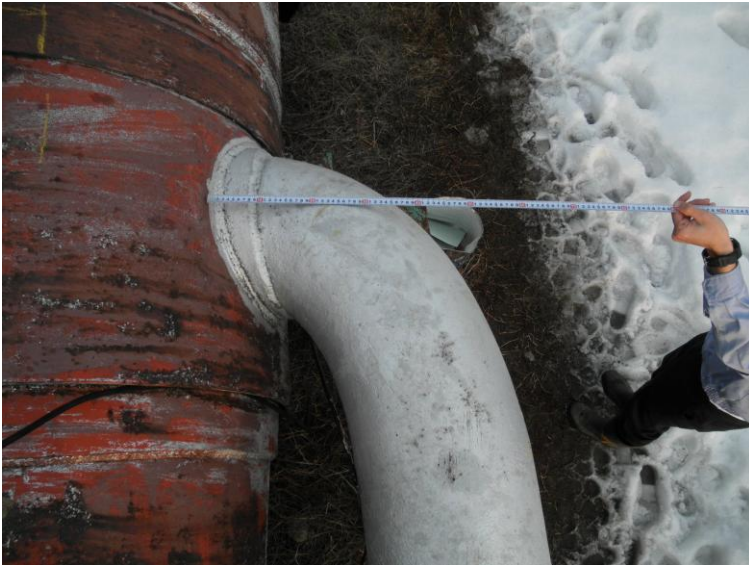
Figure 1: Photo of the ID obstacle which needed to be overcome

As you can see in the attached drawing, there are bend restrictions such as **forged bends(<1.0D)** and **mitre bends(R=1448mm)**. figure 1,2

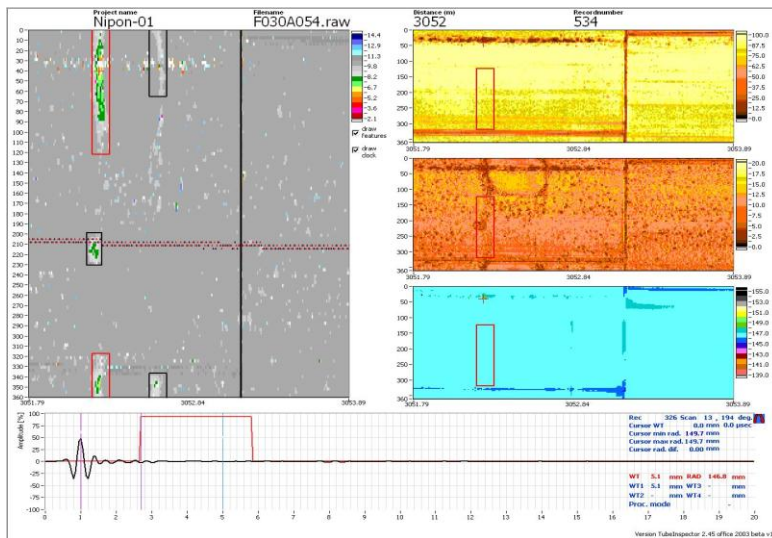
Figure 7: Example of the C-scan image of an external defect

Anomaly no.	549	Width (mm)	425
Log distance (m)	3052.33	Length (mm)	112
Joint no.	2610	Remaining t (mm)	3.4
Average l / joint (mm)	10.2	Mean anomaly depth (%)	10.5
Average radius / joint (mm)	146.6	Maximum anomaly depth (%)	66.6
Average percentage of successful measurements / joint (%)	99	Up weld distance (m)	11.17
Average reliability / joint (0-1)	n.a.	Clock position (h:min)	6:24
Joint length (m)	12.07	Reliability (0-1)	1.00
Feature type	Anomaly	Defect assessment method	ASME-B31G
Feature identification	Corrosion	PSafe (MPa)	7.78
Anomaly dimension class	General	ERF	0.13
Surface location	External	Defect assessment comment	Present operating pressure acceptable for this anomaly
Comments	In combination with internal corrosion (Stand-off = 1.8 mm; remaining t = 5.2 -1.8 = 3.4	Feature scan name	S03052_35.jpg;
