EFFECTIVE USE OF IN-LINE INSPECTION TECHNOLOGIES
TO SUPPORT PIPELINE INTEGRITY MANAGEMENT

By Peter Smith, Chevron North Sea Limited and Andrew Wilde, MACAW Engineering Ltd, UK

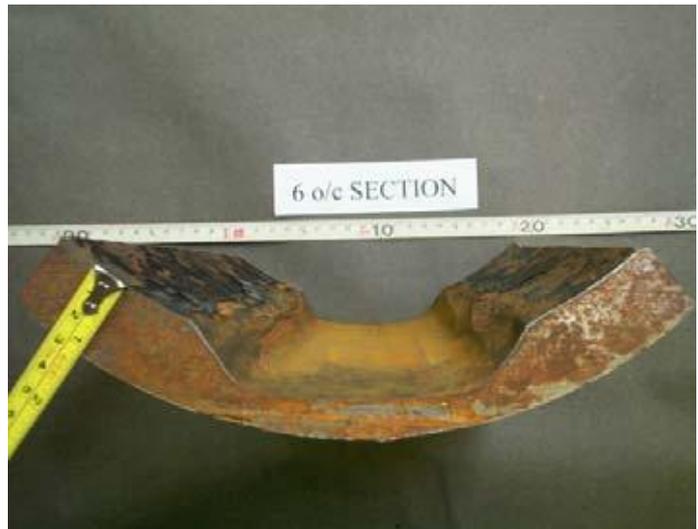
Erosion-corrosion often results in a smooth channel centred at the 6 o'clock position. Figure 2 shows a section of the Strathspey water injection pipeline which had been operated under similar conditions to the 12" Alba pipeline.

Figure 2: Groove Corrosion on the Strathspey Water Injection Pipeline

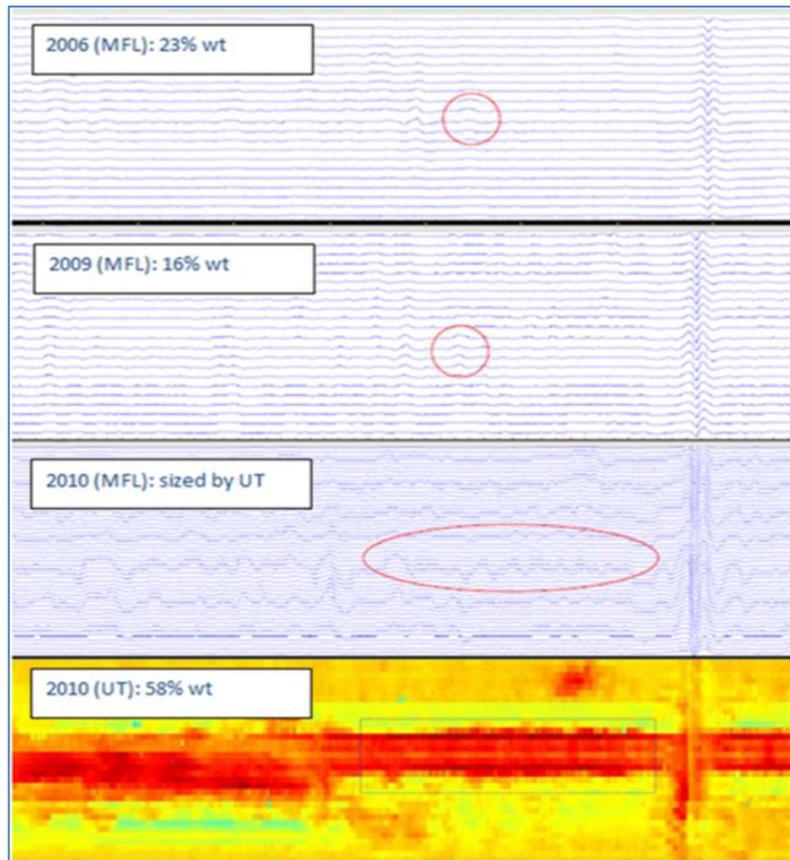
An extract of the 2006, 2009 and 2010 MFL data and the 2010 UT data is shown in Figure 3.

This shows that although a feature was detected and sized by the MFL inspections, the feature was reported with a small length and width. The 2010 UT data clearly shows the channelling corrosion that was confirmed to be present in the pipeline. It can also be seen that the MFL inspections had significantly under-estimated the depth of the channelling.

Figure 3: Repeat MFL and UT Signal Data for 12" Alba WI Pipeline

It can also be seen that the MFL inspections had significantly under-estimated the depth of the channelling.

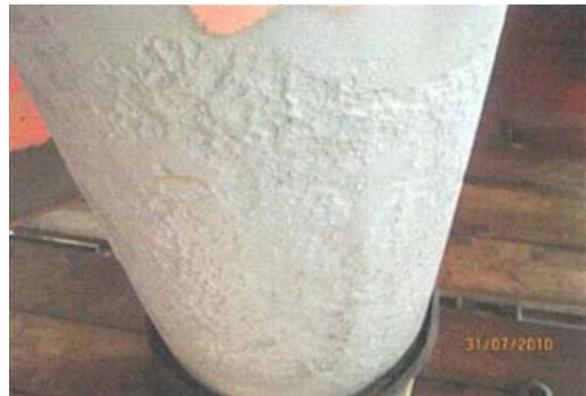
During a recent general visual inspection (GVI) of the 16" Captain Oil Export riser, an area immediately above the neoprene splash zone coating was found to be corroded (Figure 4). A work order was consequently executed to repair the area, whereupon all corrosion products were removed, and the area was blast coated and painted before a sealant was applied to prevent future water ingress. Although photographs were provided of the repair itself, it was not clear whether the neoprene had been stripped back to repair any corrosion damage below the neoprene coating during the repair operation.

Figure 4: External Corrosion Area above Neoprene Splash Zone Coating

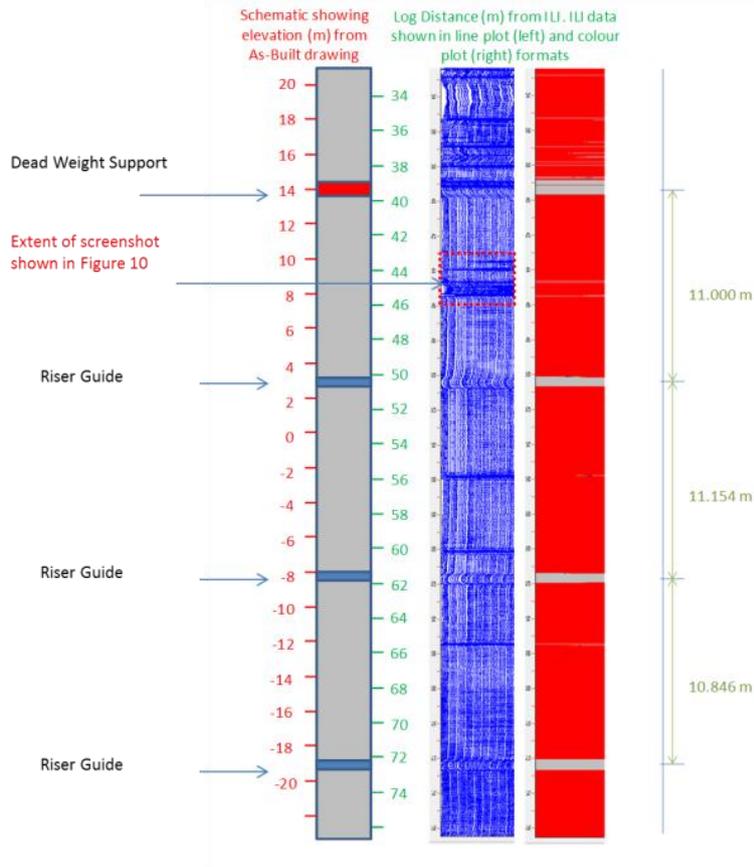
Figure 5: Correlation of ILI Data with As-Build Drawings

There was uncertainty about whether the active corrosion identified by the ILI was the same corrosion that had been identified by the GVI and subsequently repaired. This led to further verification of the MFL signal data in an attempt to correlate this with the visual inspection findings. Using the dead weight support and riser guides which were visible in the MFL inspection data, the approximate elevation of the area could be estimated by cross-referencing with as-built drawings (Figure 5).

From this it was concluded that corrosion below the neoprene had been repaired if the neoprene coating interface was greater than 780 mm downstream of the closest girth weld. The position of the neoprene interface was re-evaluated to confirm that all external corrosion reported by the ILI in this area had been repaired.

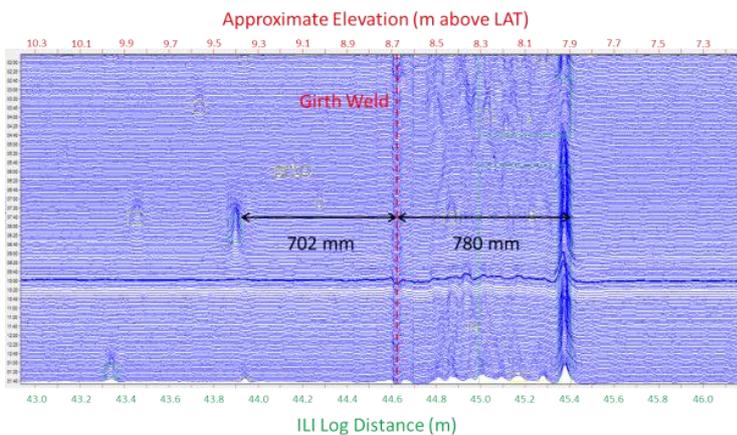
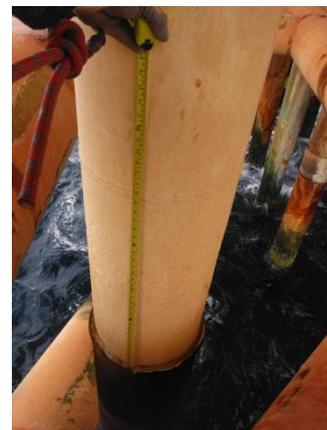
After the GVI survey, the pipeline was inspected using magnetic flux leakage technology (MFL), which reported a circumferential area of external corrosion on the riser near the splash zone (although the precise location of the corrosion could not be accurately determined from the ILI data alone with respect to the position of the top of the external

splash zone coating). A comparison of repeat ILI data in that area confirmed that the corrosion had grown since a previous (2008) MFL inspection.

Figure 6: Locating External Corrosion on the Captain Oil Export Riser

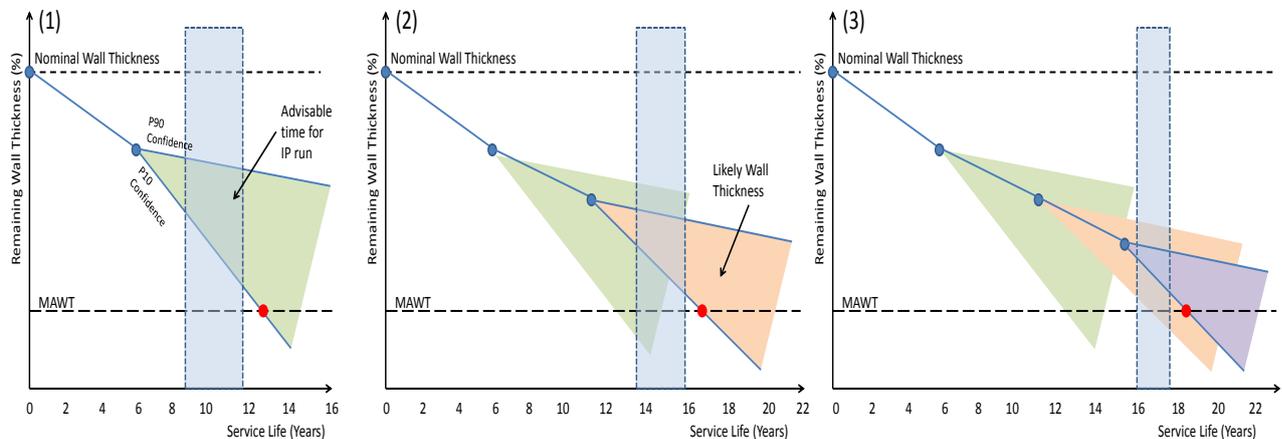
This type of analysis can be used to quantify how effective mitigation (e.g. compliance with the corrosion inhibitor and maintenance pigging targets) can extend both the ILI interval and the safe working life of the pipeline. In this way, specific performance measures can be defined and any extension to the ILI interval be made dependent on successfully achieving those measures. Figure 7 shows an example of remnant life modelling and how to define the next re-inspection interval.

Figure 7: Use of Repeat In-Line Inspections to Investigate Suitable Inspection Intervals and Safe Remaining Pipeline Life
