**THE MISSING LINK -
INSPECTING THE FINAL CRITICAL SECTION
OF A LARGE CRUDE TRANSMISSION AND EXPORT SYSTEM**

By: Basil Hostage and Dr. Rainer Schmidt, 3P Services, Germany Summary

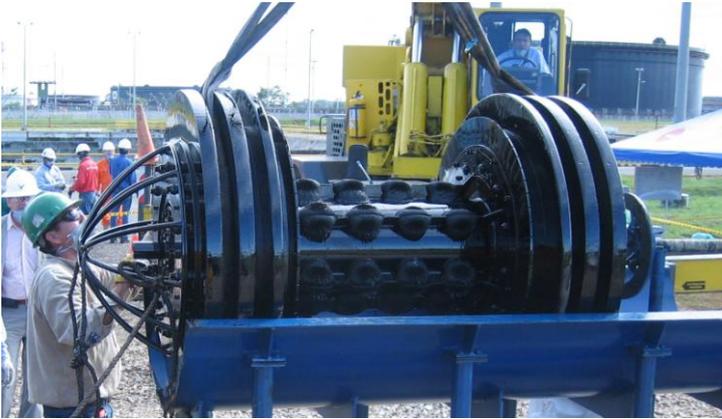
Cleaning: After the recovery of the first cleaning pigs it became clear that the pipeline did not have a significant volume of debris to be removed. Therefore, the actual cleaning program could be shortened

to one foam pig run and two Bidi runs. The second Bidi was equipped with gauge plates and served as “profile pig” to prove sufficient internal bore for the inspection tools.

Fig. 3: Cleaning pig equipped with gauge plates, transmitter, magnets and inertial system after the run

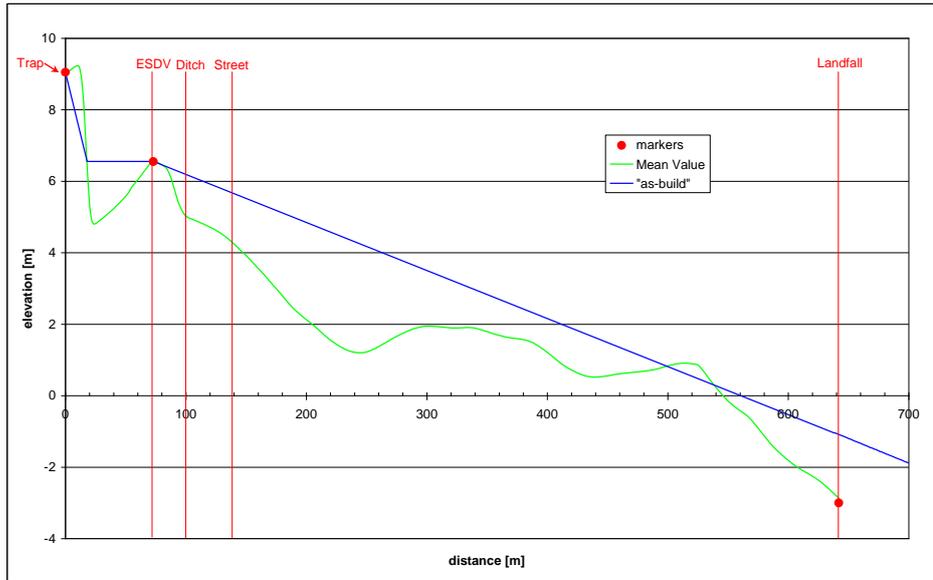
Fig. 6: Vertical pipeline profile onshore section

A multitude of further valuable information has become available. This is e.g. minor ovalities in millimeter-size (from GEO data) that are present in the land section, and a more detailed vertical profile of the pipeline than known before (from XYZ data, see Fig. 6).

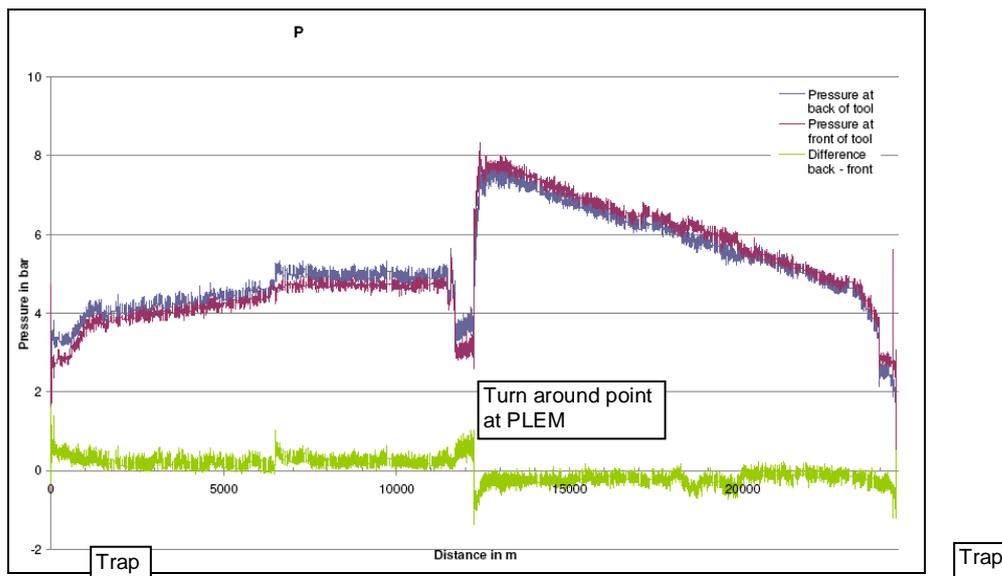
Fig. 7: Pressure recording during MFL run by the inspection pig

Moreover, tool operational data help to understand performance of the inspection tool. The pressure data recorded by the MFL tool e.g. indicate that the differential pressure necessary to move the tool is only approx. 0.1 to 0.5 bar (Fig. 7).

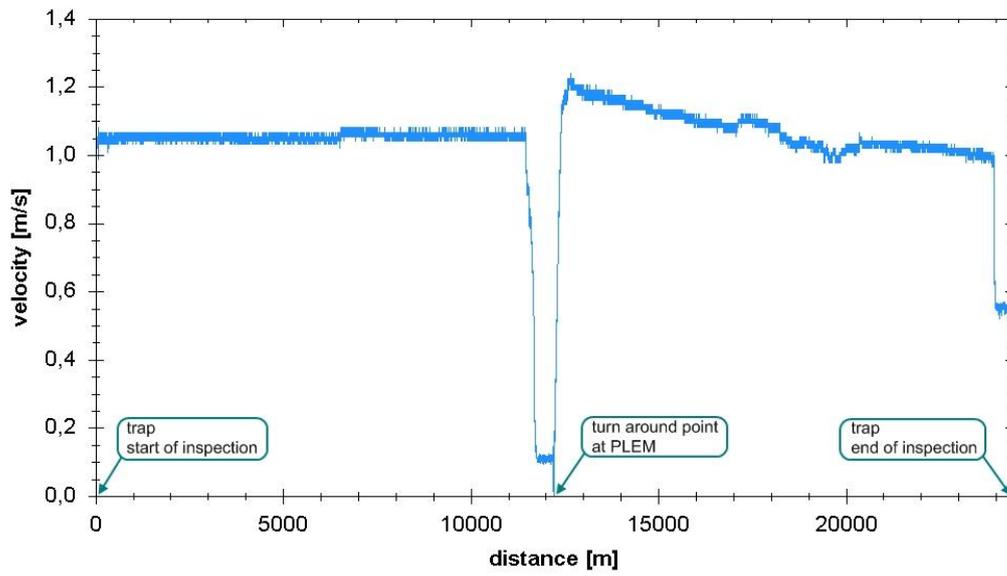
Fig. 8: Speed profile MFL run, top shore to PLEM, bottom PLEM to shore

Fig. 8 shows the speed performance of the MFL tool on its way from the launcher at the Ocesa terminal out to the PLEM and back again. On the way out, an almost perfectly constant pig speed of 1 m/sec can be found. This was exactly the agreed pig speed and it was kept accurately constant, since here Ocesa's export pumps could be used that have a highly sensitive flow control. After the first antenna indicated the pig passage, pumping was slowed to 0.1 m/sec. Following the second antenna just a few meters in front of the PLEM, valves were closed completely. The third antenna, positioned right behind the pipeline end flange, confirmed the pig's final position just at the right place.

At approx. the middle of the offshore section, there is a transition in pipe wall thickness. The flow control on the way out was that accurate, that this transition can even be found in the speed profile: While the pumps take care for a constant flow rate, the pig accelerates to a marginally higher speed when the ID is slightly reduced because of higher wall thickness. On the way back the tanker pump was simply set to a certain capacity level and not changed throughout the run. The decline of the resulting pig speed is due to the changing static tank levels: with progressing emptying of the tanker, its oil level falls while the onshore tank level rises.
