## **Inspection of water injection pipelines and future needs**

By: Mikael Georgson and Roger Hunsbedt

Statoil ASA

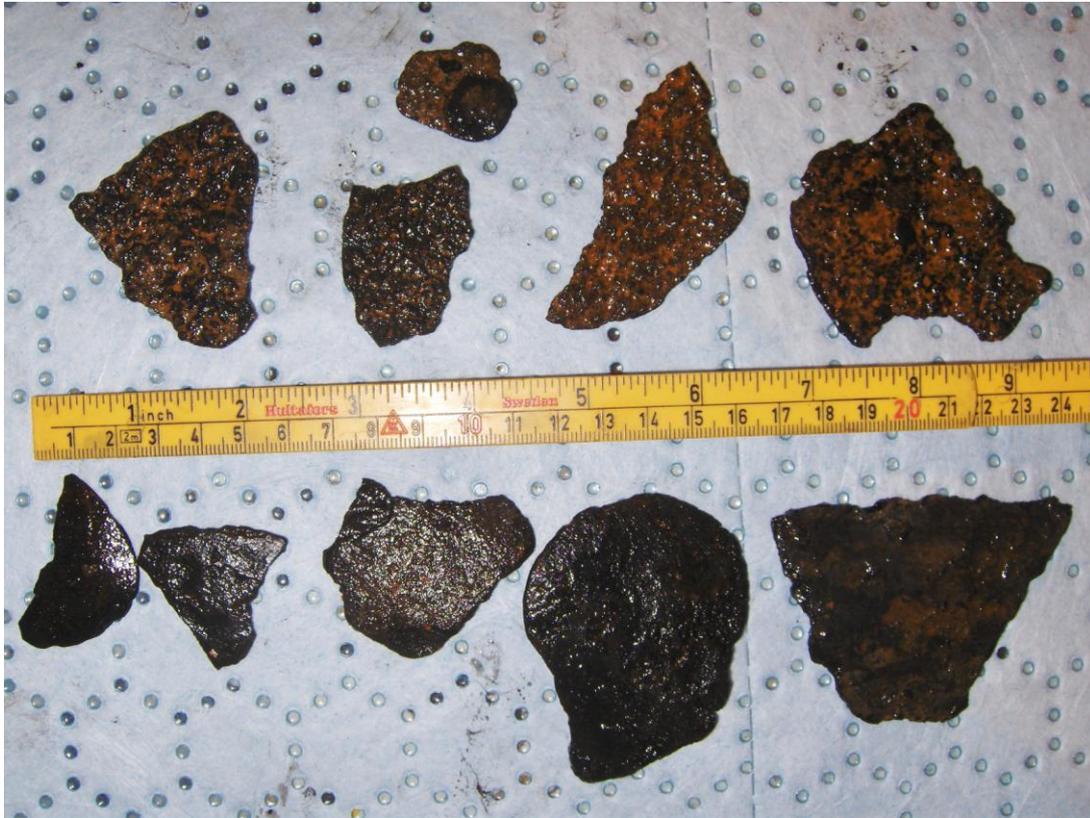
As a result of the risk evaluation made during planning of the pigging campaign, the pipeline was flushed with seawater at high flow prior to launching the first pig. The amount of debris removed during flushing was significant. The picture below shows some of the debris collected, which consists of typical scale found in water injection pipelines, mainly calcium carbonate ( $\text{CaCO}_3$ ) mixed with Iron/Sulphurs combinations.

**Figure 3. Picture shows debris flushed out of the pipeline prior to launching pig no. 1 in October 2010**

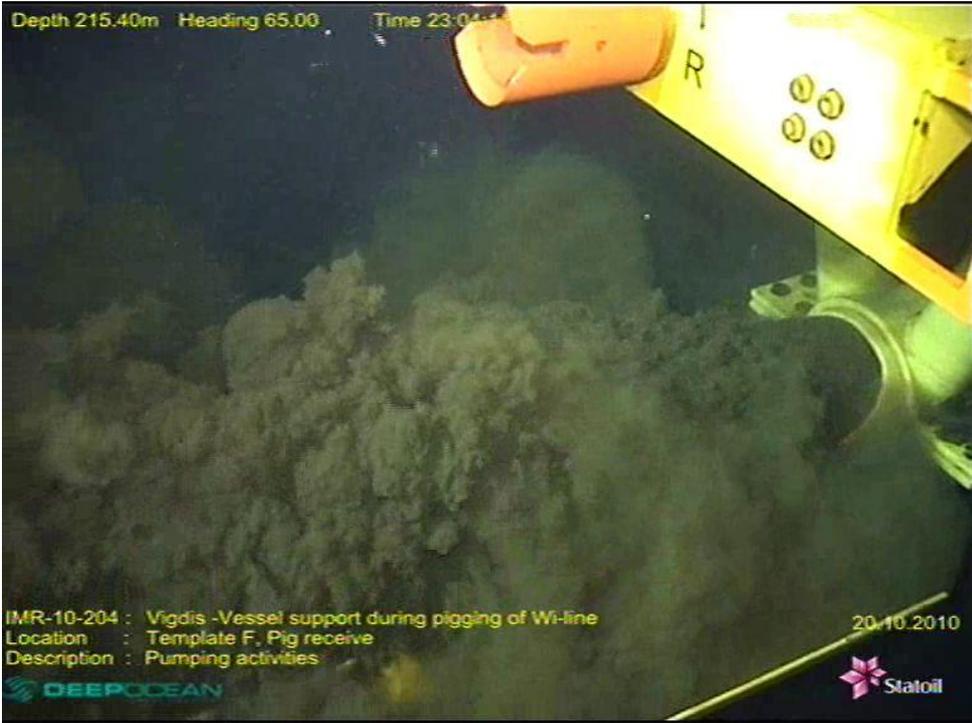
Figure 4. Large amount of debris flushed out during arrival of pig no. 02

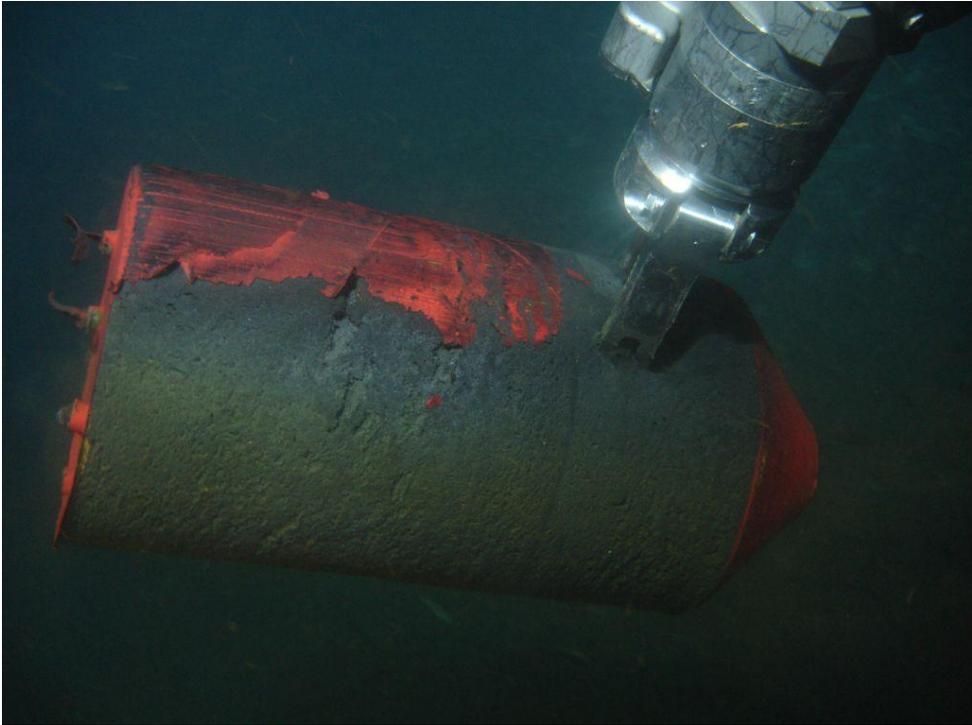
Figure 5. High wear on pig no. 02, foam pig with 4 x bypass holes

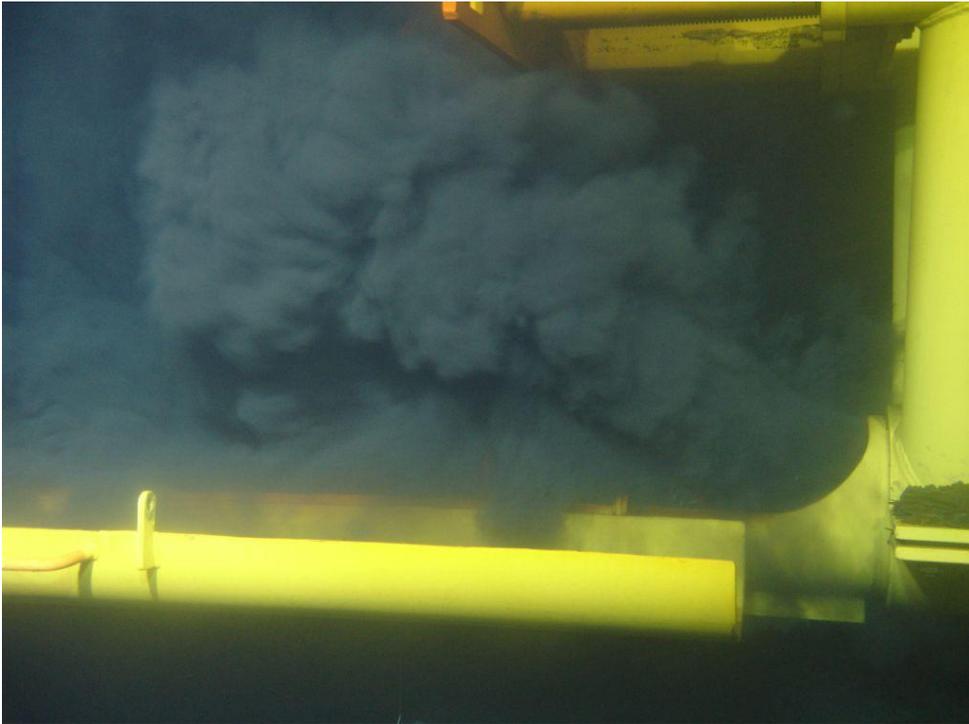
**Figure 6. Still high amounts of debris flushed out during arrival of pig no. 31**

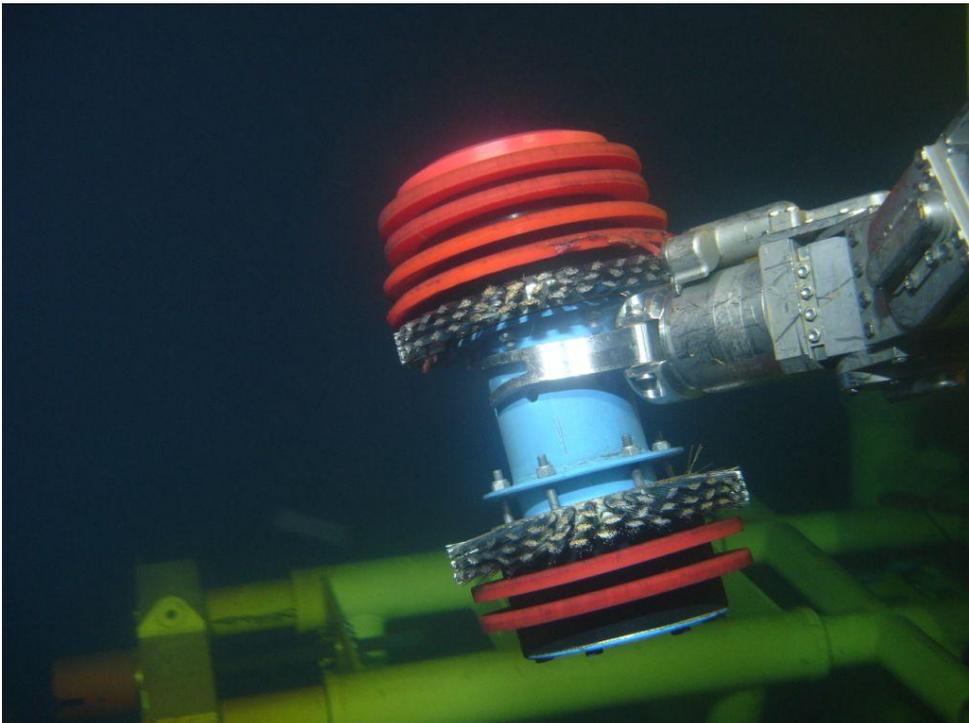
**Figure 7. High wear on pig no. 31 (missing 2 rear seal discs)**

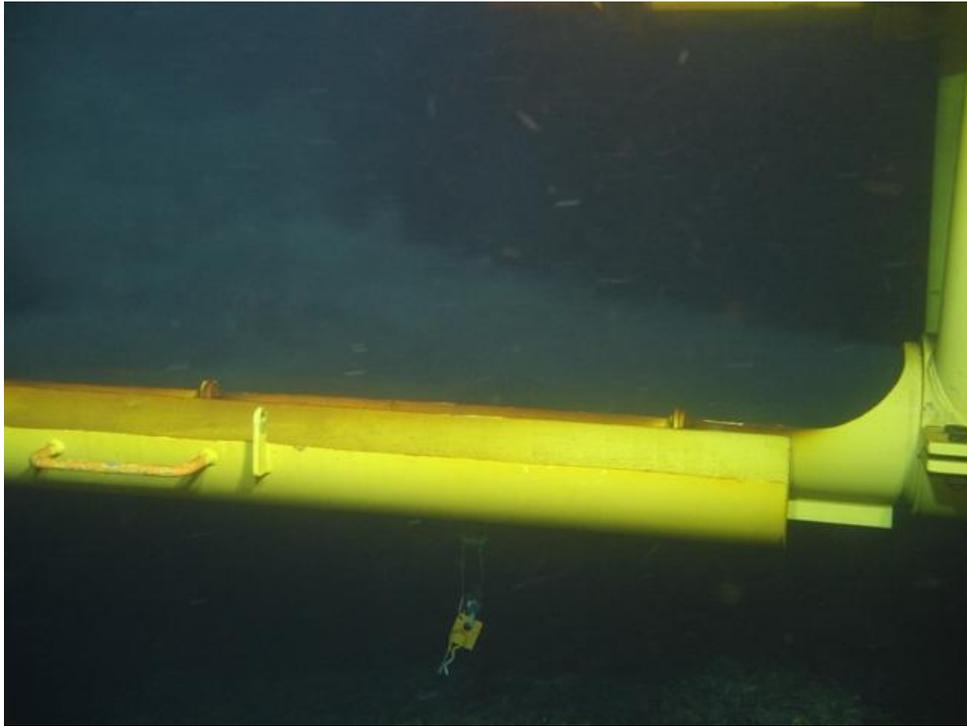
**Figure 8. Finally less debris flushed out during arrival of pig no.54**

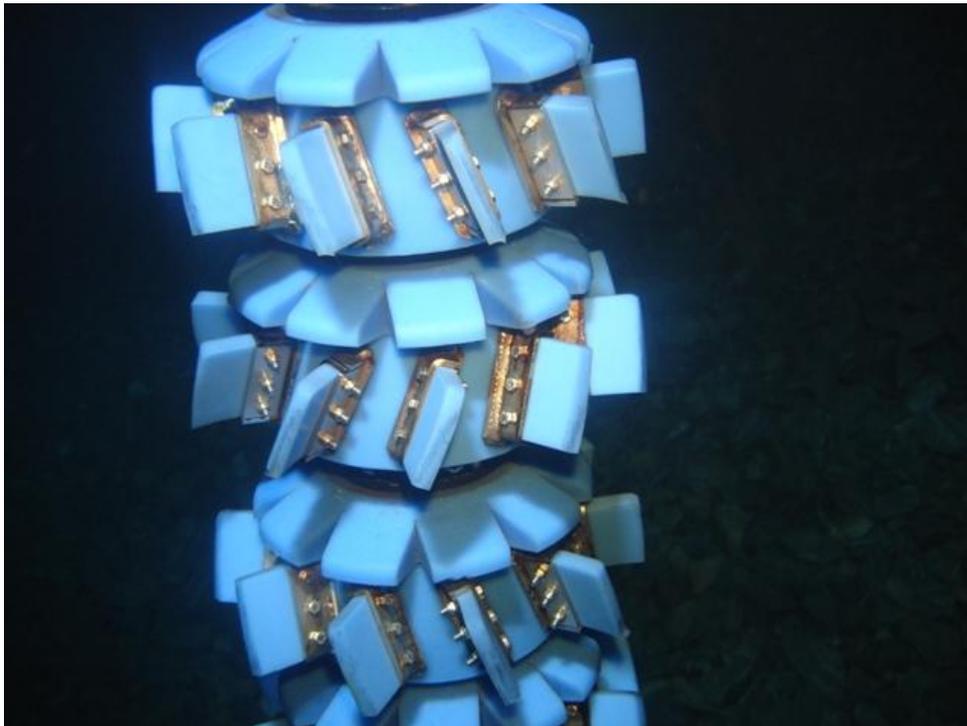
**Figure 9. Wear on pig no 54**

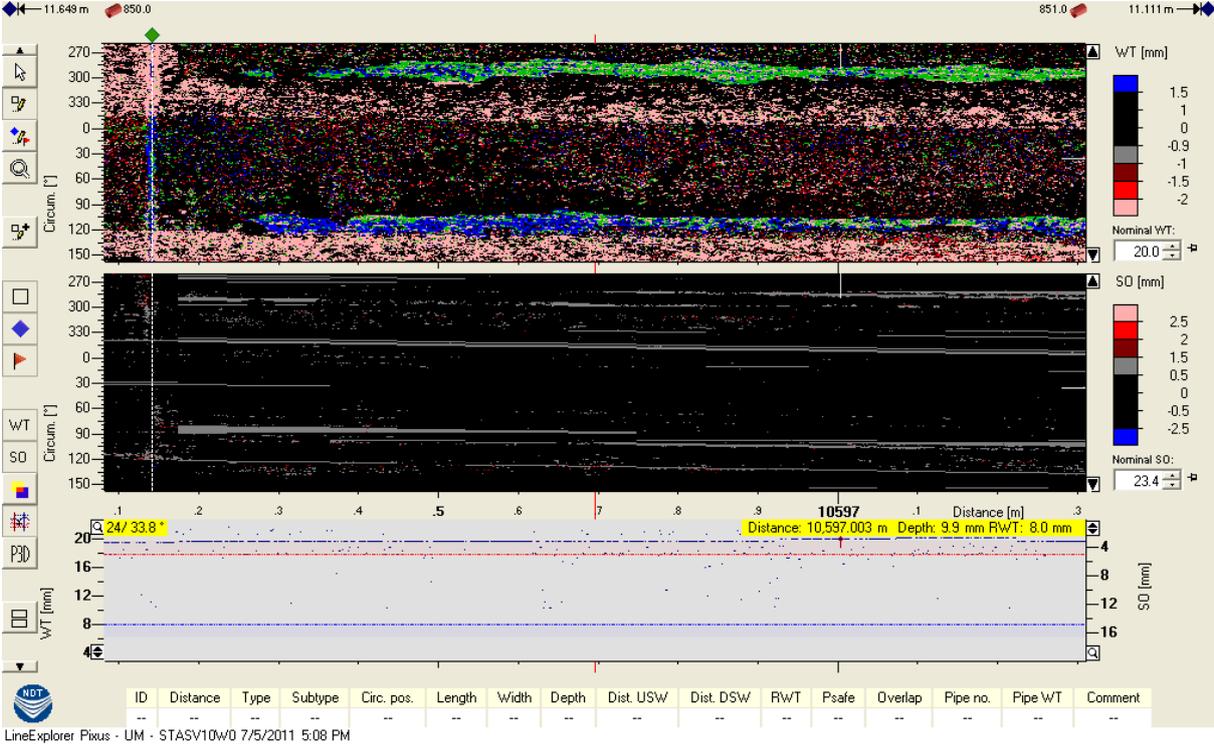
The figures below show the C-scans from the same location in 2010 and 2011. The white dots in the top band indicate echo loss due to residual scale.

Figure15. Data from 2010 inspection showing some residual scale

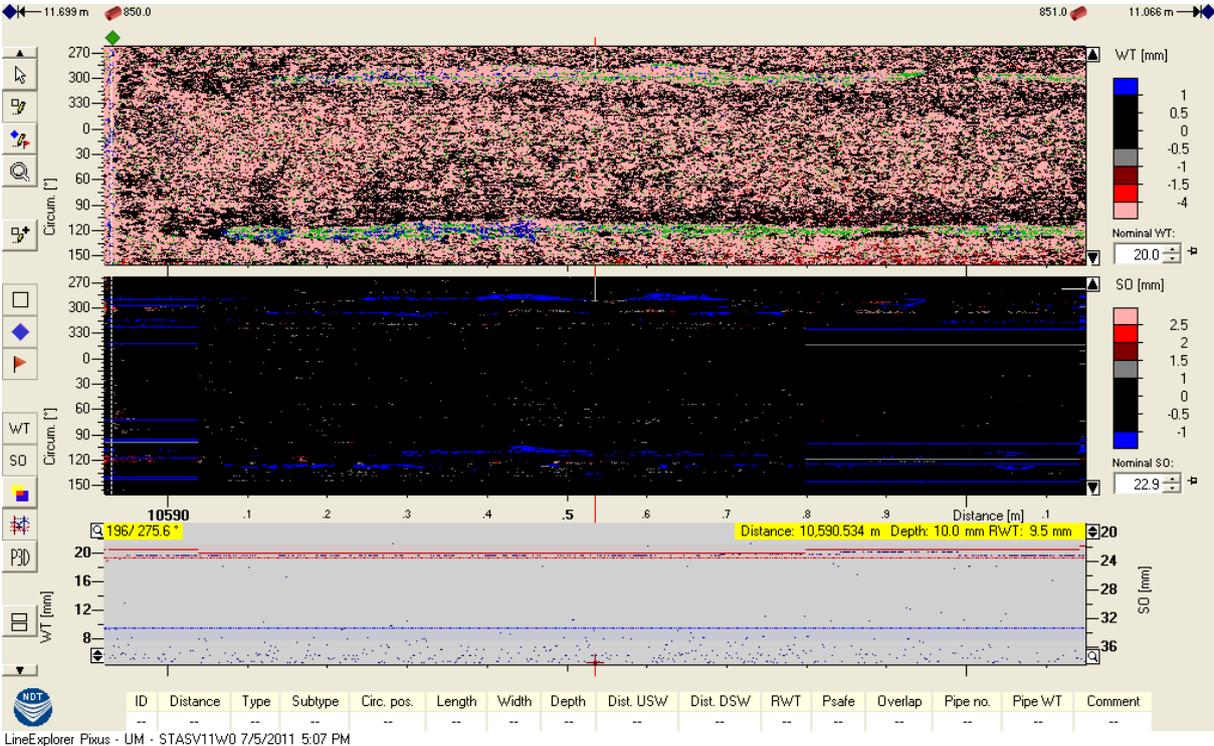
The result from the 2011 inspection campaign indicated presence of scale and corrosion. The corrosion rate was established and even with a “fit for purpose” cleaning pig design residual scale were observed in the pipeline. The most affected part of the pipeline was located after the ‘E’ template, in the section with a lower flow rate.

Figure16. Data from 2011 inspection showing more residual scale

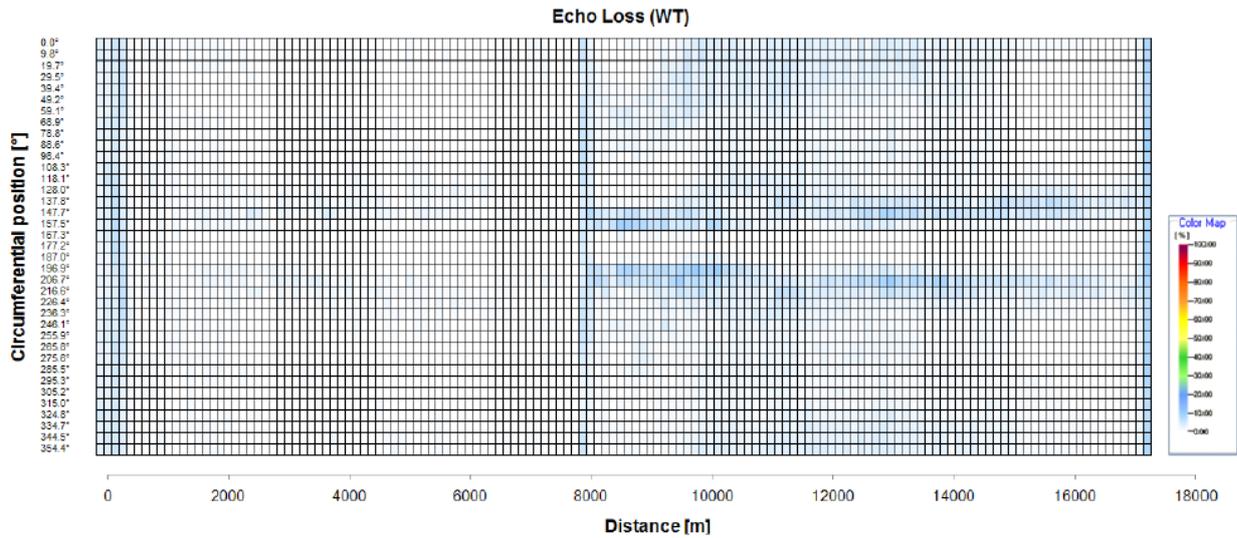
The picture below shows the wall thickness echo loss rate vs. clockwise position as the vertical axis. The distance is showed in the horizontal axis. In the beginning from 100-700 meter we see high echo loss rates evenly distributed around the circumference. This comes from the flexible riser internal carcass pattern. At 7,8 km we see the same pattern and again at the end. All these are from subsea template or flexible pipelines. We can also see the river bottom corrosion path in the 6 o'clock position. Residual scale is spread around the circumference especially the last pipeline section from Template E to Template F.

Figure 17. Diagram of echo loss along the pipeline.
