VERIFICATION OF ILI INSPECTION RESULTS WITH THE USE OF AUTO UT DATA:

A CASE STUDY OF AN OFFSHORE PIPELINE

Holly Plummer BSc MSc, Ian Murray CEng MIMechE,
Derek Balmer CEng MIMechE, Steve Farnie MSc,
(PII Pipeline Solutions, a GE Oil & Gas and Al Shaheen joint venture (PII))

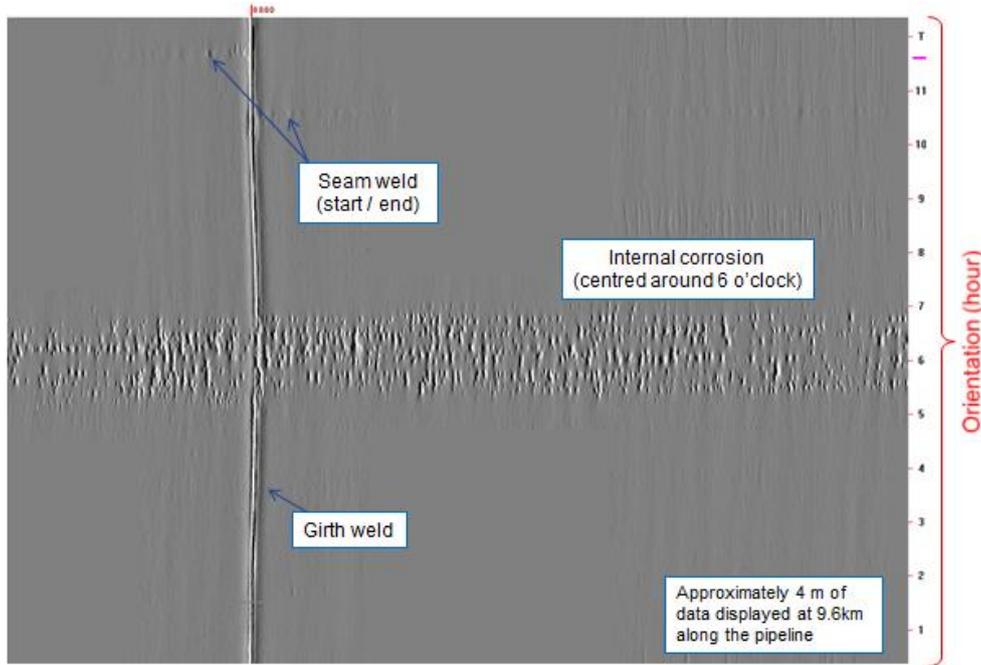
The pipeline has over 600,000 corrosion features distributed throughout its length, predominantly internal at the bottom of the line (i.e., the 6 o'clock position). Previous corrosion growth studies found that the corrosion was active and growing. The internal corrosion features are typical pitting and areas of general corrosion as can be seen in Figure 1. The most recent Fitness-for-Purpose assessment had identified internal corrosion features which are predicted to require repair within 5 years of the latest inspection survey.

Figure 1 – Example of Metal Loss/Corrosion pattern present in the Pipeline

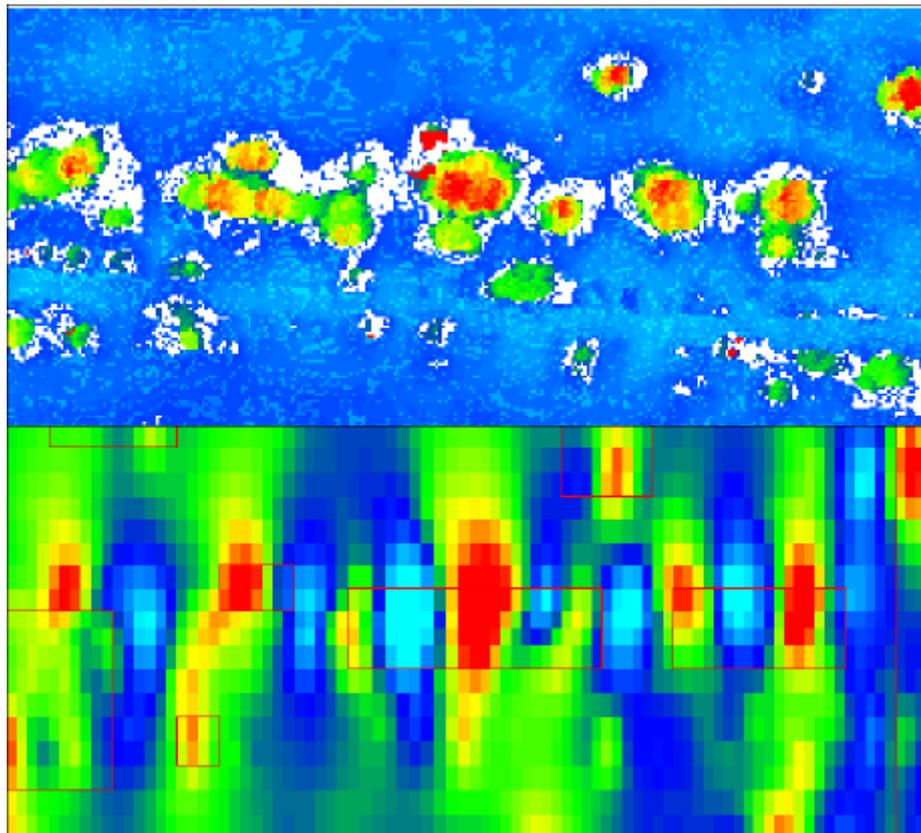
Figure 1 below shows one of the AUT locations from the operator's pipeline. The AUT data can be seen in the top half of the screen where the warmer coloured points (yellow and reds) are sites of metal loss and the white and blue shows sound pipe wall. The PII MFL data is shown in the lower half of the screen (the normal trace signals are displayed in colour mode to allow for easier matching with the AUT data); again, the warmer colours denote metal loss sites.

**Figure 2 – Example DigCom Defect Matching:
(AUT Data (Top) vs MFL (Bottom))**

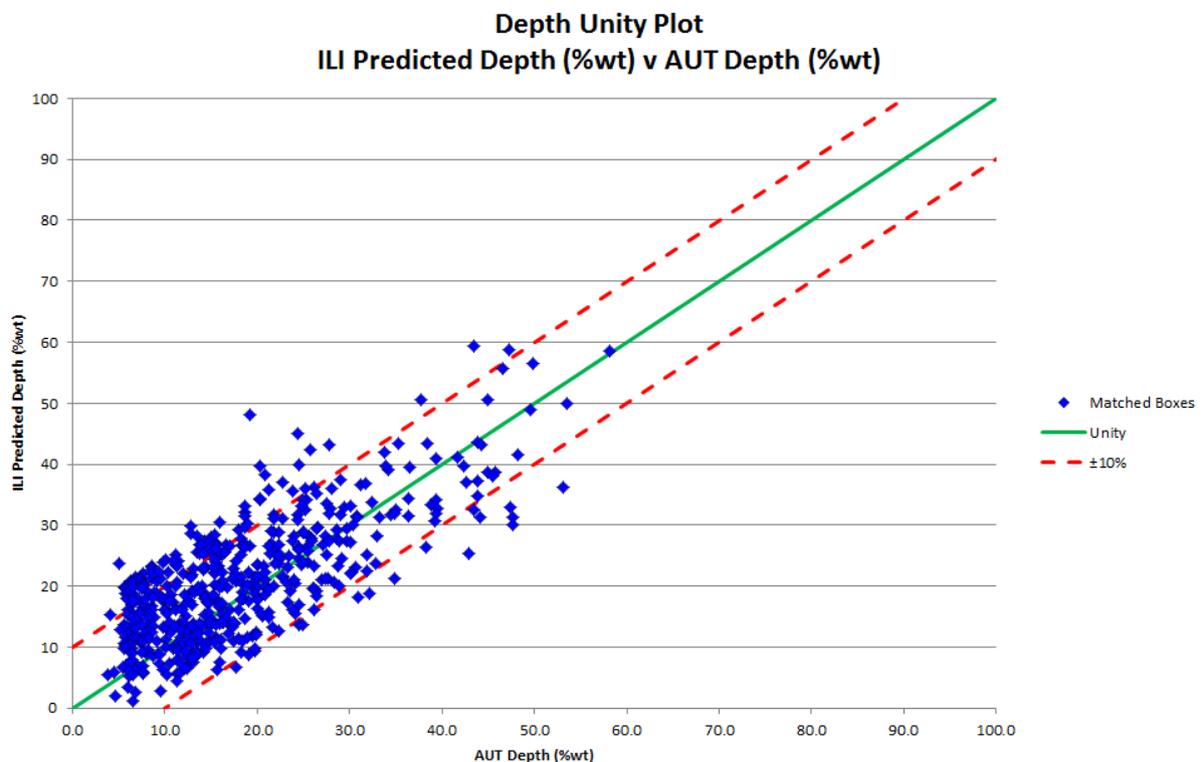
Figure 3 - AUT Depths Plotted Against the MFL ILI Depths

The contractual sizing tolerances of +/-10% for pits and general corrosion are shown on the figure.

As a result of the calculation the true MFL tool sizing tolerances have been obtained. The 80% confidence interval is equal to $\pm 5.96\%$ wt tolerance, i.e., for the matched metal loss indications the ILI contractual sizing specification was exceeded (where contractual sizing specification for general corrosion and pitting within the pipe body is $\pm 10\%$ wt at the 80% confidence interval). At 95% confidence the MFL tool sizing tolerance would be $\pm 9.12\%$ wt.

The MFL inspection tool has been shown to be exceeding the contractual reporting specification, i.e., tool performance is better than stated. This new information about the tool's sizing abilities can be used to improve the accuracy of the Fitness for Purpose results.

Using the actual tolerances versus the contractual tolerances and the determined growth rates in Fitness-For-Purpose studies has meant the operator can defer repairs to this pipeline. In addition the operator intends to continue to inspect with the MFL vehicle to ensure the ongoing integrity of this pipeline asset.
