VERIFICATION OF ILI INSPECTION RESULTS WITH THE USE OF AUTO UT DATA

Holly Plummer, Ian Murray, Derek Balmer, Steve Farnie
November 19th, 2014

A CASE STUDY OF AN OFFSHORE PIPELINE

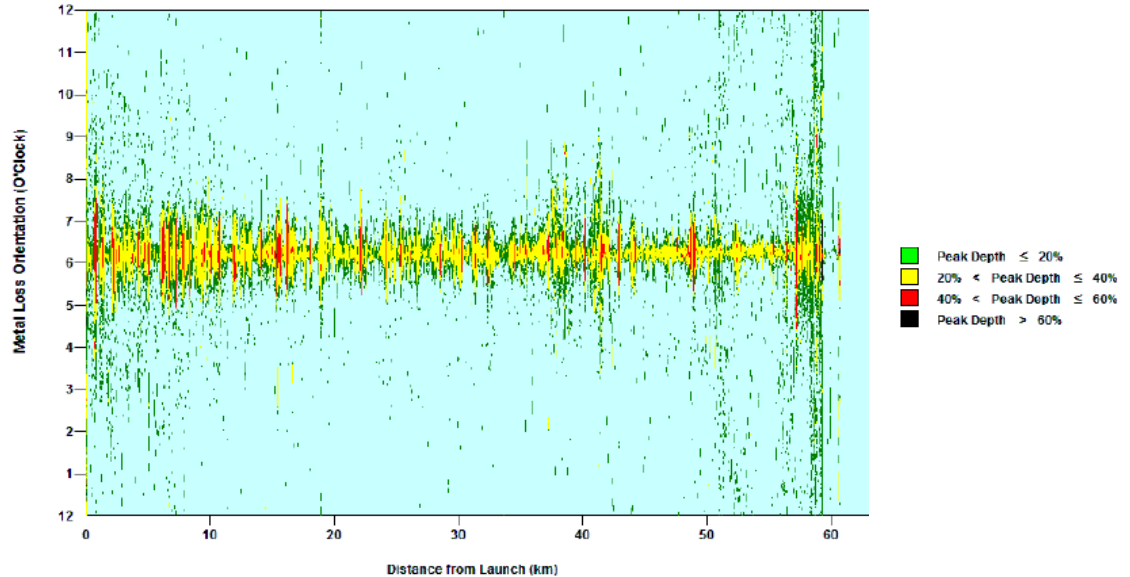
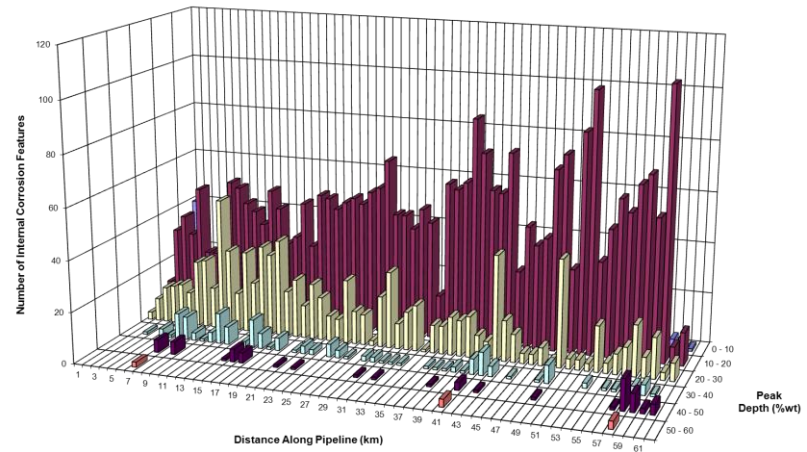
The pipeline has >600,000 corrosion features throughout its length

- Predominantly **internal** and at bottom of the line (6 o'clock)
- Previous Corrosion growth studies found Corrosion was active and **growing**
- Features typical of pitting and areas of general corrosion
- Recent studies had predicted features required repair within 5 years

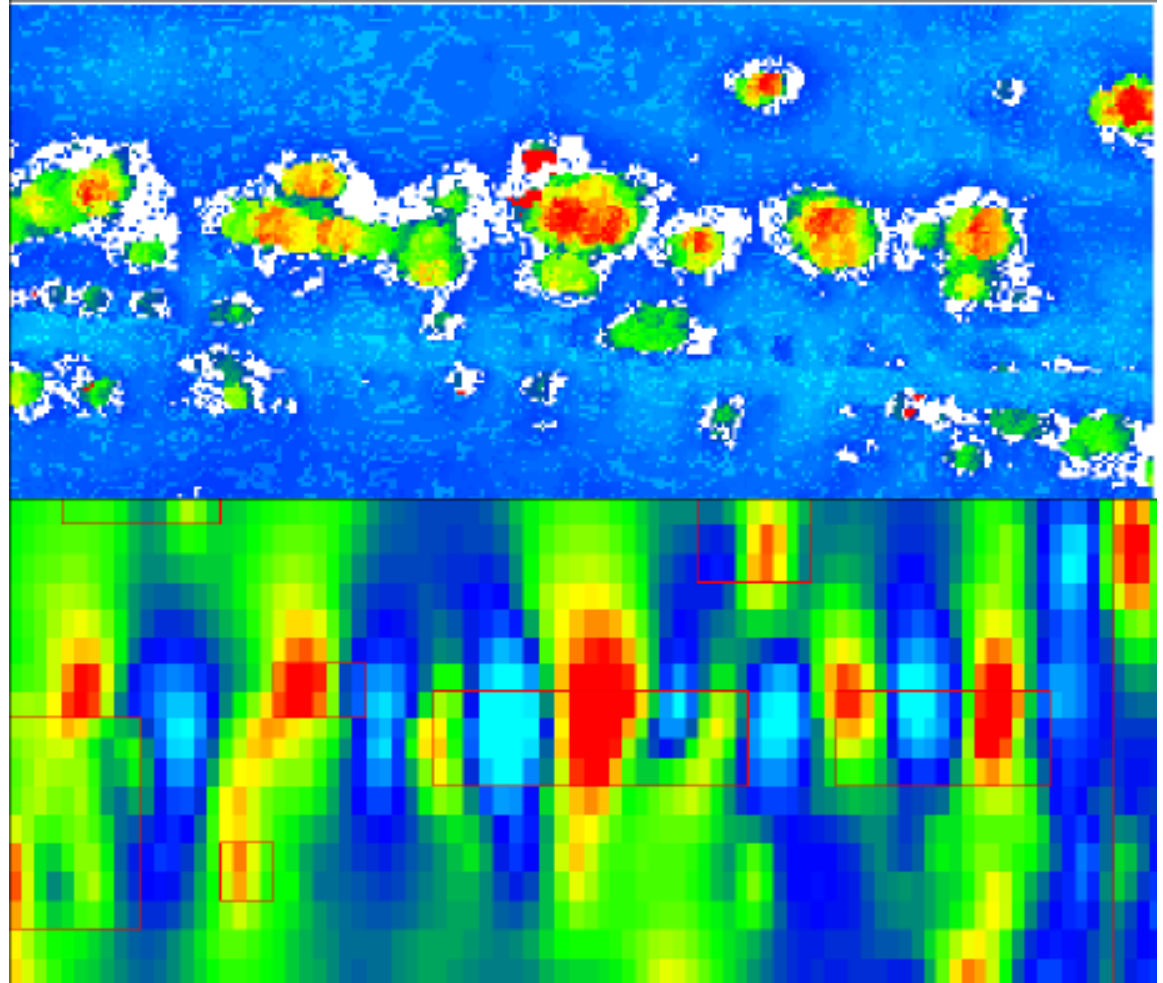
- Converted from scan grid data
- Warmer colours signify deeper pits

- Colour scale on ILI to match AUT data
- Warmer colours signify deeper pits

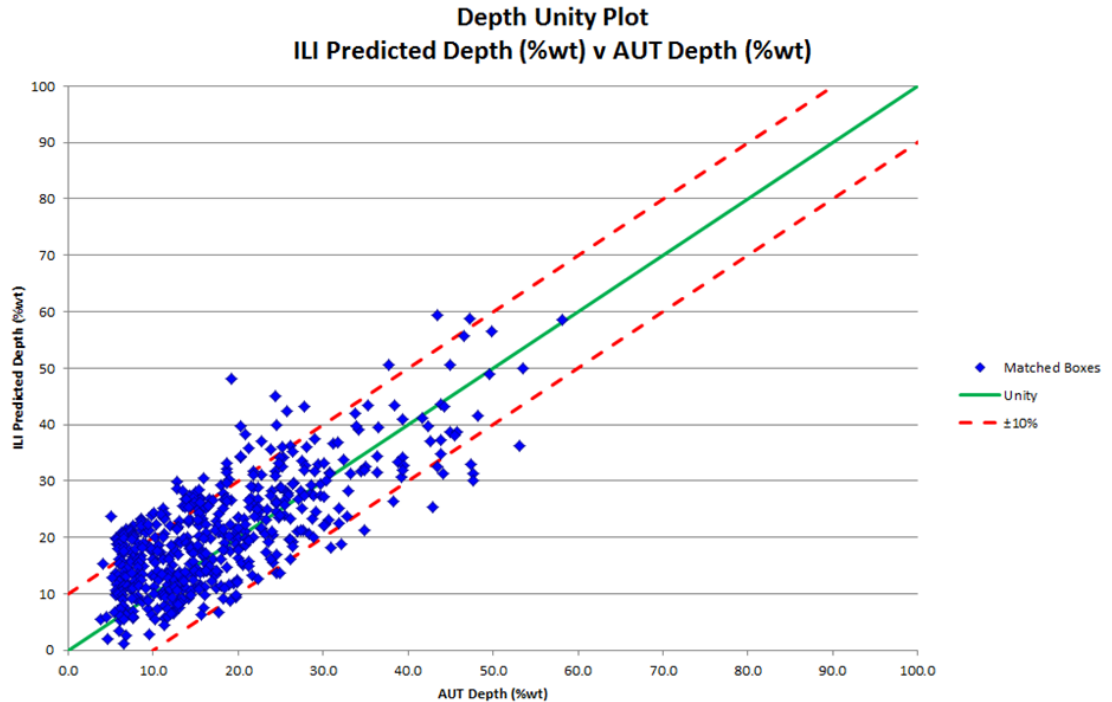
Excellent agreement
between MFL and AUT

- >500 defects matched
- Sample taken from 9 spools throughout the line
- Sample included a range of feature depths
- Sample is considered representative
- 80% confidence interval is $\pm 5.96\%$ wt, therefore the ILI contractual sizing specification was exceeded

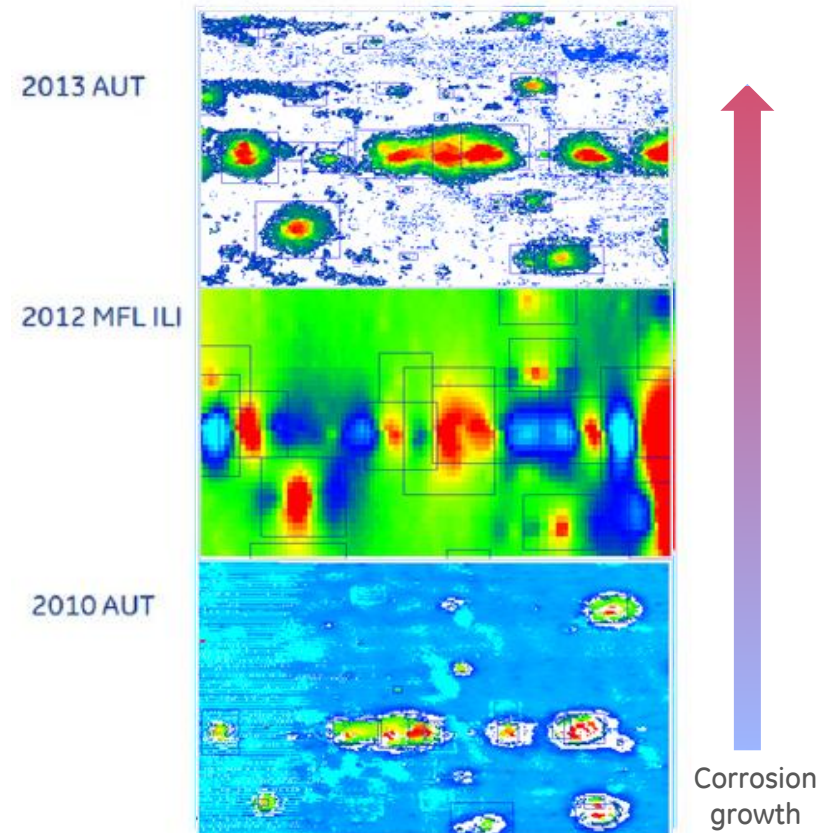
Several sites had been scanned using Auto UT previously

- Corrosion Growth rates were determined by matching and comparing the depths
- This was carried out using the DigCom software using the MFL ILI data as a reference to enable defect matching
- Sample is considered representative
- In order to complete the integrity assessment on these defects a combination of the measured defect morphology was used (MFL ILI and AUT)
