## **FEASIBILITY STUDY FOR AN UNPIGGABLE SUBSEA PIPELINE A CASE STUDY OF AN OFFSHORE PIPELINE**

James Stewart, Inessa Yablonskikh,  
Baker Hughes, a GE company (BHGE)

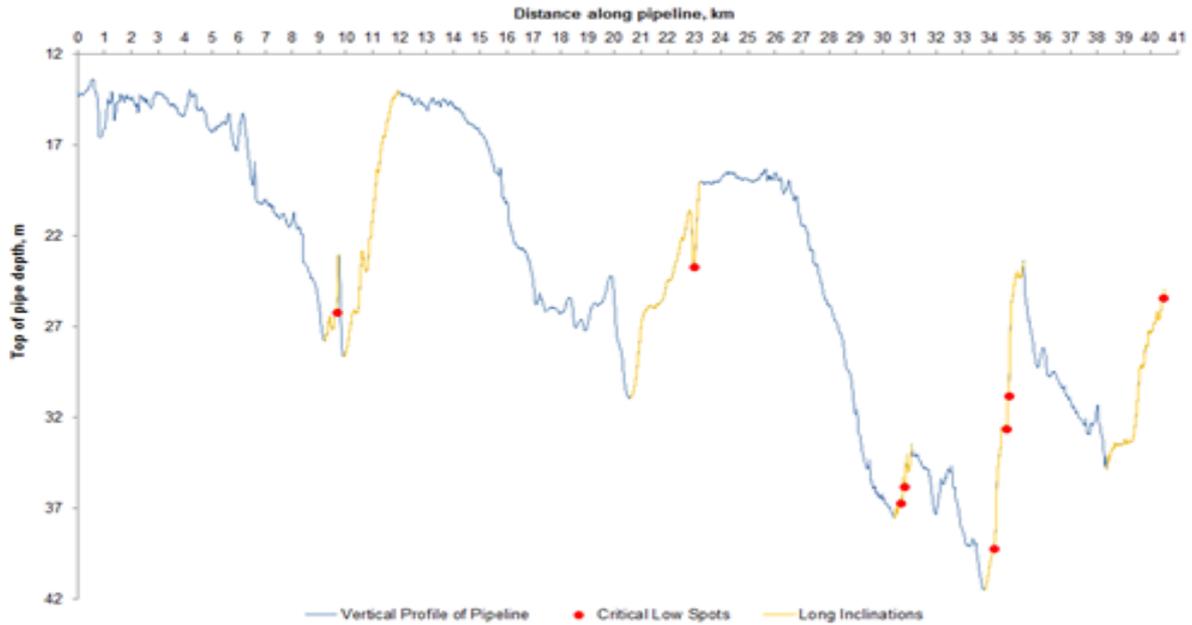
NACE SP-208 provides an approach to predict water accumulation in a pipeline based on the critical inclination angle. The pipeline inclination angle, which corresponds to a rapid drop of the in-situ water velocity, is a critical angle. Segments of the pipeline upstream from such an incline are locations where water would be expected to accumulate and should be considered for examination. In the case of the

subject pipeline the inclination angle of 2° was determined to be critical for water accumulation. The most critical low spots and inclined sections in the subject pipeline are presented in Figure 1 below.

**Figure 1 - Critical Low Spots and Long Inclined Sections in the Pipeline**

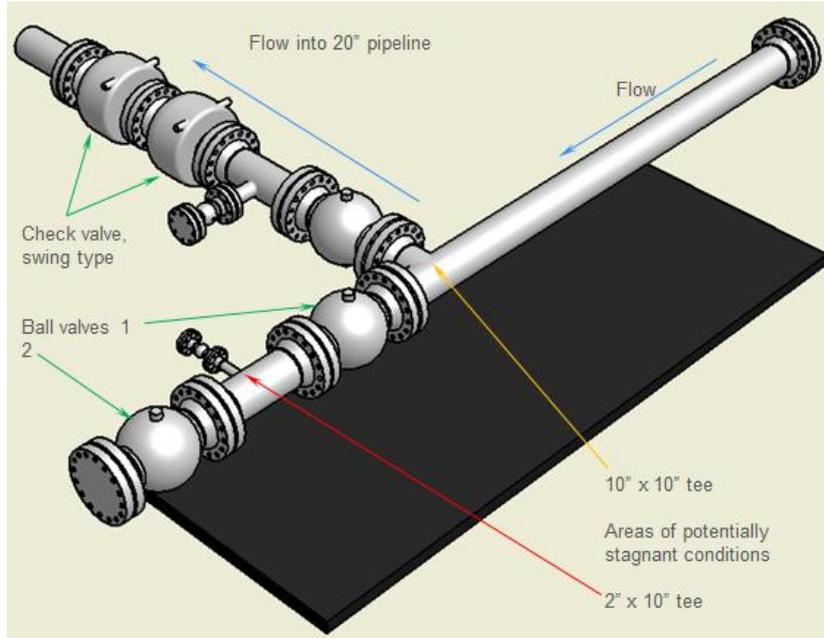
During the review, it was determined that the most likely area for this to occur in the line would be the PLEM (Pipeline End Module) (Figure 2). It was found that due to the configuration in this area the bottom part of the tee may be susceptible to water, solid and wax deposition and microbial accumulation.

Figure 2 - Pipeline End Module (PEM) Configuration
