NAVIGATING DIFFICULT UNDERWATER INSTALLATIONS - AN ILI CHALLENGE

Primary Author: Viviana Martinez, 3P Services GmbH & Co. KG, Germany

Abstract

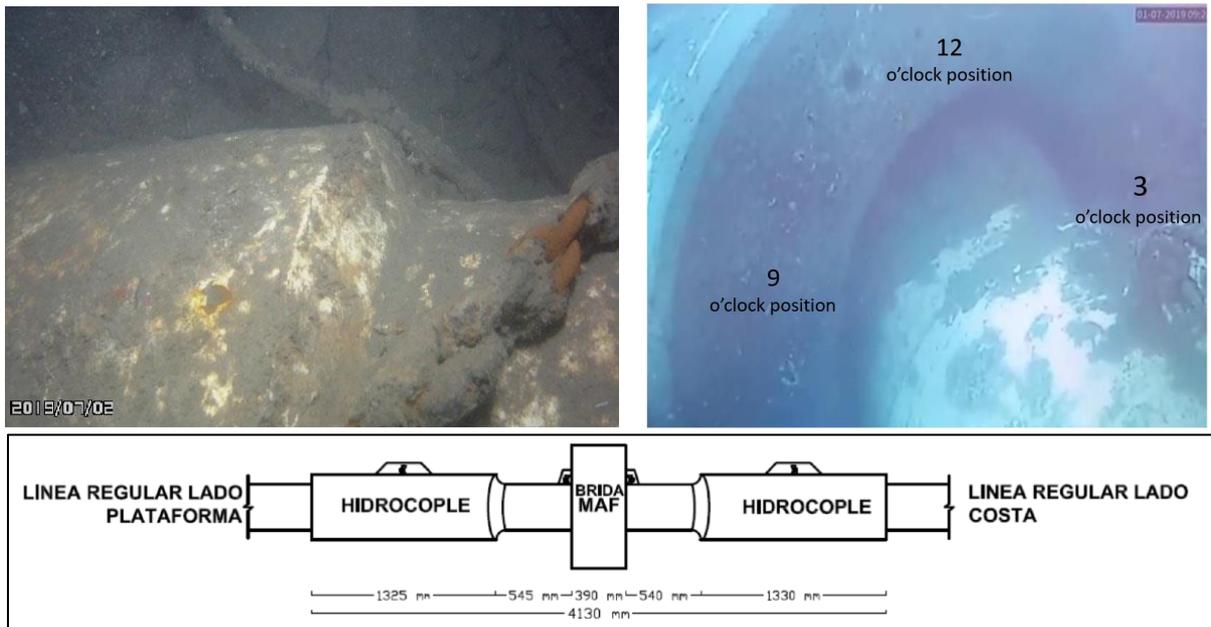
Figure 1-3: Subsea Installation Overview

The installation found by the divers, consisted of two hydrocouplers in combination with a misaligned flange (MAF), which is used by many pipeline operators to carry out repairs or replacement of offshore pipeline sections in reduced time and cost. The MAF flange allows a linear deflection of the pipe of approximately 10° in the horizontal plane.

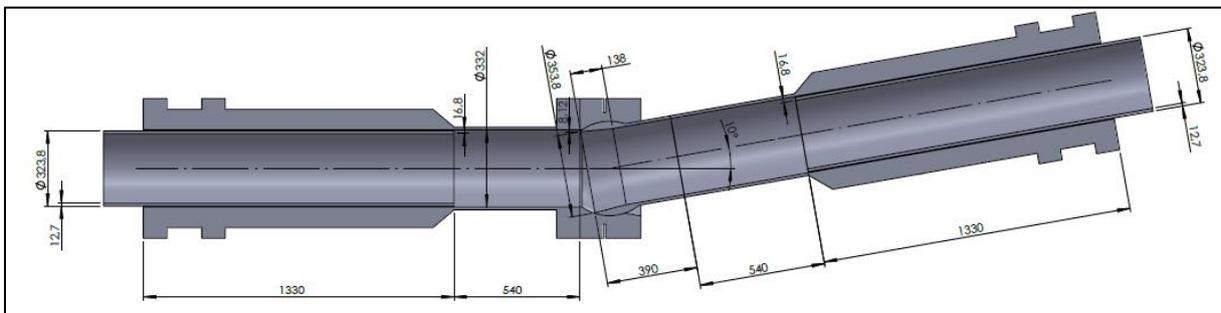
Figure 7: sketch of the subsea installation

The hydrocouple represents sharp edges and severe changes of the internal diameter (ID) of approximately 33.6mm. On the other hand, the ball swallow configuration on the MAF flange has a local ID expansion of 49mm; this, compared to the nominal ID of the pipe, results in an ID difference of almost 2". The combination of these fittings presents a challenge for proper and safe in-line inspection with standard ILI tools for both vendor and operator. 3P Services worked closely with the operator to design and build an MFL tool capable of negotiating the challenging features present in the pipeline without the need for changes to the pipeline configuration or operating conditions.

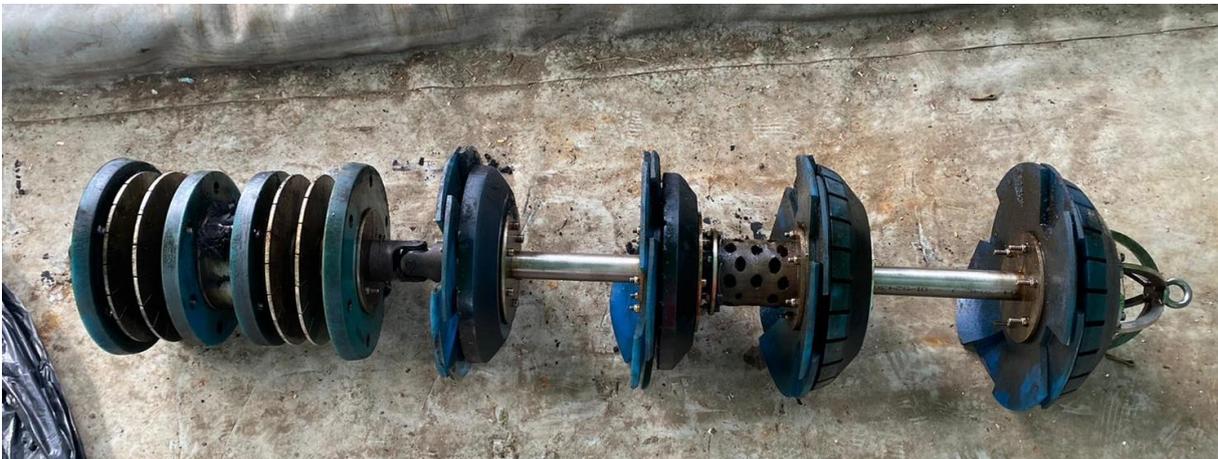
Figure 10: Dummy tool after the run

Prior to the MFL run, the dummy tool was run successfully. No significant damage to the gauge plates indicated a lack of critical restrictions for the identically sized magnetizer of the MFL tool. No significant changes in flow rate or pressure could be recorded during the run of the dummy tool. The subsequent intelligent inspection tool was launched using the same procedure.

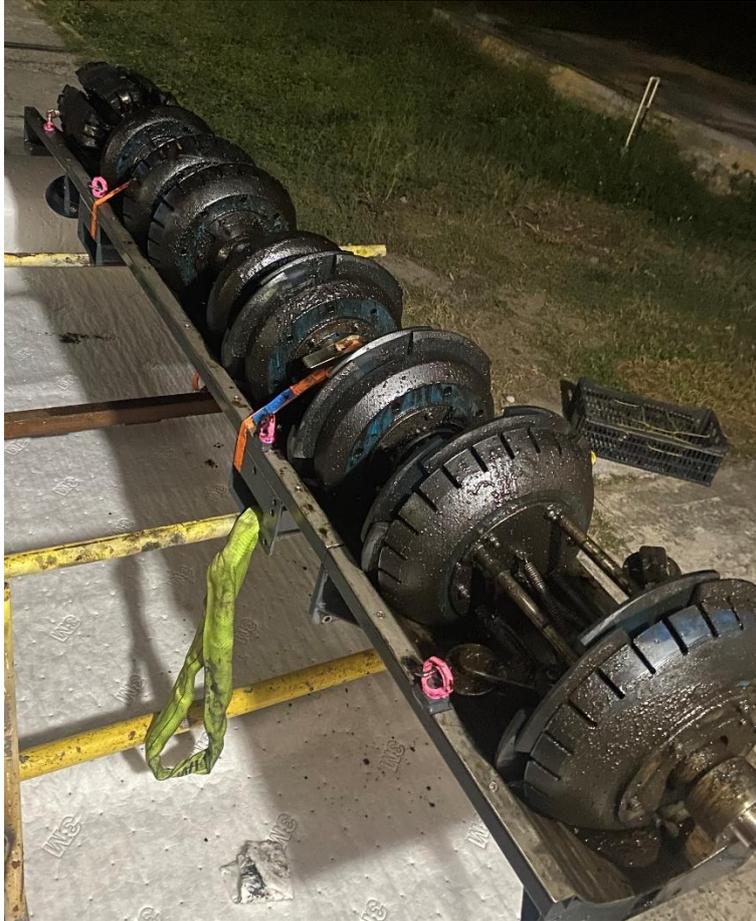
Figure 11: MFL tool after the run

The tool was received in excellent condition, the run was successful, the quality and completeness of the data was checked by the field technician and the analysis department in Germany. No significant changes in flow rate or pressure were recorded during the tool run.

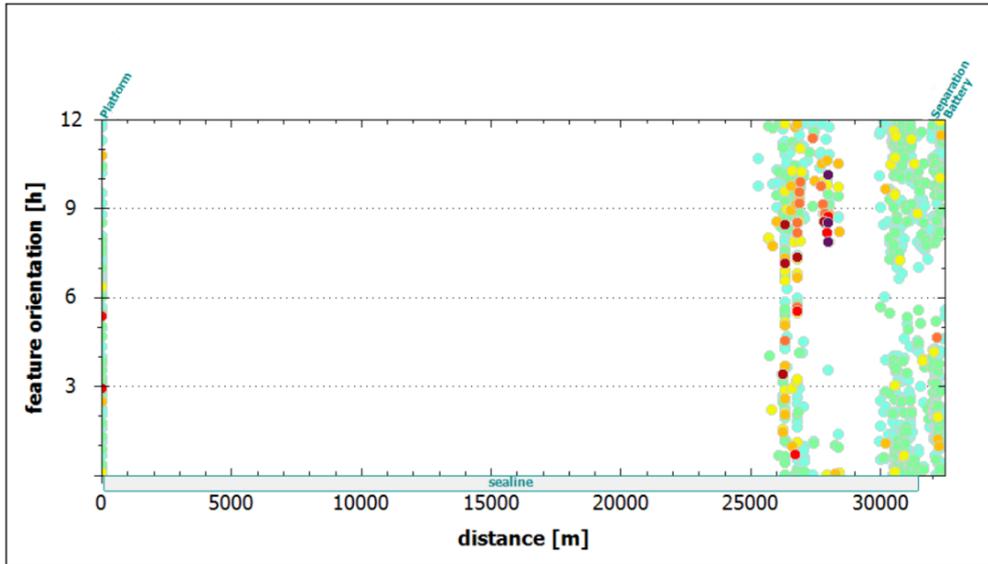
After successful inspection, data was obtained over the entire length of the pipeline. Prior to this inline inspection by 3P Services, no usable data beyond KP 25 was available to the client since the year 2009. Several critical metal loss features were reported downstream of the sequence of subsea installations at KP 25.

Figure 12. Distribution of external metal loss over the pipeline length and circumference

A possible verification of reported indications is currently being assessed by the operator.

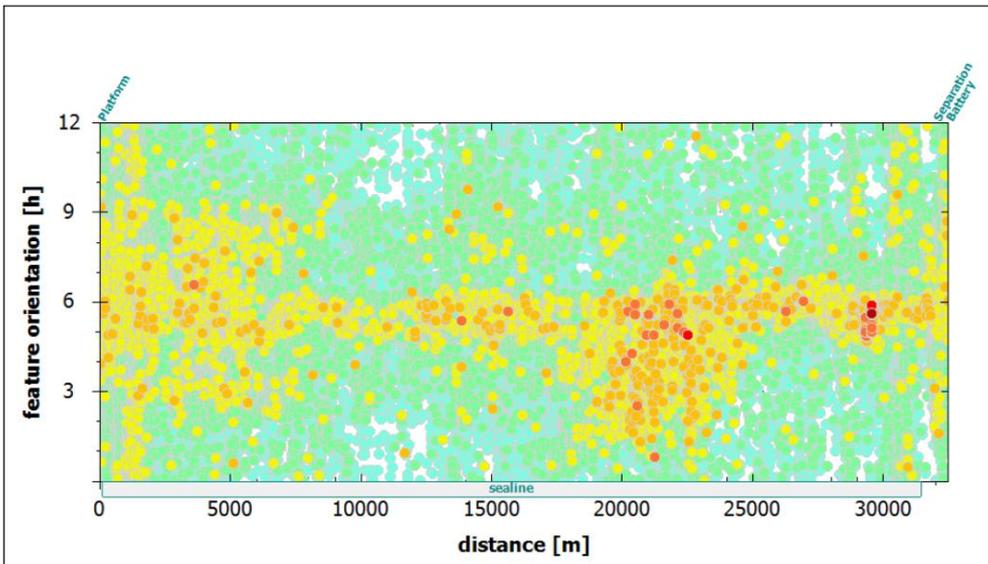
A number of internal metal loss indications were reported. A trace of metal loss in the bottom half of the pipe can also be observed in the data recorded by the MFL tool.

Figure 13. Distribution of internal metal loss over the pipeline length and circumference
