VISUAL ASSESSMENT OF PIPELINE CLEANLINESS FOR CCUS CONVERSION: A NEW DIAGNOSTIC APPROACH: LIVERPOOL BAY CASE STUDY

Authors: Scott Greig - Author¹, Edward Bartlett – Co-Author², Shaun Peck – Co-Author³, Chris Scott – Co-Author⁴

Case Study: 24", 27 km Line in Liverpool Bay

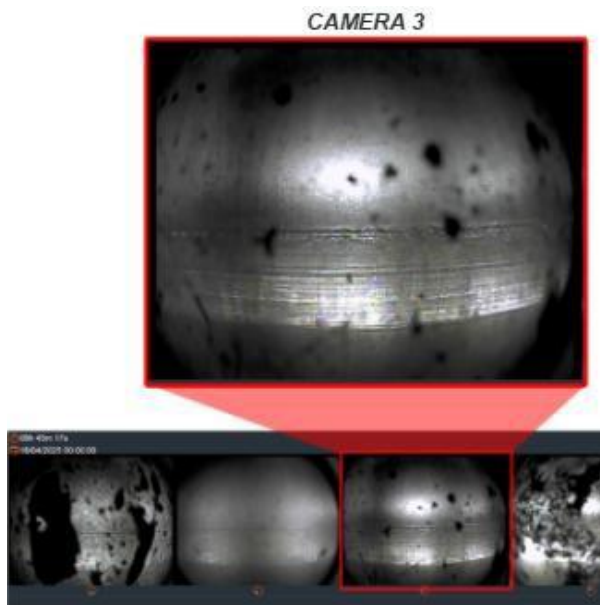
Camera 3

Footage taken ~10hrs into the operation clearly depicting the girth weld of the pipeline. Showing good root weld of the pipeline which has been in service since ~1990.

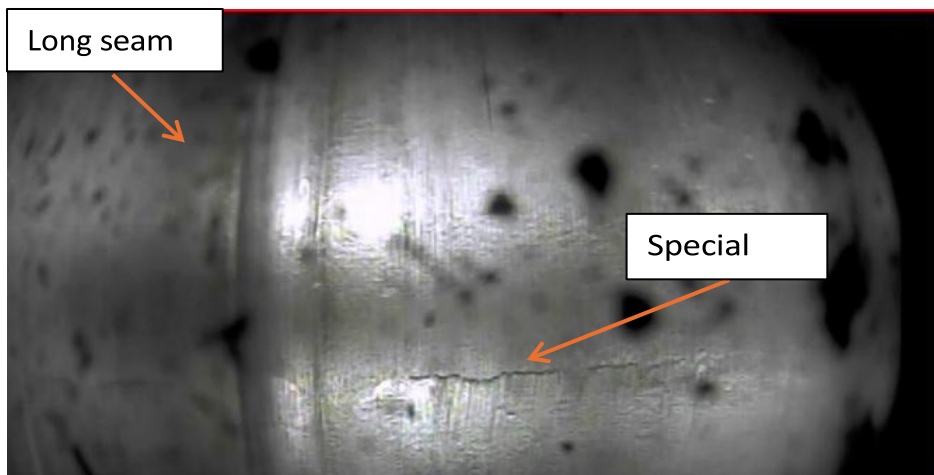
Fig 8: Feature with special interest, circumferential

- No major obstructions, severe corrosion, or gross geometric anomalies were apparent in the footage.
- A feature of special interest (circumferential, >400 mm length; sub-millimetre height) was noted across multiple views at 16:55:33, referenced to the long seam weld at ~90° position (*Fig 8*)
