Feasibility Study for an Unpiggable Subsea Pipeline

by James Stewart
Integrity Engineer
Baker Hughes, a GE company

November 21, 2017

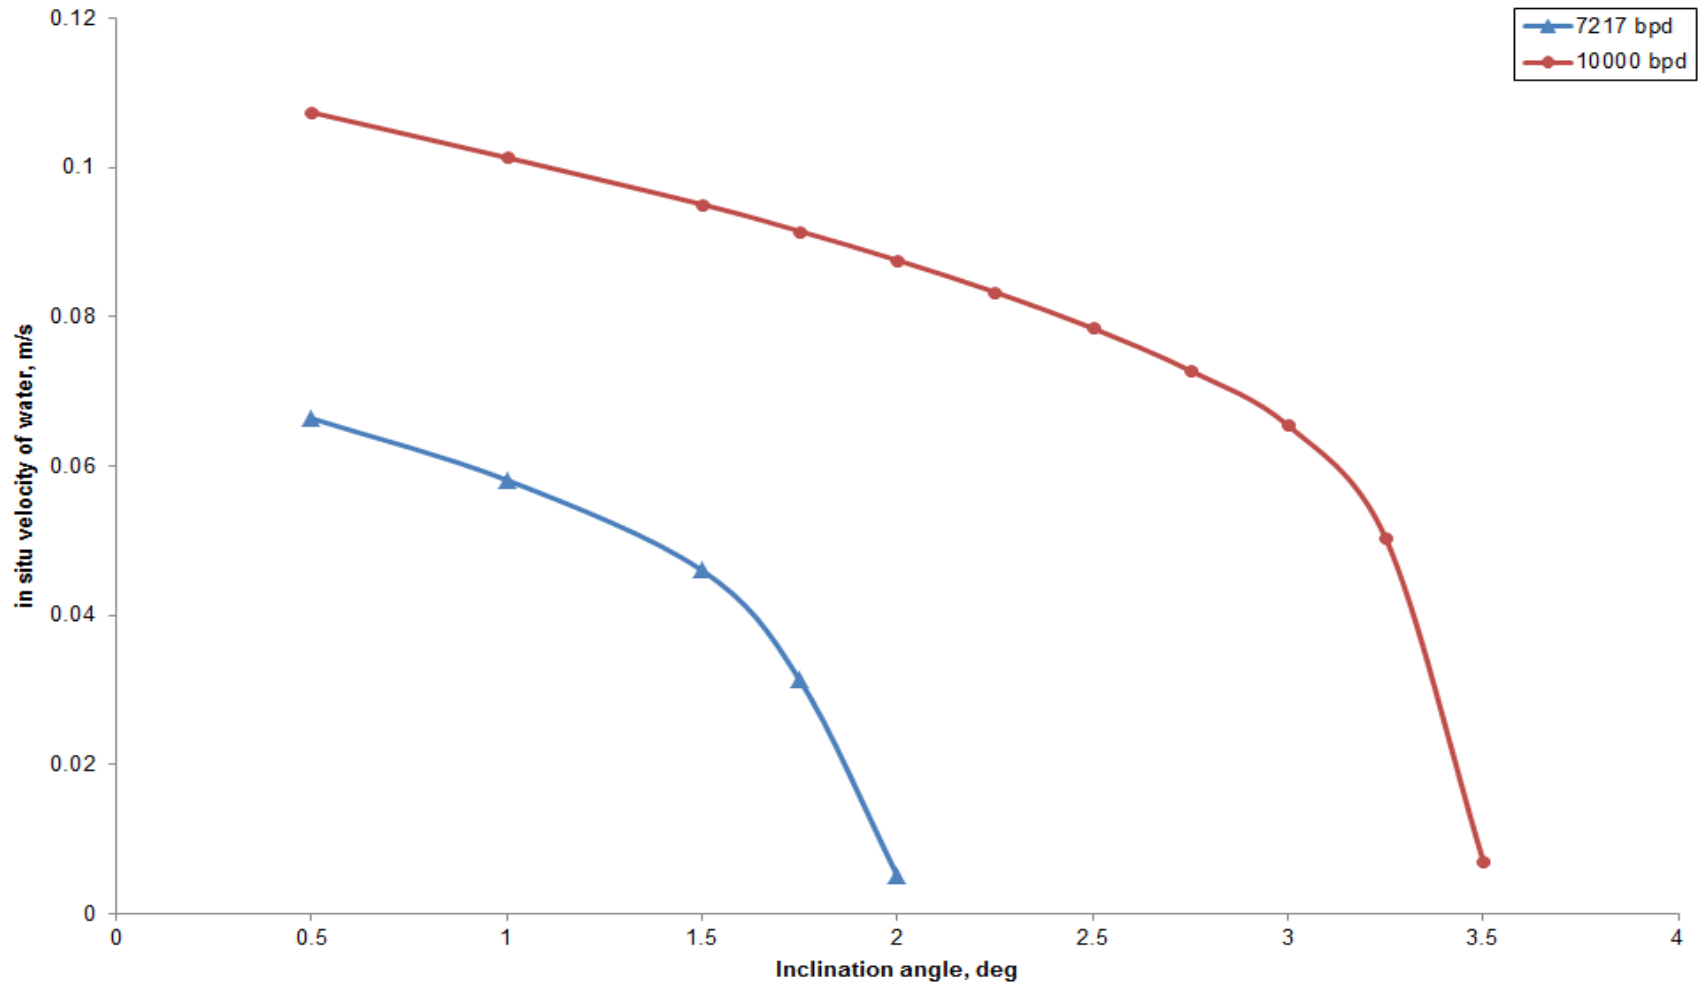
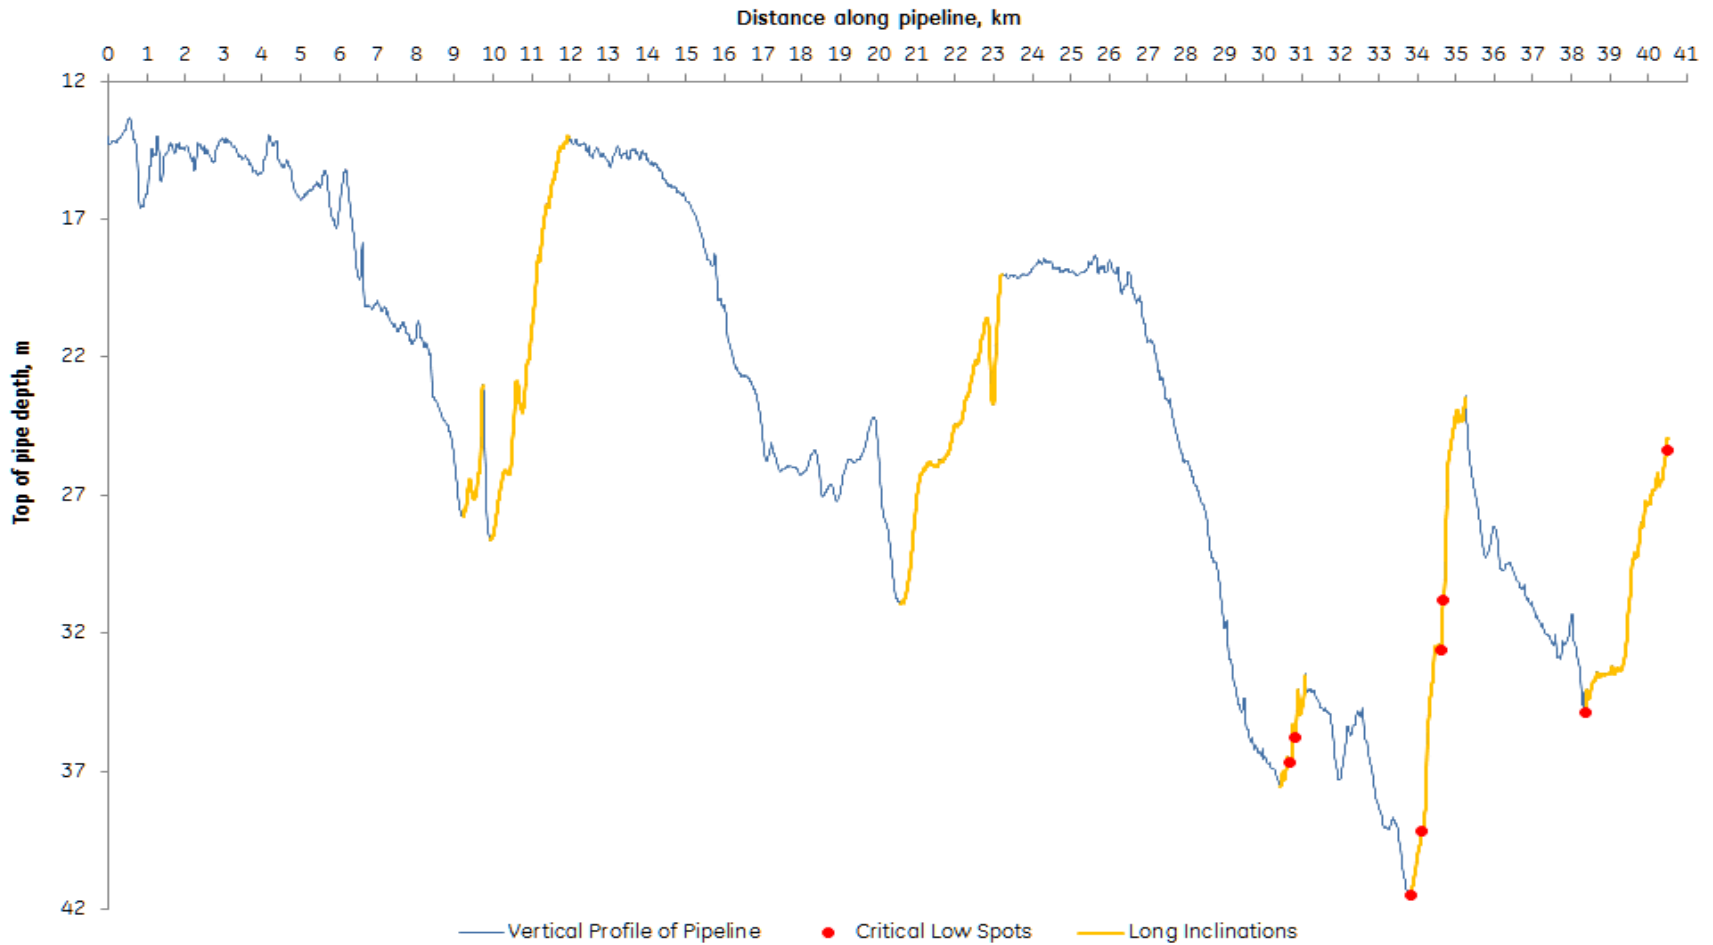
Possible locations of water drop out are:

- Low spots
- Long uphill sections (causing water in oil emulsion separation).
- Sections directly upstream of segments with inclination angle exceeding critical angle for water drop out. [NACE SP 0208, Appendix A, page 25]

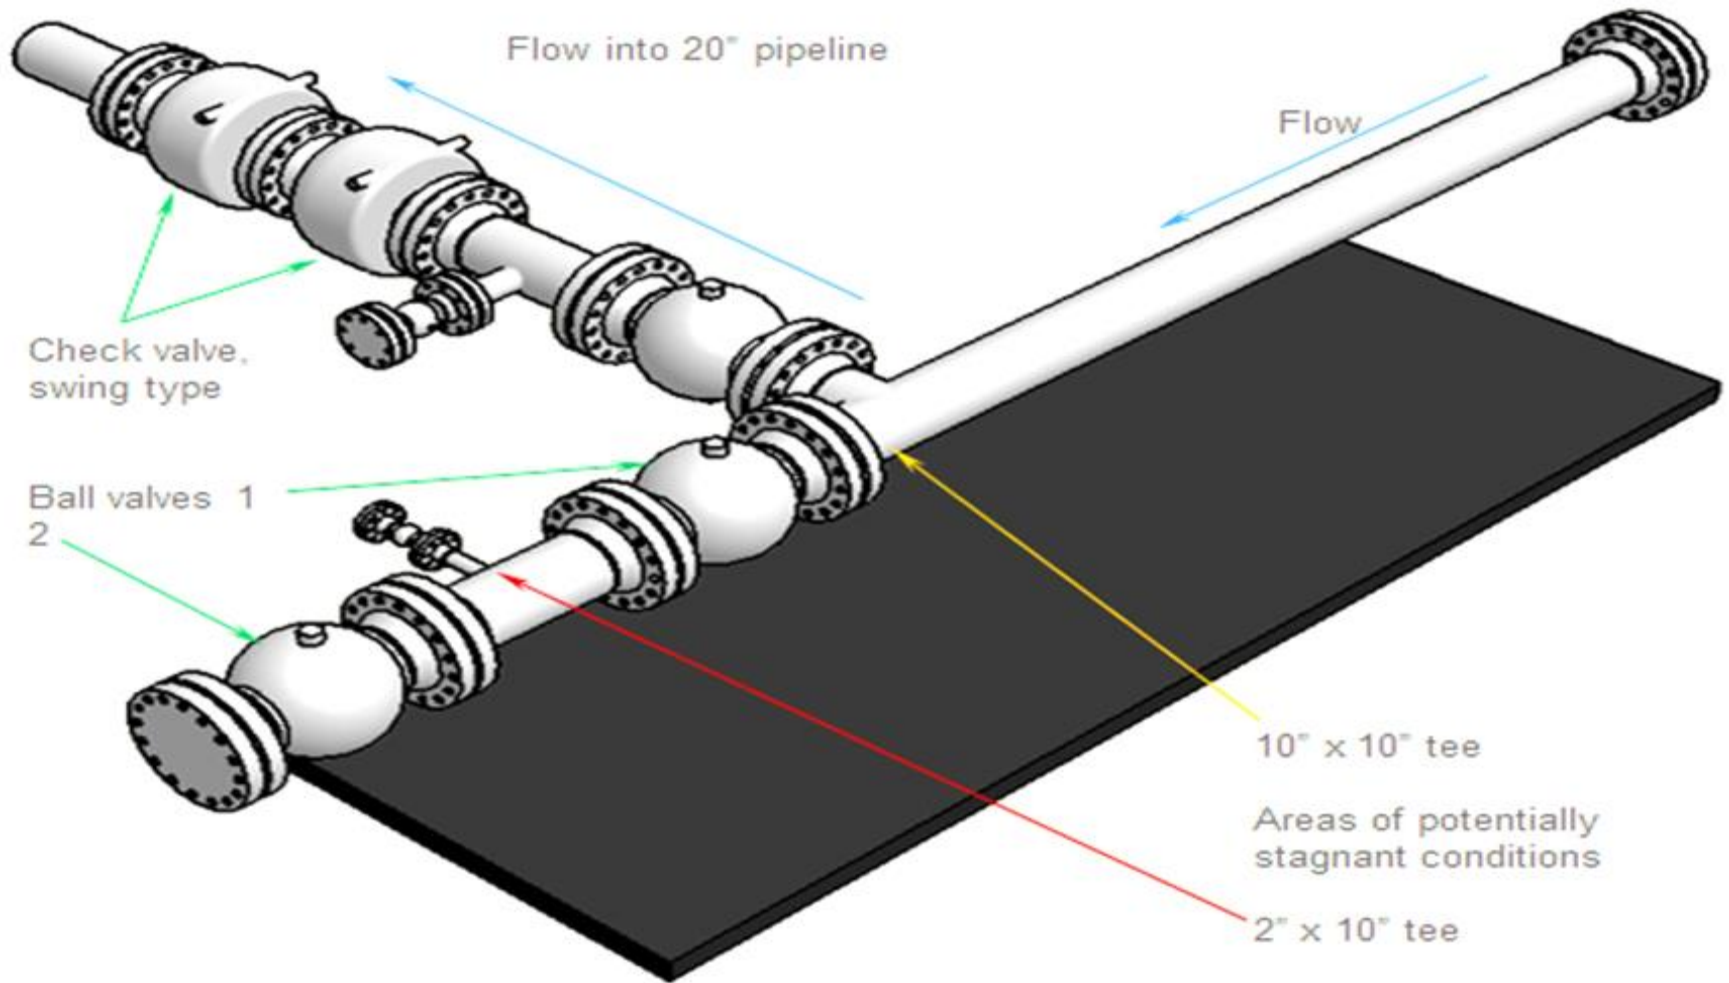
Locations that are predicted to have the highest susceptibility to solids accumulation include (but are not limited to):

- For solids drop out
 - Overbends
 - Isolation valves, fittings
 - Pipeline diameter increases
 - New product inlets
 - Long uphill sections
- For water, solids and microbial accumulation
 - Stagnant areas, facility components or fittings that rarely or never experience flow (dead legs, tees)

Four locations prioritised in terms of success for an Auto-UT inspection in finding internal corrosion

2 low spots @ 22.980 km and 34.683 km along the pipeline

2 locations within the PLEM, bottom of 2" and 10" tees.

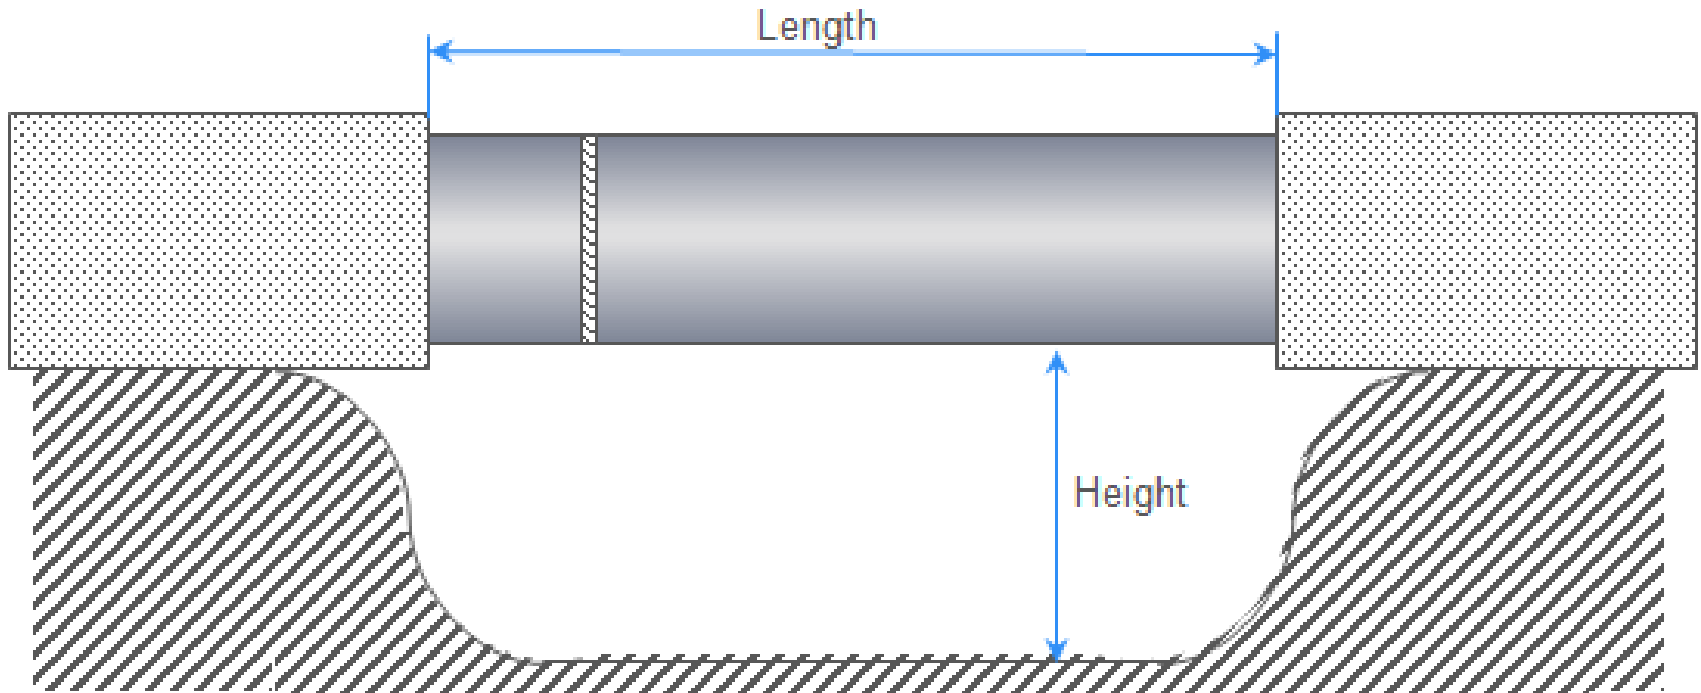
NACE SP 0208 does not provide general guidance on the required length of each Auto-UT site. However the standard practice contains some recommendations for pipelines susceptible to solid deposition and flow disturbance by pipeline fittings.

- Valves (downstream joint or 5 m minimum)
- Diameter increases (downstream joint or 5 m minimum)
- Overbends (5 m downstream, beginning at overbend)
- Injection points (5 m downstream, beginning at injection point)
