February 2016

Pigging Industry News

the newsletter of the Pigging Products & Services Association

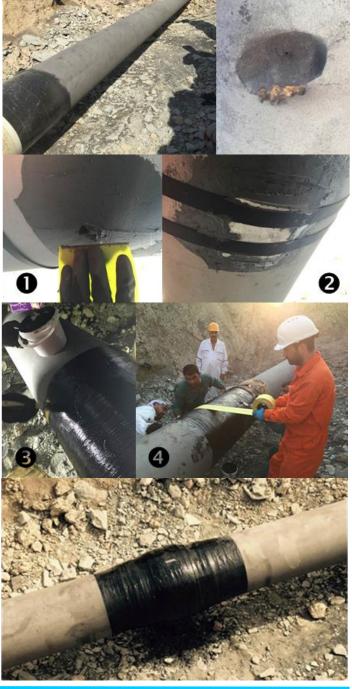
3X Engineering's composite repair

- After calculations and Finite Elements Analysis (FEA), 68 layers have been determined to perform the repair.
- Because of the leaking defect the repair was performed offline. An initial sandblasting was made prior to 3X intervention to get a rough surface (75-micron surface profile).

- Before wrapping, climatic conditions had been checked and the surface had been cleaned and degreased.
- The wrapping repair was performed as follows:
- 1/ Special filler (F3XS1) application to rebuild the surface.

- 2/ Metallic steel plate (with filler), fixed with straps during curing time, installed over the defected area.
- 3/ Second filler application performed to ensure the proper impregnation of the first layer.

Thanks to the efficient collaboration between 3X and its local distributor, the pitted areas have been repaired using the REINFORCEKIT 4D-ECHT and the pipeline is now protected from external corrosion. The pipe integrity has been restored and the pipeline has been pressurized successfully back up to 153 barg.
