DEVELOPMENT OF THE PATHFINDER FOAM CALIPER PIG

By: Peter Ward, Pipeline Innovations Ltd, UK

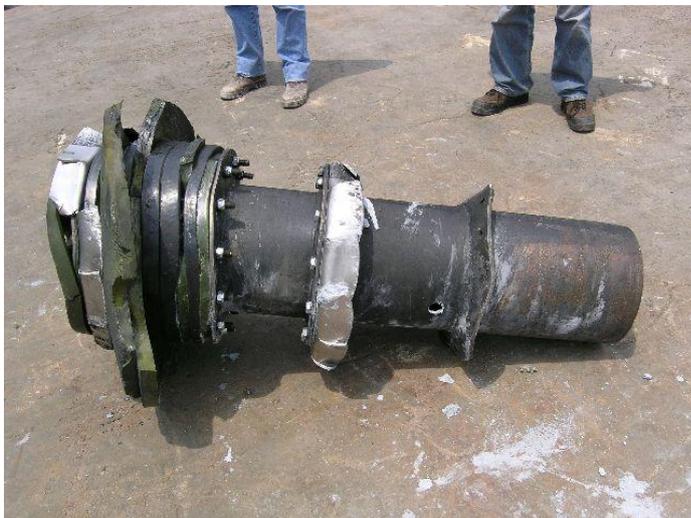
Figure 1: Gauging Pig After Recovery from Sea Line 2

However, when the gauging pig was run, it was severely damaged and the rear disc stack was completely stripped off the pig and left in the line (Figure 1). Clearly the restriction in this line was much more severe than in Sea Line 1. Fortunately the pig had not been completely stuck in the line and by measuring the damage we were able to figure out the key design parameters of a caliper pig which should be able to get through the restriction in the bend at the bottom of the riser.

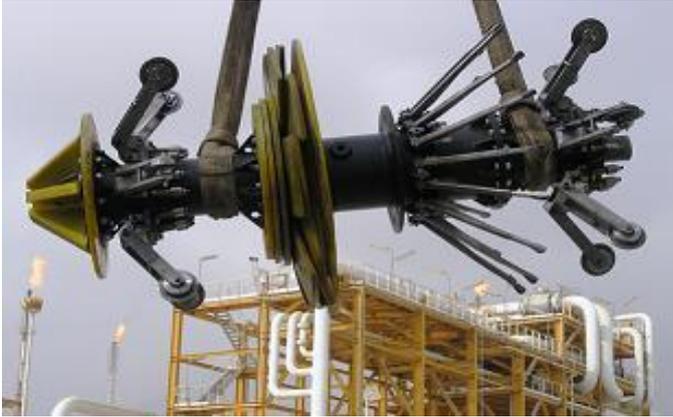
Figure 2: Caliper Pig After Recovery from Sea Line 2

With help from the engineers at Propipe, a caliper pig was produced and much to our relief, it passed through the line without a hitch. Once again, data from the caliper run was used to produce a mapping of the scale deposits and this time the post cleaning caliper run showed that the deposits had been successfully removed.

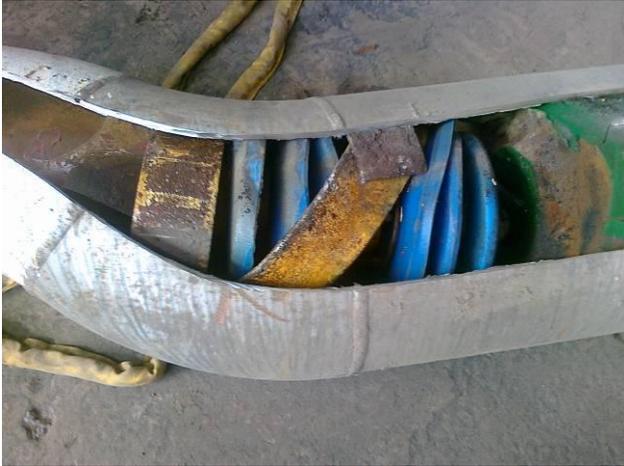
Figure 3: Bi-Di Pig With Dislodged Anodes

The first job that we were offered for the Pathfinder tool was a refined products pipeline owned by Exxon Mobile in Naples, Italy. The 12" x 3.5km pipeline runs from a dockside terminal to a tank farm on the outskirts of Naples. The pipeline had been decommissioned in preparation for MFL inspection. As the line had never been pigged, a standard soft foam pig had been run through the line followed by a bi-di gauging pig. The gauging pig had become stuck in the line and following the cut out of the pig, it was evident that internal ring anodes had been dislodged by the gauging pig, causing it to hang up as it traversed a bend. Since the pipeline records contained no information concerning these anodes, the extent of the problem would have to be determined before running MFL or UT pigs or even a standard calliper pig through the pipeline.

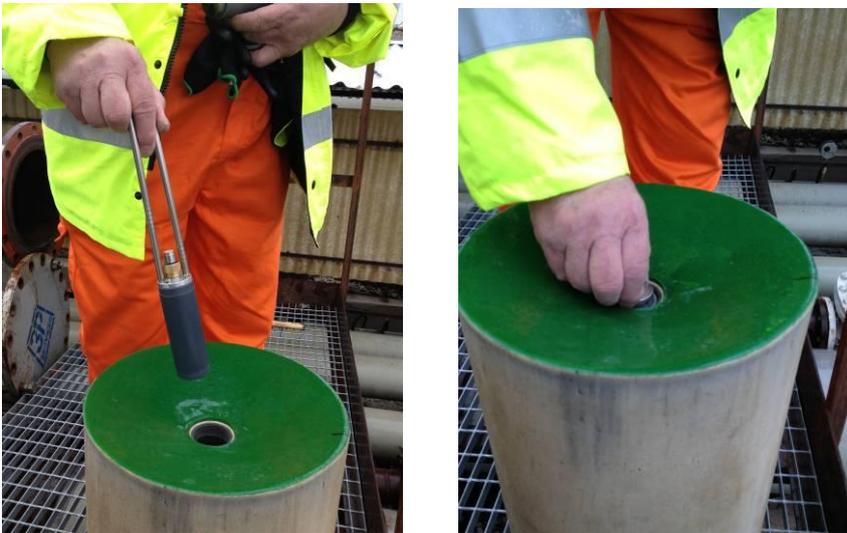
Figure 4: Loading Caliper Module and Transmitter

The foam caliper survey was carried out in April 2012 in conjunction with Tecma Pipeline Services S.r.l, who provided the operations support for running the pig. From launch to receive, the pig run took approximately 3 hours, with the pig running at an average speed of about 0.3m/s. When the pig was removed from the receiver, it was observed that the foam at the front of the pig body had been damaged but the rear section, where the caliper system is located, was in relatively good condition. Communications were established with the caliper data-pack and it was found that a full dataset had been recorded and the quality of the data was good.

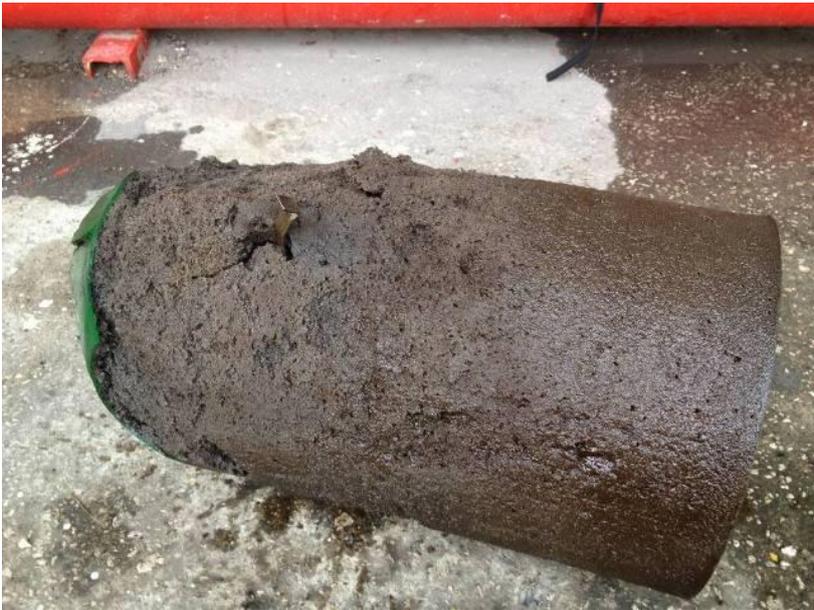
Figure 5: Anode Retaining Strap Embedded in Pathfinder Pig Body

Using the roll sensors, the tilt sensor and the characteristic response of the caliper sensors it was possible to identify the type and direction of a total of 80 bends in the pipeline. By reference to the strip maps of the pipeline it was possible to correlate bends identified in the data with bends indicated on the maps. As the bends were distributed along the length of the pipeline, this provided regular 'markers' in the time based data, allowing the location of other features in the line to be accurately identified. Anode features in the line were identified by comparison with the caliper response to simulated anodes in the test loop at PIL. A total of 144 internal anode features were positively identified and using the bend marker data, the location of each of the anodes on the strip maps was pinpointed.

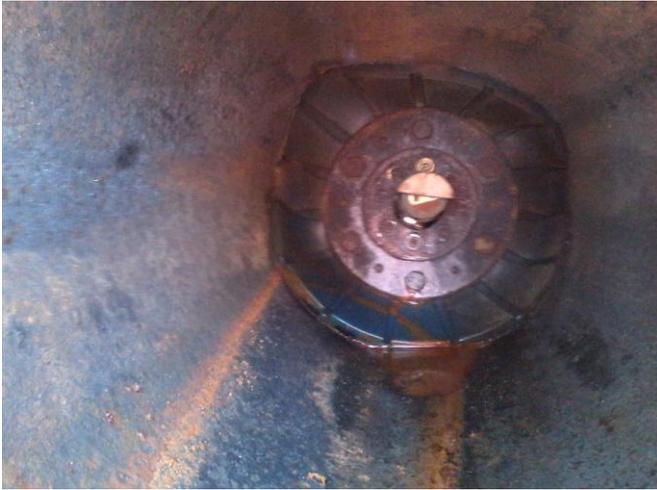
Figure 9: Bi-di Pig Stuck in Restriction

A bi-di cleaning pig with a transmitter was then run through the line until it became stuck in the restriction and a diver with a receiver was deployed to locate the exact position of the transmitter on the sea bed.
