Pipeline Decommissioning – Cleaning PPSA 16.11.2022

Pipeline Decommissioning – Veslefrikk

Veslefrikk 16^{..} Oil Export Pipeline

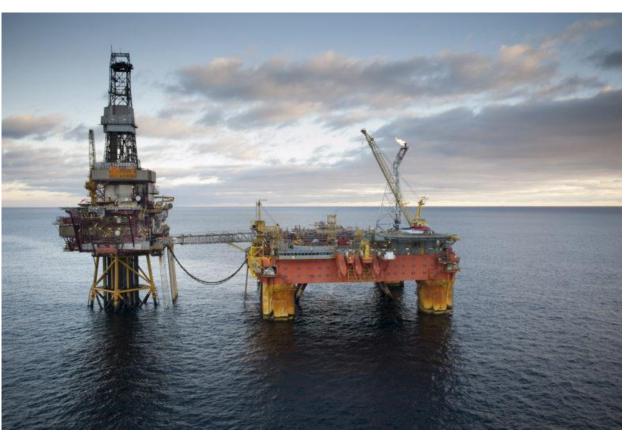
Export pipelines at the Veslefrikk field:

- 25 km, 10" gas export pipeline from Veslefrikk A to Statpipe pipeline, connected by Veslefrikk Tee structure
- 37 km, 16" oil export pipeline from Veslefrikk A to Oseberg A via Veslefrikk Y structure

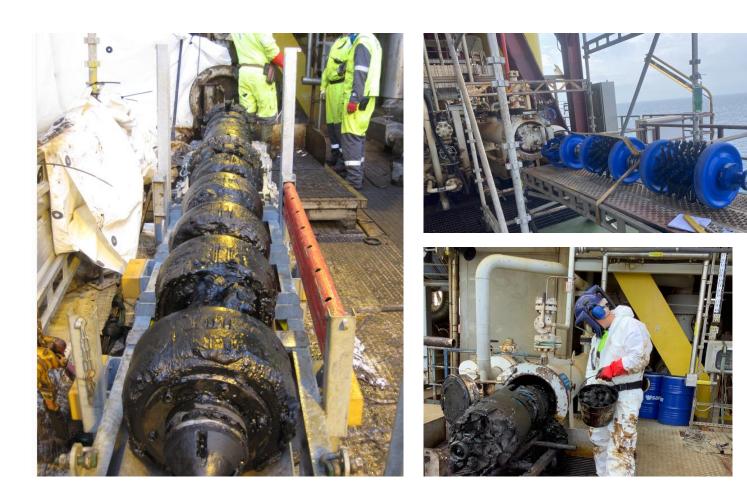
Pigging History of the 16 "Veslefrikk Oil Pipeline

- ILI 2006, 2013 and 2018.
- Heavy wax pipeline, operational pigging optimized.
- Precleaning program and wax inhibitors from March 2021.

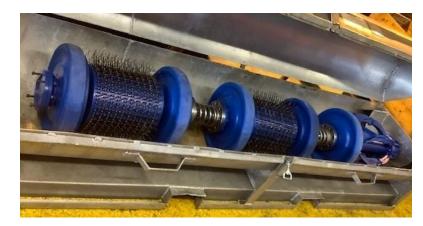
Decommissioning Pig Train

- 20m³ batches of wax dissolving chemicals and sea water.
- Customize pig designs.
- Two isolation tools last.

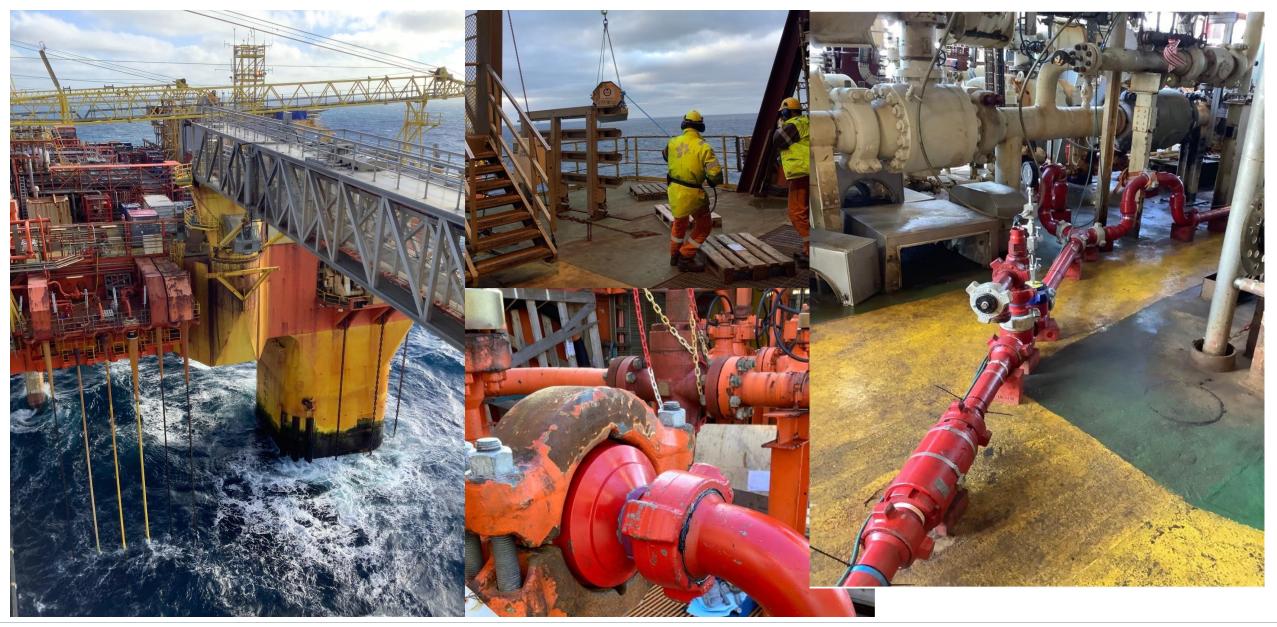
Pig detection/setting of isolation tool with E-Rov

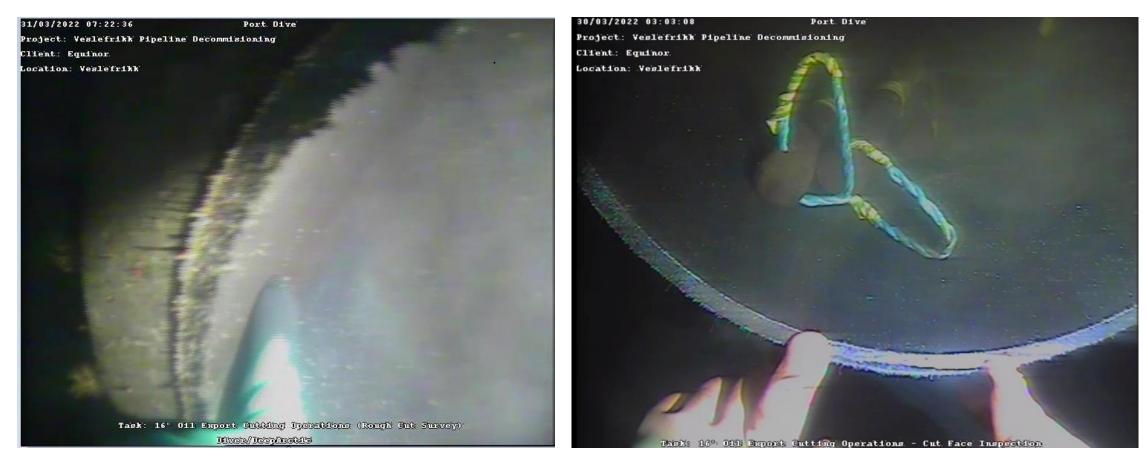
Clean 16" Oil Pipeline

. The dive supervisor asks about the quality of the pipe and the diver responds as follows:

- At 07:22:10 the diver confirms the pipe is in 'good condition'
- At 07:22:20 the diver confirms there is 'no scale or damage' and that it's 'good clean pipe'
- At 07:22:38 the diver confirms there is 'no trace of oil'
