June 2014

Pigging Industry News

the newsletter of the Pigging Products & Services Association

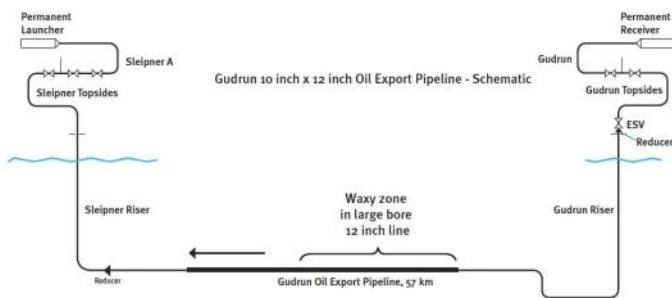
Overview of Gudrun Oil Export

The oil line is 10" x 12" with 10" risers and a 12" pipeline where wax is expected to deposit. This deserves special attention in order to control this wax. Initial pigging frequency will be weekly. The diameter change is 23% and the challenge is to clean the wax from the large bore pipeline as effectively as possible. By their nature, dual diameter pigs are not aggressive in the large bore pipeline. Pig design, development and testing have been performed to establish a more aggressive pig for this pipeline without compromising its ability to negotiate the line.

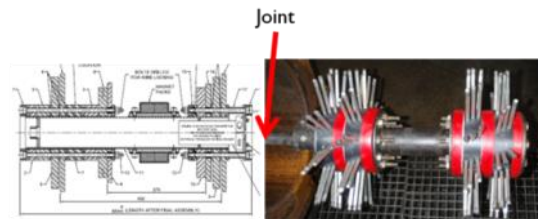
Tow Pig: -
 • Optimised for aggression;
 • Magnets;
 • Data logger;
 • Bypass (Maximise in 12");
 • Flushing action over body?

Trailer Module: -
 • Brushes (stainless);
 • Capped / collars;
 • Torsion springs

Schematic of the Gudrun Operational Pig

The tow module is an aggressive version of the Flooding, Cleaning and Gauging pig with thicker guide discs for example. The trailer module is an aggressive brush module with specialist brushes to withstand the change in diameter to allow good scraping in this diameter.

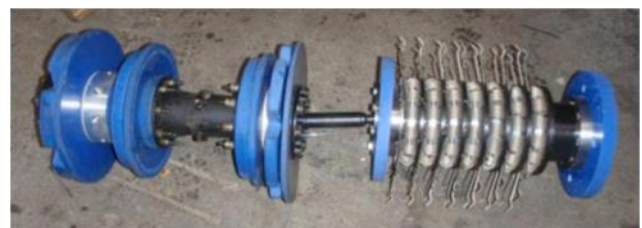
Final Gudrun OE Operational Pig

All were trialled and all were successful but the Torsion spring style module was considered to be the best for ploughing up the wax and preparing it for removal by the next pig.

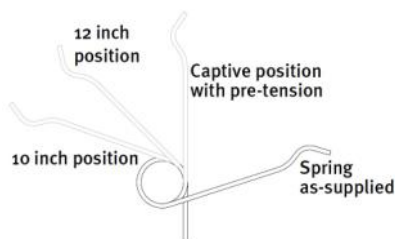
Action of the Torsion Springs

A torsion spring can have angular deflections up to 270 degrees. This means that they can be held in tension and deflect through 90 degrees from one diameter pipe to another.

The small contact area means that the resulting force can penetrate through the wax to the pipe wall thus ploughing it up in preparation for the next pig run.

The operation of the torsion springs are noted below. By its very nature, a torsion spring is ideal for dual diameter pigging in general as large angular deflections can be accommodated (90, 180, even 270 degrees rotation). Pre-tension can be designed in, thus maximising the force on the pipeline wall in the large bore. The large deflection and small contact area with the wax makes it ideal for any diameter change and penetration of hard wax deposits: -

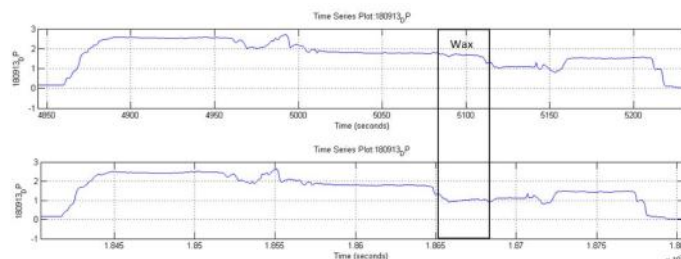
Two dewaxing Pig runs during tests (using data logger)

The graphs show data logger output during the initial run to remove a short section of 6 mm thick hard wax (top plot) and the second run (lower plot). The reduction in differential pressure over the hard wax zone shows that the majority of the wax has been removed. By comparing this to a base case run in the line it is possible to monitor the pigs ability to control wax in the line. ●

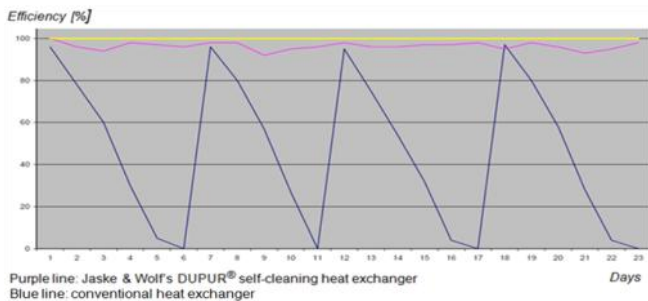
The chart shows the efficiency over the first 23 days. The system is successfully proven and has already operated for over 25000 hours. Today, further heat exchangers with permanent cleaning pigs are in operation in several industries. The pig run intervals can be adjusted as needed, e.g. regulated by differential temperature. In this specific case, cleaning pigs circulate every 30 minutes. The pigs remain in the system and can be replaced quickly if required.

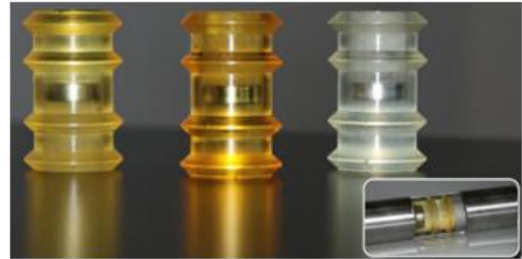
Fig. 1: permanent cleaning pigs for different conditions.

The lifetime of the pigs depends on the kind and amount of debris. Some pigs were removed after 4 weeks. Other pigs have been running for over 3 years.

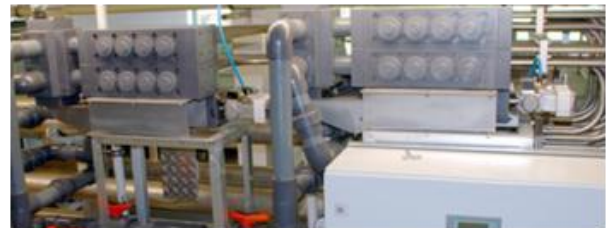
Fig.: 2 pig stations (dark grey boxes), each station controls 4 pigs in 4 different pipelines

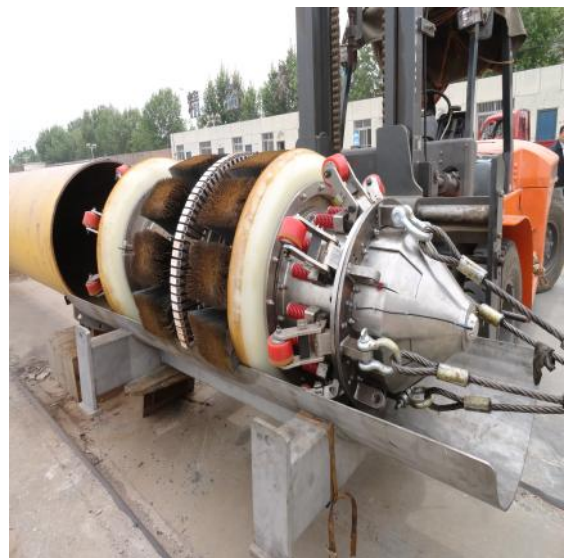
CPPI launches 40" and 48" Tri-axial MFL inspection tool ●

The 40inch and 48inch Tri-axial MFL inspection tools will continue to assist pipeline operators in improving pipeline integrity. The Tri-axial MFL inspection tools is currently available in 20inch, 28inch, 40inch, 42inch and 48inch.

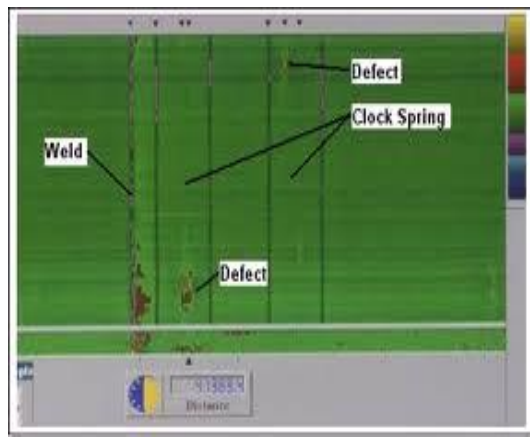
Figure 1. Detection of Marker Bands by MFL tool. The Clock Spring is situated between the two marker bands

Clock Spring Marker Bands are steel bands that are installed at each end of the Clock Spring repair. These bands are clearly detectable by MFL inspection tools and they indicate the position of a Clock Spring repair. Figure 1 shows MFL readings of two defects close to a girth weld that have been repaired with Clock Springs that had the markers bands installed.

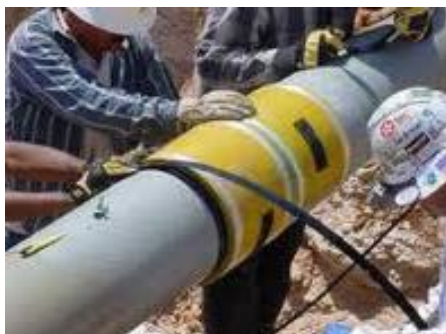
Figure 2. Clock Spring Marker Bands being installed

Figure 2 shows marker bands being installed. Figure 3 shows the marker bands installed over the repair however, you will see in Figure 2 that some operators prefer to install the markers bands outside of the repair area. This is an acceptable method providing that the marker bands are well insulated from the pipe ensuring that metal to metal contact is not possible. Both methods of installation are in accordance with Clock Spring's documented literature.

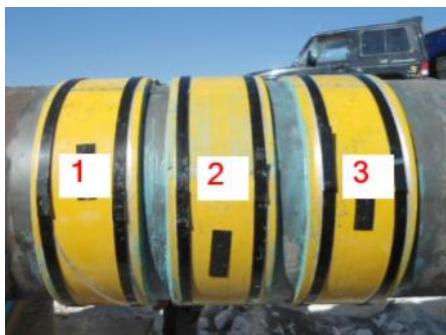
Figure 3. Clock Spring Marker Bands installed as per standard procedure

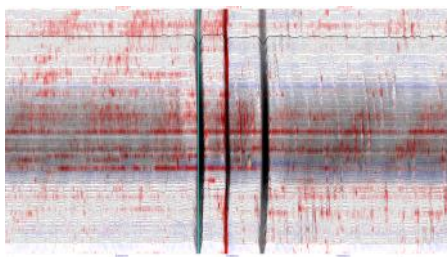
Figure 4: The Clock Spring Marker Bands are seen along with a girth weld

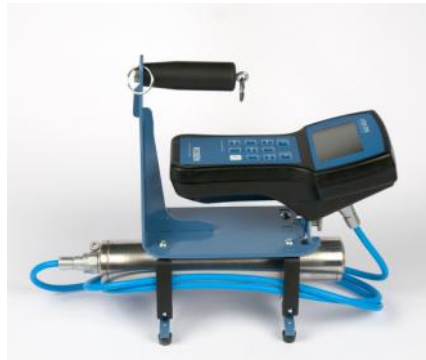
ATEX EPD with carrier

The new ATEX EPD combines essential features of previous receivers. In addition, the partially very weak electromagnetic fields can be displayed on an LCD display with the ATEX EPD, improving the readability of the received signals significantly. The new

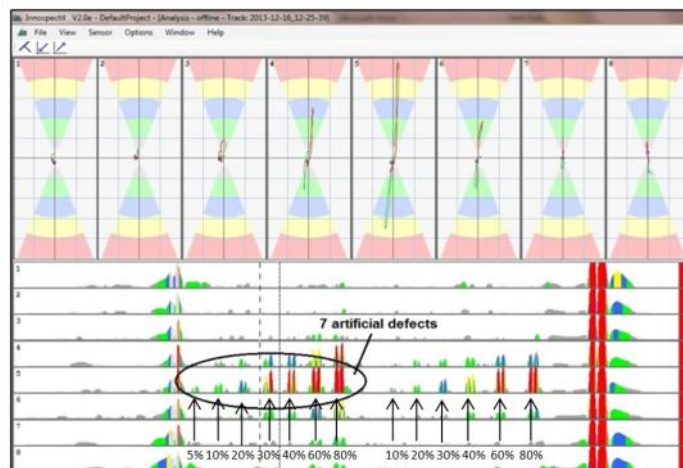
Signals display showing detectability down from 10% wall loss onwards for Ø10mm and Ø20mm internal defects on 6" coated riser sample

The full detectability down to 10% wall loss was achieved for both the 10mm external and internal defect on all three coated pipe samples. In addition, this target was exceeded as the MEC-MPS200+ scanner was able to detect the 20mm external defects having a wall loss of 5% on all three coated pipe samples. This demonstrated the superior detection capability of the SLOFEC technique despite the fairly thick pipe coating.
