Pigging Industry News

the newsletter of the Pigging Products & Services Association

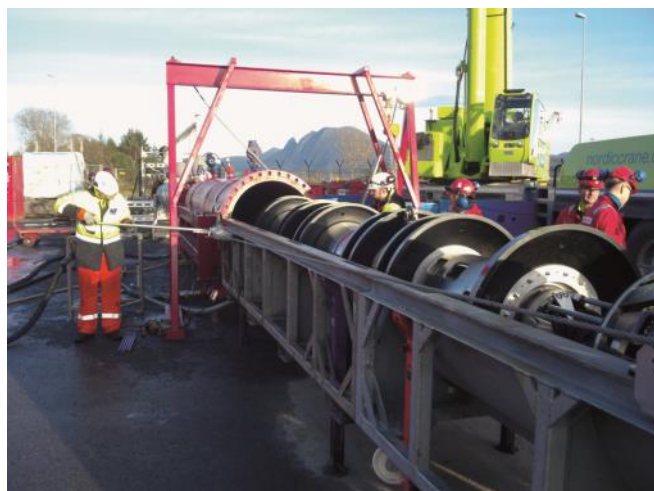
NDT Global's custom solution for an extreme subsea pipeline

NDT Global provided an accurate and detailed baseline survey of **Statoil's** new Polarled gas pipeline. Polarled is the first pipeline on the Norwegian continental shelf that crosses the Arctic Circle which brings both operational and environmental challenges. Statoil utilized NDT Global's ultrasonic technology (UT), a solution that offers highly accurate results for feature depth sizing of their Polarled gas pipeline, a pipeline with varied wall thickness.

The inspection was completed using high-resolution pinhole and pitting (UMp) metal loss inspection technology. This configuration features an optimized sensor carrier design and a high-resolution grid that is unmatched in the industry. The ultrasound measurement is ideal for thick walled pipes used in deep sea operations with depth sizing accuracy of 0.4 mm (0.02 in).

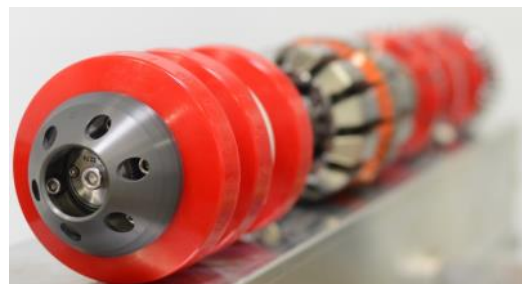
Entegra's ultra-high resolution MFL/Caliper tool

Entegra is pleased to announce the successful pull test of its latest ultra-high resolution MFL/Caliper in-line inspection platform. Weighing in at a mere 55 lbs. and measuring only 4'-7" in length, this 6-inch diameter ILI tool packs in nearly twice the number of primary corrosion and caliper sensors.

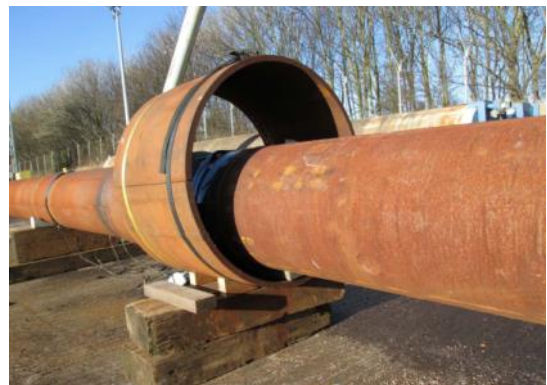
Pull-through line build with simulated caisson and pipe defects at 6 o'clock position

To simulate the wall thickness change of the tapered area, Maersk Oil supplied a pipe section with 31.75 mm wall thickness, which was welded together with a section of 16.1 mm wall thickness using the method closest to that used on the infield pipeline.

Maersk Oil also supplied two 30-inch, 20.3 mm half shells to simulate the caisson present in the operation. These were positioned to ensure that pull-through field levels were the same as those during the infield MagneScan™ inspections.

Three internal defects were machined into the transitional welds: two with lengths and depths matching the critical defect as reported by the two infield ILI runs (80% and 85% WT) and a calibration feature of 55% WT. These were spaced 120° apart around the pipe circumference, and five pull-throughs were conducted with each defect positioned at 6 o'clock directly inside the simulated caisson. All 15 pull-throughs (3 defects x 5 pullthroughs each) were conducted with the same MagneScan™ tool used for the infield inspections, and at the same speed.

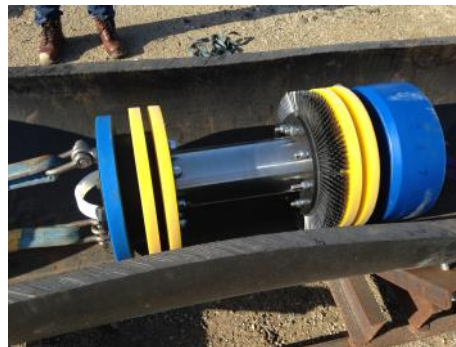
A 16" Pioneer Smart Utility Pig ready for pull tests at PRCI TDC

In 2016 the Pioneer smart utility pig was put through a series of pull tests at the PRCI TDC in Houston, as well as operational field trials to prove up the capabilities of these new tools. The Pioneer tools employ a novel electromagnetic inspection technique that is capable of inspecting in dry gas or multiphase conditions and a maximum standoff of 1" from the pipe wall. There is no requirement to clean the pipeline prior to use and the inspection technology is not affected by speed variations. The tools can be adapted to carry additional cleaning capabilities like wire brush disks and magnets.

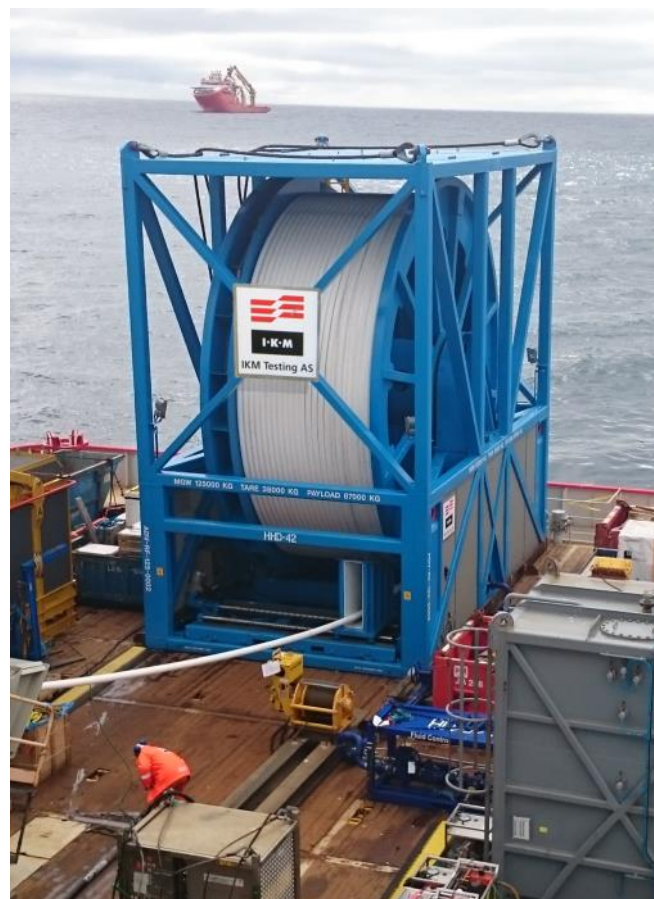
The down line system consists of a reel and 1600m 2.5" ID Thermoplastic Composite Pipe (TCP) downline manufactured by Airborne. The down line and the installation reel was custom designed and fabricated for the project.

Parameter	Requirement
Inner diameter	63.5 mm
Outer diameter	112 mm (+/- 2.5 mm)
Length	1600 m
Pressure rating	5,000 psi
Factory acceptance test pressure	1.5 times pressure rating (7,500 psi)
Downline weight on reel (water filled)	Approx 21 Te (+/- 3 Te)
Brake capacity	15 Te
Constant tension range required for the pipe	10 – 50 kN
Downline bending stiffness (EI) at minimum operating temperature	41 kN*m ²
Minimum barrel diameter	7 m
Minimum bend radius (not on reel)	5.9 m

Reel details: Electro-hydraulic reel with 2-off integrated HPUs, constant tension & remote control

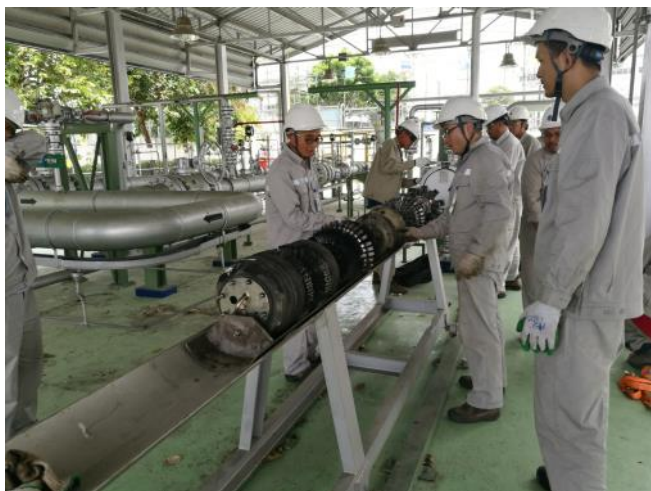
CPPI's triaxial magnetic flux leakage (MFL) inspection tool. ●

China Petroleum Pipeline Inspection Technologies Co., Ltd (CPPI) team successfully inspected a 11.5 km-long, 10 inch diameter gas pipeline in mid August for **PTT** company, Thailand with a triaxial magnetic flux leakage (MFL) inspection tool.

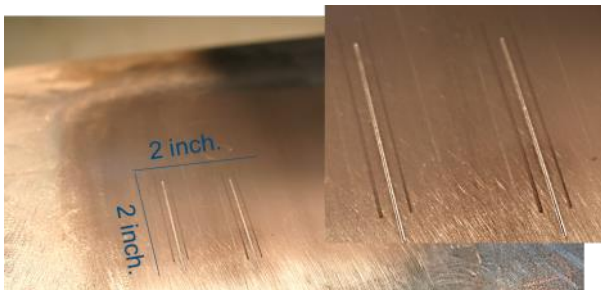
Surface grooves from two HSD Tests on pipe exterior surface

To solve this problem MMT has developed the **Hardness Strength and Ductility (HSD) Tester**, a novel, portable and nondestructive testing apparatus for directly measuring the mechanical properties of pipelines during integrity digs. The HSD Tester attaches to a pipeline to perform a frictional sliding test, where a hard stylus is pressed into the sample material and slides along the surface to form a superficial groove.

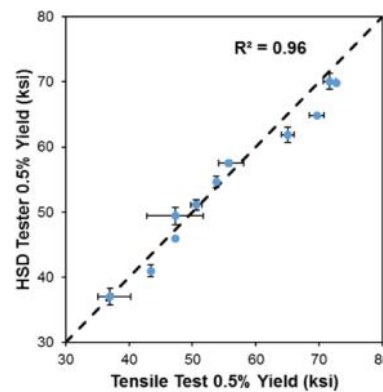
Excellent correlation between the HSD Tester and laboratory tensile tests for pipeline grade steel identification

The HSD Tester is proven for both ERW and seamless pipes through their material database and multiple blind testing projects. They are available to perform additional testing for validation, if required.

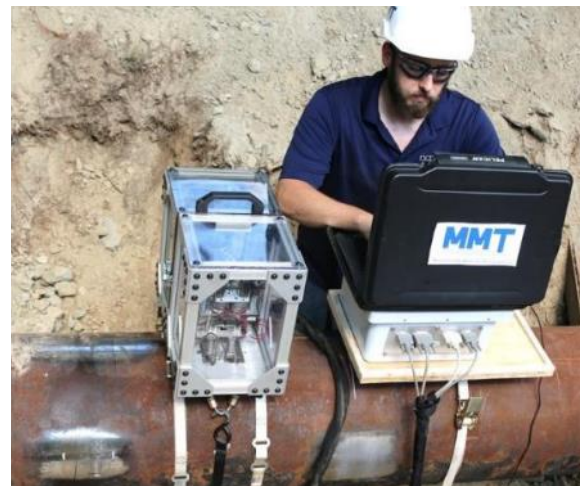
HSD Tester attached to a pipeline in the field

They have recently constructed a protective enclosure for the HSD Tester which enables testing in-ditch on active pipelines. Their technology is now ready for field trials to verify pipe seam fabrication methods and determine material grade properties.

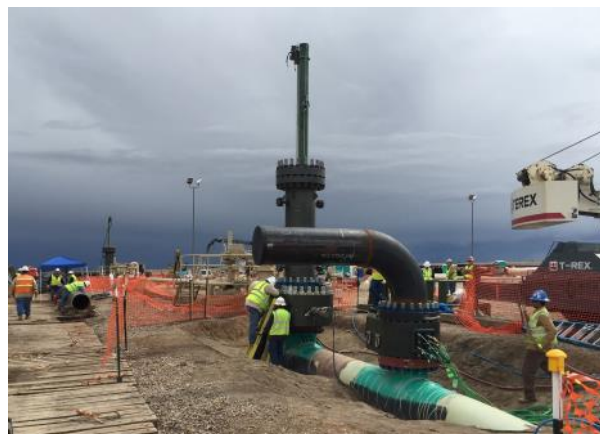
STATS Group Cortez 24 inch bypass line installation

While the pipeline operated under normal conditions, the site contractor excavated the pipeline and welded on split tee fittings. Two 30" fittings provided access for the BI-SEPs™, enabling mid-line isolation, and two additional 24" fittings allowed production to continue around the isolated section through a bypass line.

High pressure slab valves were installed on each fitting and STATS technicians leak-tested and hot tapped the pipeline at each location, successfully breaking containment and retrieving the pipeline coupons. The 24" bypass line was then installed, purged and leak-tested allowing the slab valves to be opened and flow to pass into the bypass line. The BI-SEPs™ were then installed onto the 30" fittings and the upstream BI-SEP™ was deployed into the flowing pipeline.

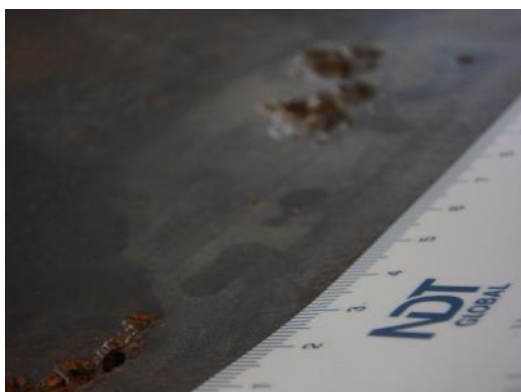
Example of pinhole corrosion

Many inline inspection providers offer corrosion inspections without the resolution required to detect and size pinhole defects. However, operators have identified pinhole and especially embedded pinhole defects as a significant risk factor in their integrity management programs.
