February 2017

Pigging Industry News

the newsletter of the Pigging Products & Services Association

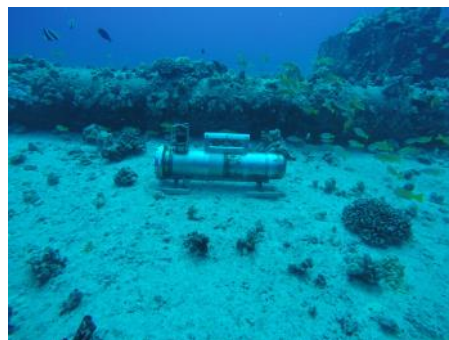
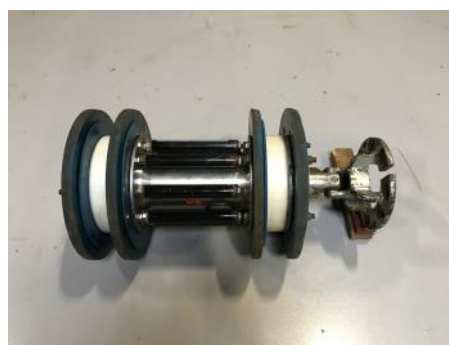
Sub-sea marker (top) & high output transmitter carried on board the ILI tool (bottom)

16" high resolution GEO and MFL/DMR tools suitable to meet the challenges. Special tool transmitters and subsea markers were purpose designed and manufactured and confirmed performance in heavy wall pipe-in-pipe tests. These were deployed by divers at the reference points every approx. 1km on the pipelines.

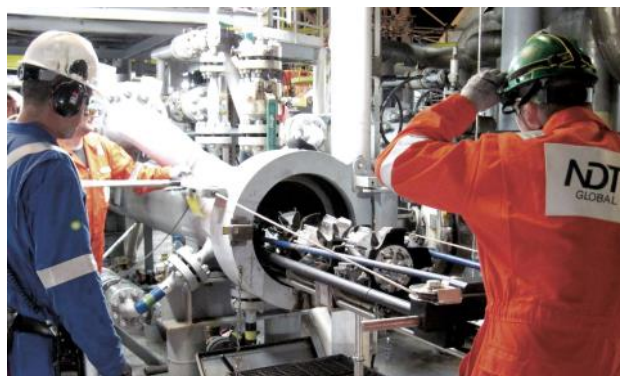
First run success due to a reliable and flexible tool

However, during the pipeline cleaning phase, a huge problem occurred: the gauging pig returned showing a reduced minimum diameter, i.e. smaller than tested and qualified during the onshore testing phase. The challenge was now to engineer a solution to run the ILI tool below its current design limit and at the same time keep risks within acceptable levels. The NDT Global engineering group and the operator's flowlines team conceived a plan in record time to "put the pig on a diet", for a safe passage through the smaller inner diameter of the pipeline. The inspection had to be completed during the planned shutdown window to avoid costly production delays.

After 96 hours of re-modeling, design assurance and risk assessments, the modified ILI tool was launched and returned safely to the FPSO. The new flexible tool achieved a First Run Success!

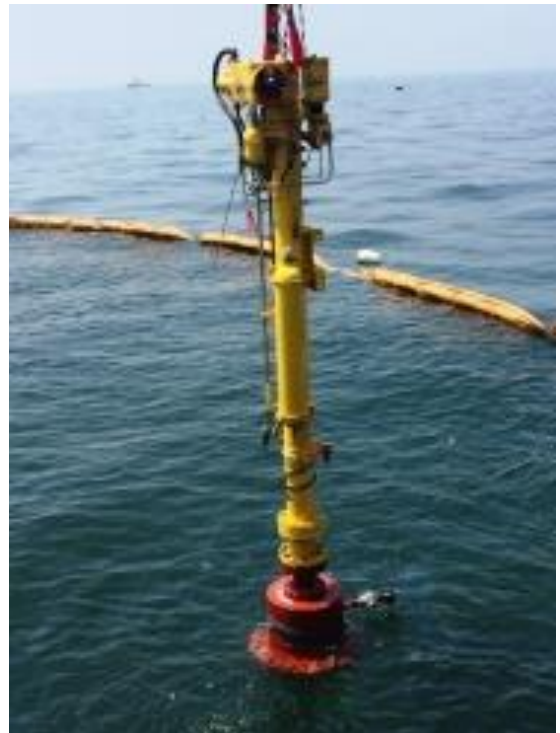
First subsea application of STOPPLE isolation technology in Japan.

To ensure a safe and efficient isolation without additional delays, prior to deployment TDW prepared and tested the subsea tapping machines and STOPPLE isolation equipment, conducted divers' training, and completed a mock-up to confirm the STOPPLE machine would be completely compatible with the subsea mechanical clamp. According to Project Manager Rakesh Shetty, those steps safeguarded performance and helped the operator avoid cost overruns. "All equipment is specified and tested for each unique STOPPLE isolation," Shetty says. "Because the equipment, the vessel, and the diving teams are all on standby, the isolation has to be flawlessly executed to avoid huge standby charges."

Using the STOPPLE methodology, TDW achieved a successful first-time isolation just 5 meters (16 feet) from the damaged elbow. The isolation remained secure for the entire 70-day project timeframe, allowing the operator to safely complete the replacement with no product loss or interruption of service. ●

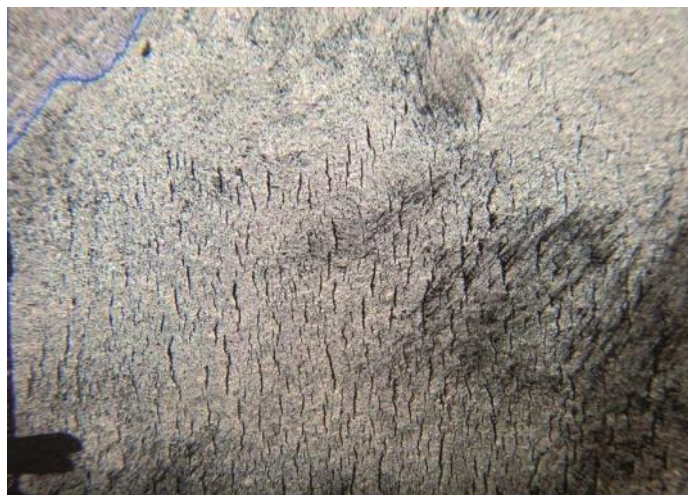
Circumferential crack field detected with ILI results using UCc

In 2013, a new gas line with internal stainless steel CRA cladding experienced a failure. This 16" pipeline was commissioned early in 2013 and occasionally used. The failure consisted of circumferential cracking in a girth weld at a pipe bend. The investigation team recommended a complete inspection of all weld joints on this 10 km (6 mile) line.

Ultrasonic ILI was the only feasible means to inspect this line, doing so required that a liquid coupling medium be introduced. Due to the importance of the pipeline, a sequence of two inspection runs was selected. The first run was completed using an **NDT Global** ultrasonic circumferential crack (UCc) tool to address the detection of circumferential cracks and crack-like anomalies. The second tool selected was the ultrasonic metal loss with pitting resolution (UMp) tool to detect metal loss anomalies, pitting, laminations and inclusions.

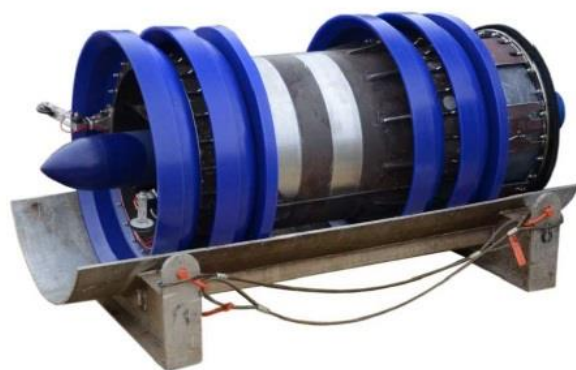
Speed Control Pig ●

orientation. An Inertial Measurement Unit (IMU) detects Roll, Pitch, Yaw and Vibration. Pressure differential across the tool is continuously recorded and can be used to calculate drag. Condition of the internal surface of the pipe, the presence of liquids, debris and Black Powder can be inferred from the changes in ride characteristics, tool dynamics and drag [Pipelines 2 Data Ltd. control units].

Therefore, the SCP is not just a speed controlled cleaning pig; it is a smart cleaning tool that can provide a vehicle or platform on which to accomplish other tasks. It can be used to focus inspection resources where they are needed. SCP is an integrated pipeline cleaning and inspection tool on which sensors can be mounted to monitor changes in operating conditions and gather other useful data points.

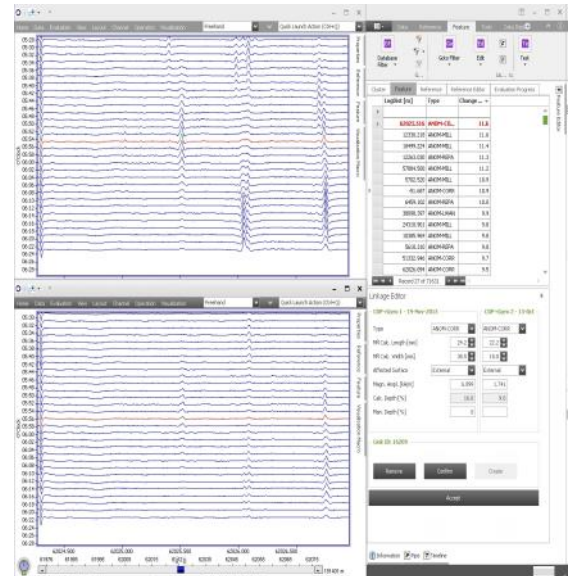
Rosen AutoSCANTM software

ROSEN has responded with its own software – "AutoSCANTM" (Automated Signal Correlation and Normalisation). With AutoSCANTM, ROSEN can precisely match metal loss indications between two axial field magnetic flux leakage (MFL A) inspections, using pattern recognition algorithms. By normalising the magnetic response, depth changes are then estimated directly using the change in signal amplitude and shape. In comparison to traditional methods, AutoSCANTM provides a significant step change in the accuracy of historic CGRs.

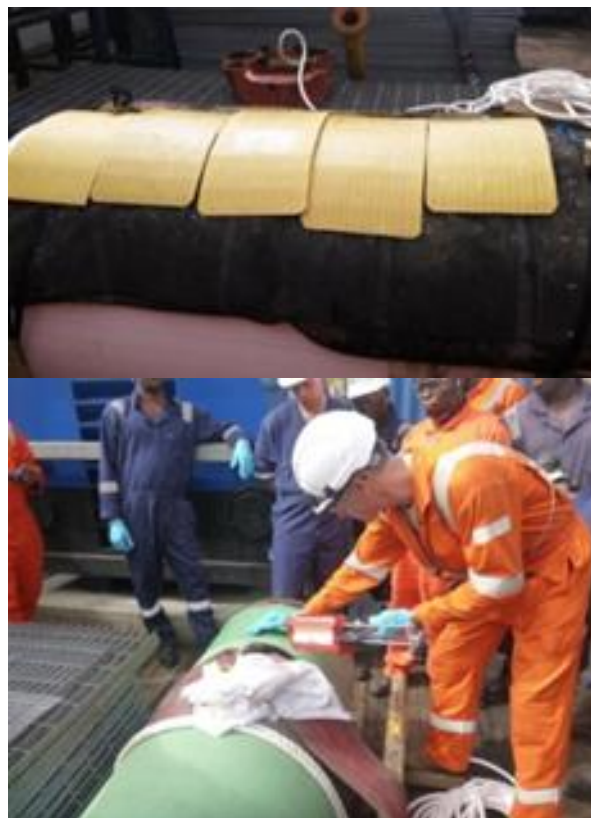
Composite plate manufacture on the foot print of the dented area & primer application (training picture). ●

1. A foot print of the dent was made in order to manufacture appropriate composite rigid plate.
2. Primer (P3X32) was applied to the defect, using a dispensing gun, providing a good adhesion of the composite materials.
3. Five rigid composite plates covered with F3XSS filler were positioned over the dent and strongly fixed with ratchet belts for a curing time of 3 hours (*illustration picture*).
4. 82 rolls of Kevlar® tape, pre-impregnated with R3X1050-S resin, using a special 3X device called BOBIPREG) were wrapped around the pipe.
5. Finally, a neoprene soft cover was applied to protect the repair from shells and other elements.

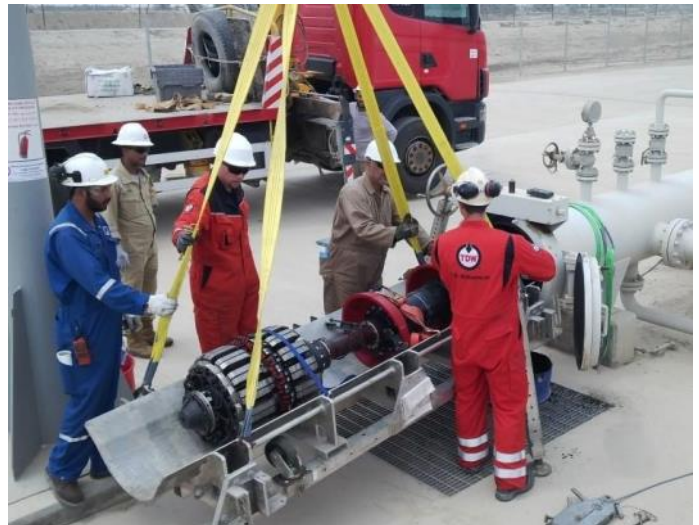
T.D. Williamson uses KALIPER® 360 tool and gas magnetic flux leakage technology to prove pipeline integrity

The ILI runs included the KALIPER® 360 tool, which provides geometry inspection; and gas magnetic flux leakage (GMFL) technology, responsible for identifying corrosion and pitting. TDW performed 15 tool runs—five gauging, five KALIPER 360, and five GMFL—with 100 percent success. The field work was completed within five weeks, ahead of schedule.
