## Pigging Industry News

*the newsletter of the Pigging Products & Services Association*

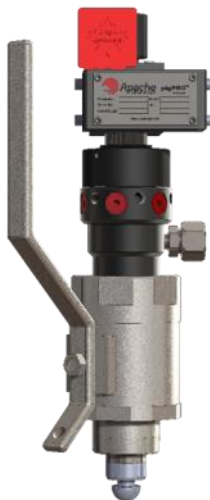
Apache Pipeline Products' pigPRO™ Series 67

**The Model 67 is a visual flag indicator with manual reset and comes standard with an isolation ball valve. It can be serviced on flowing, pressurized pipelines.**

Includes a thread mounting nipple, isolation extended lower housing with fluorocarbon O-Rings, and hemispherical plunger with a flag assembly.

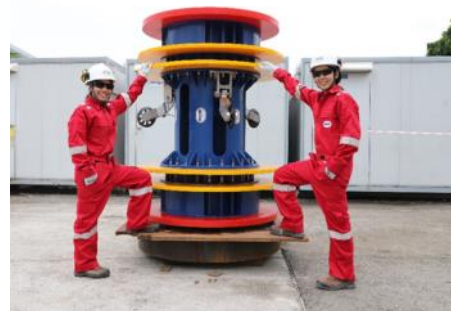
Dacon's 52" UT-R Pig Inspection

The 52" UT R tool provides the highest possible resolution available, which in turn will provide the most accurate and complete inspection results. This will provide the customer with a complete assessment of their pipeline condition and allow accurate remaining life calculations.

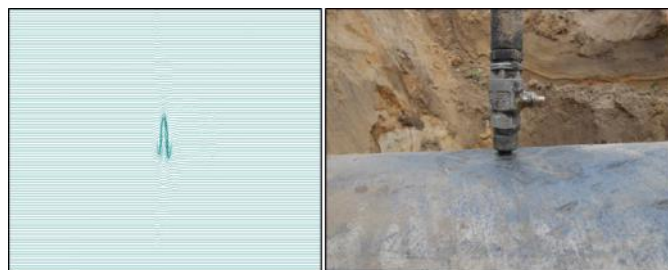
As operators strive to find an effective early warning system that will provide alerts as pipelines are encroached upon, alternative approaches are required to assist in the location and identification of both existing and new illegal tap attempts. An existing pipeline inspection technology, with a proven track record of accurate location of illegal tap locations, is In-line Inspection (ILI) – specifically Magnetic Flux Leakage (MFL) tools. **BHGE** has developed and implemented various theft inspection solutions, with many ILI runs conducted in Europe using different MFL tools and techniques. See Figure 1 for an example of an illegal tap in ILI data.

In 2016 BHGE carried out a pilferage inspection on a European pipeline using the MagneScan vehicle. This particular pipeline had been targeted multiple times by thieves in the past, and the operator decided to carry out regular ILI inspections to identify changes and new features between consecutive inspections. A number of new features were detected and reported during the analysis, but one location exemplifies the extreme lengths thieves will go to, to avoid visual detection. Two attachments were identified under a

pipeline casing, near to a river crossing. These attachments were new compared to the previous inspection, carried out in 2015.

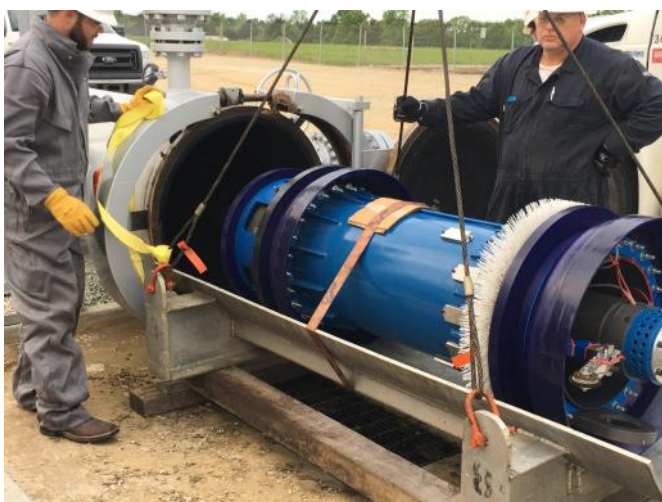
*Inline Services's new Speed Control Cleaning Tool*

To meet this challenge, **Inline Services** has designed and manufactured a new series of Speed Control Cleaning tools ranging from 30" to 48". The tools onboard technology maintains optimal cleaning speeds of 6 to 10 mph within a gas flow velocity of up to 33mph. In addition, the tools IMU collects performance data that can be exported onsite.

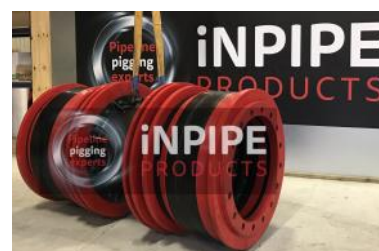
iNPIPE PRODUCTS™ piggable plug

The 36" and 48" welding pig design utilises the iNPIPE PRODUCTS™ uniquely patented tyre design to provide proven reliability. The piggable plugs are provided with 2 sets of inflatable tyres to provide failsafe proven performance and reliability and ensure that the differential breakout pressure is uniform.

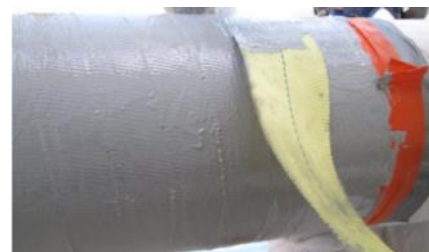
*Wrapping in progress* ●

- F3X8 filler application on each defect to give back the initial shape to the pipes.
- Wrapping process covering the delimited areas was completed using Kevlar® tape impregnated with R3XHT+ resin (4 layers for each defect but with a specific repair length in accordance to defect characteristics —> 260mm repair length for both 10" line defects, 457mm and 1060mm for the defects on 12" line).
- Reference plate for traceability purpose was positioned on each repair.
