Pigging Industry News

the newsletter of the Pigging Products & Services Association

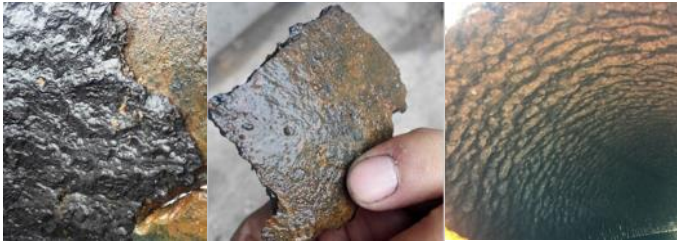
The slurry pipeline has not been pigged since its operation in 2010. The scale of the pipeline is severe with a thickness of about 3 to 4mm. The scale is hard, and there are obvious flow marks at the bottom. The outlet pressure of the main pump has reached maximum design pressure, and the pipeline is near the minimum transportation capacity.

Internal views of the pipeline before cleaning

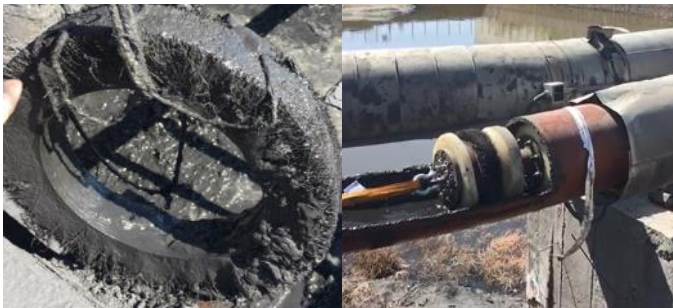
Steel Brush Cleaning Pig pull through test & Slurry Soaking test on steel brush

Based on calculating the diameter of the brush hair and the density of the brush, the steel brush can maintain a good passing capability after soaking in the slurry, and the steel brush Cleaning Pig has a good cleaning effect on the soft dirt in the pipeline.

In order to ensure safe and effective pipe cleaning, CPPI carried out a pull through test with the designed steel brush Cleaning Pig and Scraper Pig

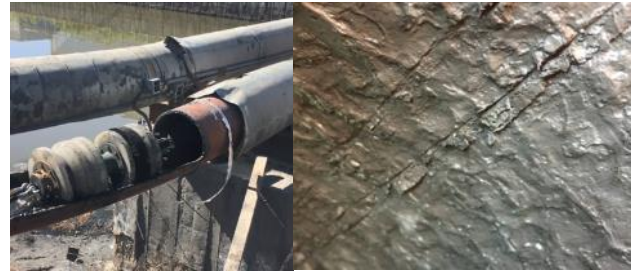
Scraper Pig pull through test & Partial shedding of scale after the pull through test

The Scraper Pig is of alloy material, and equipped with 8 Scrapers, which divided the pipe hard scales into small pieces. The pigging runs using the Scraper Pig proved very successful in moving deposits and greatly reduced the risk of the pig getting stuck.

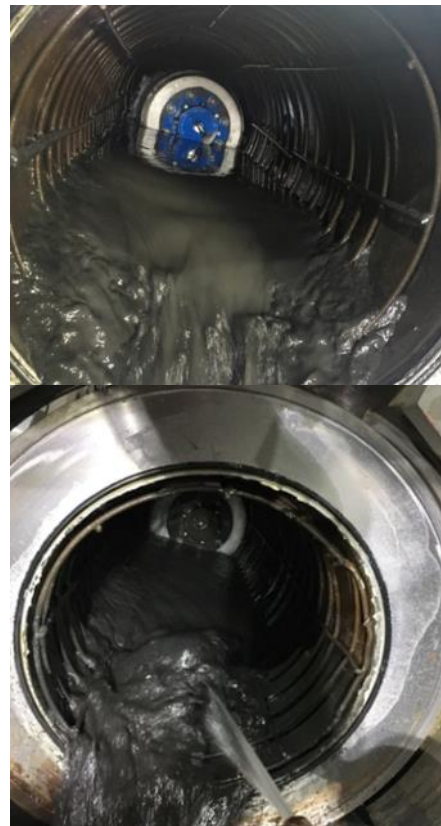
Pipeline Cleaning at worksite

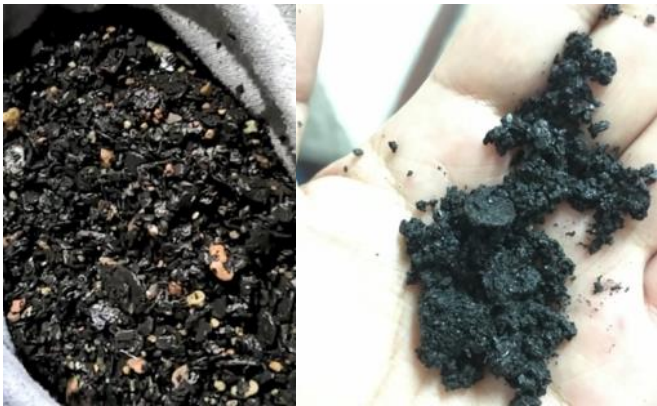
The scale after cleaning

According to the monitoring data, the rotating speed of pulp main pump increased from 52% to 58%, the pipeline pressure reduced from 14000 KPa to 12500KPa, and the transportation capacity increased from 470m³ to 500m³ per hour. The whole system has been restored to the design capacity of 5.5 million tons per year, and the cleaning operation has achieved obvious results. ●

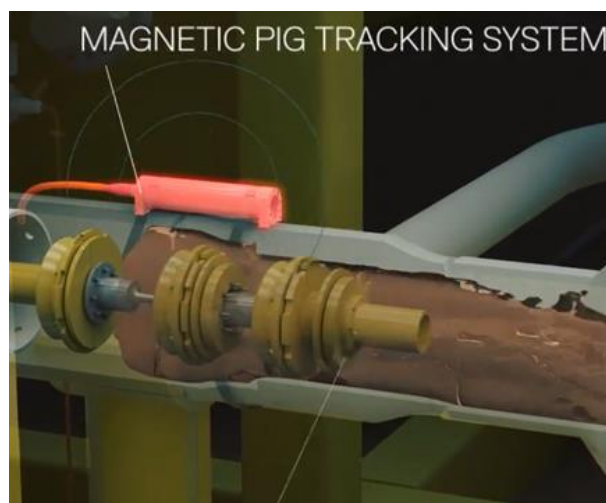
The SAPL system relies on positioning of the pigs by aid of a sensor that indicates the exact position of a pig even at standstill. A second sensor in passage mode detects that the launched pig properly enters production flow. A conventional pig tracker would employ radioactive isotopes to determine position, but as this was not an option for the project, and there was not a viable pig tracker on the market, NOV had to develop its own solution.

Pig has been positioned at correct position before launching ●

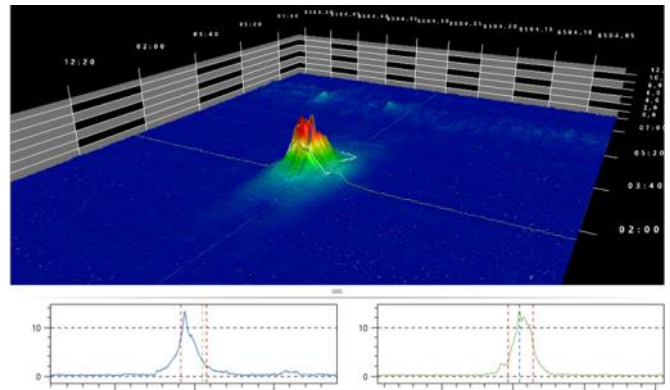
standard MFL technologies and essentially moving from individual data points to true imaging, an example of which can be seen in Figure 1 below.

Figure 1: With the Ultra resolution, true pipeline imaging becomes possible

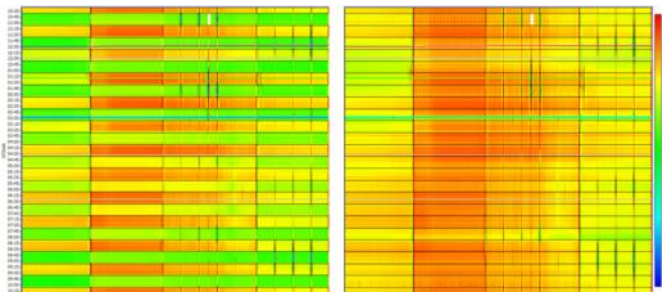
and the now offset physical location, two data sets needed to be generated – one measuring closer to the front and one closer to the back of the magnetic field. Using image-processing algorithms, these sets were then normalized in order to create one triaxial magnetic image for the pipeline. Figure 2 shows the data sets before and after normalization, with the separated data sets from each sensor ring on the left and the combined image on the right.

Figure 2: With two sensor rings, complete wall coverage is possible

The combination of the three elements – highly sensitive sensors, dual-sensor rings and image-processing algorithms – allows for full ultra-resolution circumferential coverage and the detection of the smallest pinholes.

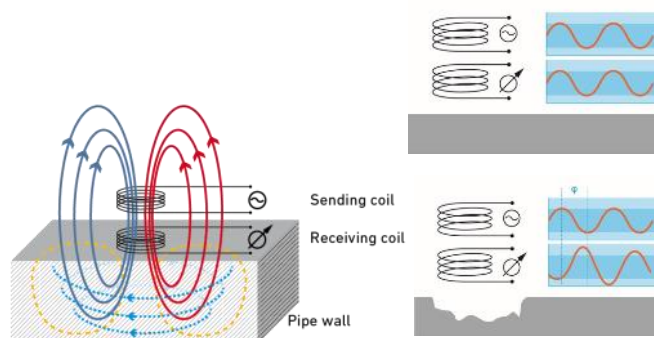
In this case, IEC was used for support. Although MFL-A Ultra is optimal for detecting pinholes, its axial magnetization means lower sizing accuracies for long circumferential features in comparison to using circumferential magnetization. Therefore, the combination with IEC best addressed axial channeling corrosion in this pipeline. This technology allows for the detection of surface corrosion. Based on electromagnetic induction, eddy current testing involves placing a cylindrical coil, which carries an alternating current close to the pipeline. The current in the coil generates a changing magnetic field and thus produces eddy currents in the pipe wall. To collect data, the variations in the phase and magnitude of these currents are monitored by using a second coil or by marking changes in the current that flows in the primary coil. The IEC signal gives additional information about the length and width of a detected feature and as such significantly improves depth sizing.

Figure 3: Variations in the electrical conductivity or magnetic permeability due to the presence of flaws will change the flow patterns of the eddy currents, and there will be a corresponding change in the phase and amplitude of the measured current.

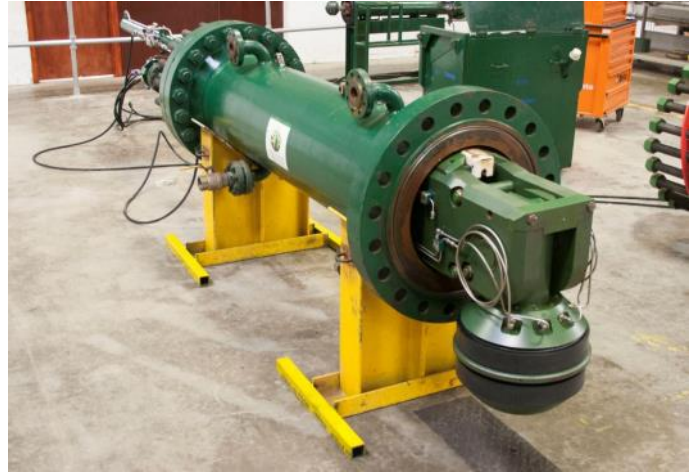
ambient through the BISEP and verified as a zero-energy zone. The vented annulus void was then closed and monitored confirming leak-tight isolation. Following successful seal proving, an Isolation Certificate was issued to notify all parties of the safe isolation of the pipeline. The BISEP then remained in the pipeline for five days while all four valves were installed into the pipeline, during this time the BISEP seal annulus was monitored and remained leak-tight.

STATS Group's BISEP® isolation tool

Onsite a mechanical hot tap fitting and gate valve was installed onto the pipeline at the isolation location and leak tested. Hot tapping of the pipework was then conducted with STATS SureTap hot tapping machine and the pipe coupon was recovered, providing access for the BISEP. With the hot tapping completed, the BISEP in a pressure competent launcher was attached to the closed gate valve and leak tested. The pressure in the BISEP launcher was then equalised and the gate valve was opened allowing the BISEP to be hydraulically deployed into the pipeline. The dual elastomer seals of the BISEP were hydraulically set providing fail-safe double block and bleed isolation, without the need for additional hot tapped bleed or vent ports. The BISEP was then subject to a test regime to independently test both the primary and secondary seals with full pipeline pressure, the cavity between the seals (annulus) was vented to

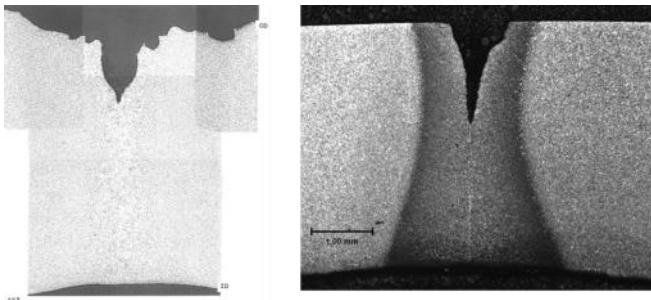
For example, selective seam weld corrosion (SSWC)—which occurs when corrosion attacks the seam material more aggressively than it does the base pipeline material—is a higher-risk condition compared to corrosion crossing the long seam (CCLS). However, the two conditions frequently intersect: SSWC is often recognized as a v-shaped groove in the long seam weld within a larger region of CCLS. (Figure 1)

Figure 1: Selective seam weld corrosion (SSWC) creates a v-shaped groove in the long seam weld within a larger region of corrosion crossing the long seam. Photos: Kiefner & Associates

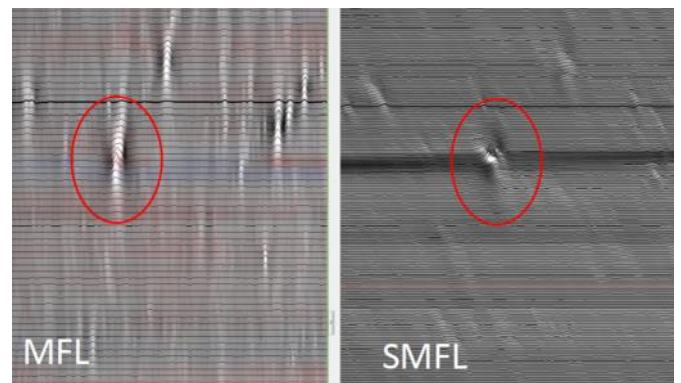
To date, the classifier has proven highly effective in discriminating SSWC. In a case study presented at the 2019 Pipeline Pigging & Integrity Management Conference [2], an axial MFL image indicated that metal loss produced a uniform response across multiple sensors circumferentially. (Figure 2) The field response recorded within SMFL documented both the seam weld (discoloration) and the characteristic sharp axial response. Clearly, the metal loss was a narrow, planar axial feature located coincident with the seam weld. The classifier leveraged the field response in each data and identified this region as having a high probability for the presence of SSWC. Dig verification confirmed the presence of an SSWC anomaly.

Figure 2: High field axial MFL field response to SSWC (left). High field spiral MFL (SMFL) field response to SSWC (right).

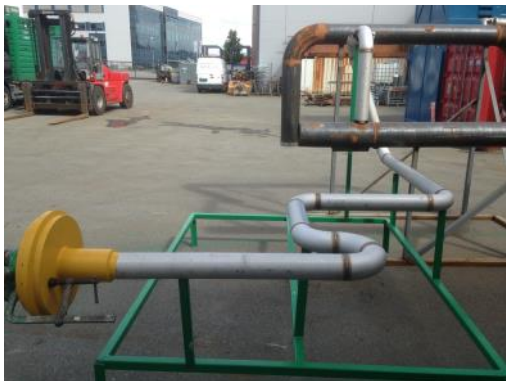
The outer diameter of the manifold to be inspected is 141.3 mm with a wall thickness of 12.7 mm. Simulations of the pipe located the most critical area of corrosion to be approximately 1.5 meters into the manifold, just after the third 1.5D/90° bend; therefore, this section was determined to be the most distant point in need of inspection. Previous internal video inspection attempts of a neighboring manifold revealed a potential additional challenge of excessive weld roots, which made negotiation of that manifold impossible for the other service provider at that time.

Figure 1 – Mock-up of the manifold.

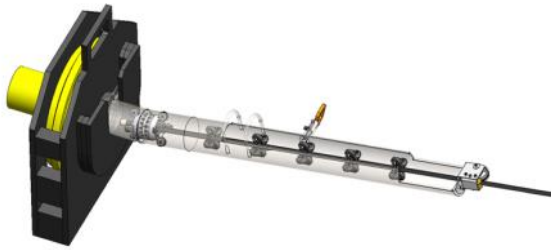
The launching concept itself also needed special considerations. A cap was designed to interface the temporarily open launcher on the front end. On the back end, an odometer arrangement was designed and mounted on the flat pushrod, enabling precise tracking of the tool’s progression through the manifold. During subsea transport, the tool was secured in the launcher via a tailor-made security handle for the ROV. Details of the final solution can be seen in Figure 3.

Figure 3 – Black protection cap and “snap-on” launcher arrangement.

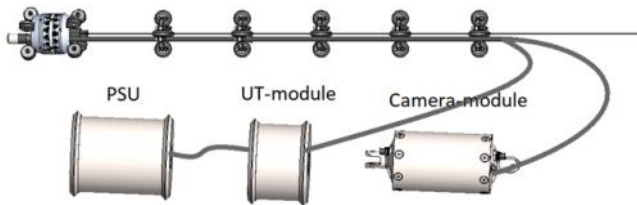
32 pulse echo probes were mounted on a probe ring in the front module of the ultrasonic ILI tool. A camera was also embedded into the probe ring and connected to a separate pressure vessel, which contained electronics connecting to the ROV. Two cables were used to connect the complete tool to the ROV. The main components of the inspection tool can be seen in Figure 4.

Figure 4 - Main parts of the inspection system.

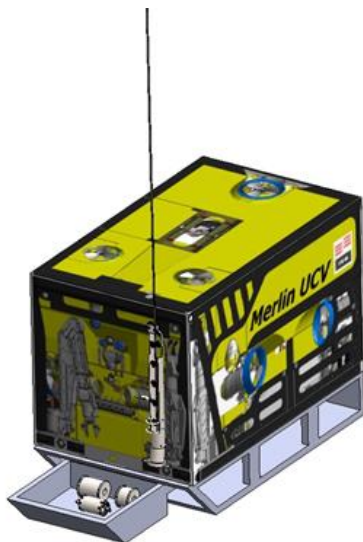
Figure 5 – The ROV with the inspection tool parts secured.

There were several steps that needed to take place before the tool could be launched. First, the ROV had to remove the blind flange of the manifold and then mount the cap to prepare for the installation. The tool was then electrically connected to the ROV and placed into the basket under the ROV while on deck (Figure 5). The ROV travelled with the launcher down to the seabed and mounted it to the

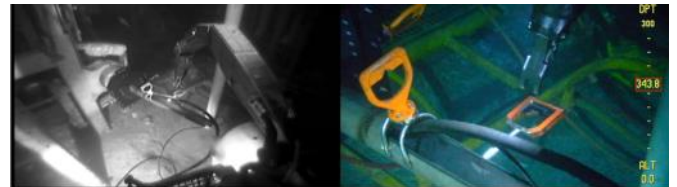
adapter. Finally, the ROV operator carefully pushed the tool into the pipeline via the push rod. As shown in Figure 6 and Figure 7, the operating space for the ROV was limited. As the ROV claw could easily damage the cables, the ROV operator had to proceed with extreme caution.

Figure 7 – The umbilical and push rod in the launcher arrangement.

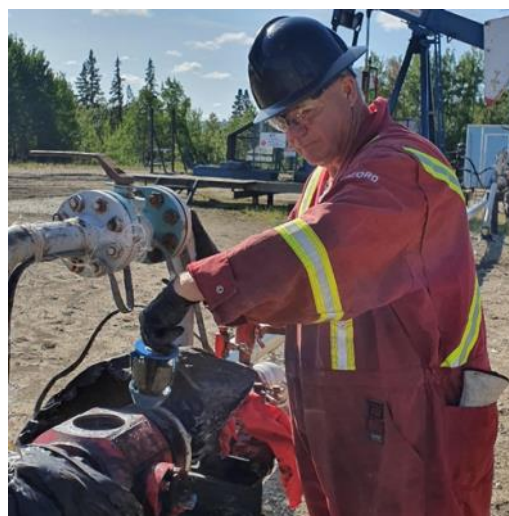
Pioneer tool being dropped into a typical pig valve

The 3 & 4inch Pioneer tools can be easily dropped into a typical pig valve, like an Argus valve or similar, and pushed through the pipeline by either the product or by Nitrogen.

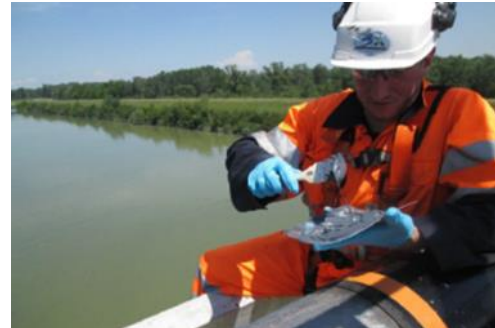
- 1/ F3X8 filler application on weld and defect to reshape the pipe.
- 2/ R3X1060 resin application on the whole surface to protect it from corrosion.
- 3/ Wrapping process using Kevlar® tape impregnated with R3X1060 resin → 4 layers completed for a total repair length of 400mm.
- 4/ Finalization of the repair. R3X1060 resin application over the repair to ensure good wetting of the fibers and good visual aspect and identification plate application for traceability purpose.

F3X8 filler application ●
