Pigging Industry News

the newsletter of the Pigging Products & Services Association

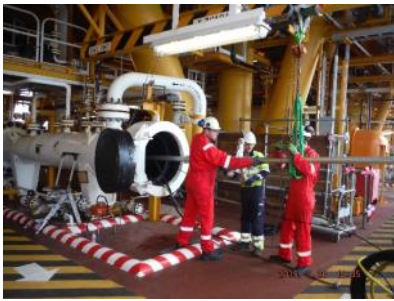
Deployment for pig recovery tool

Once TDW identified the appropriate recovery force, they could configure the recovery tool. It included a spring-loaded mechanism that would click into place on the bypass holes of the stuck pig's body, gripping it as it was pulled out by a hydraulic pulling system that was attached to a strong hold anchor point behind the launcher.

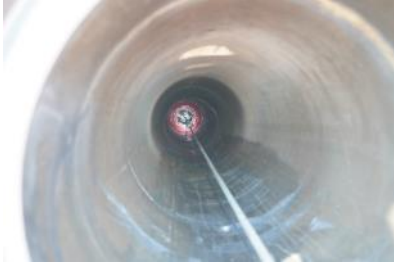
Gripping tool with wire attached to the pig body

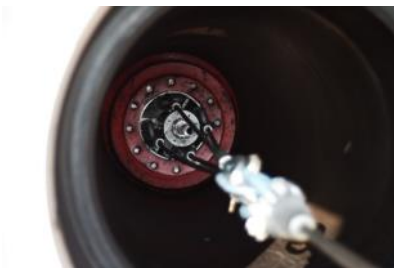
Pulling the pig

Once the rescue operation was underway, the recovery tool worked as designed. Crews spent just seven hours successfully and safely rescuing the pig, completing the project well ahead of schedule.

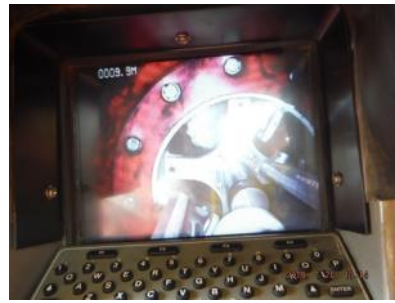
Camera system

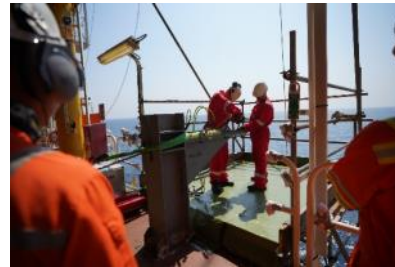
Wire attached to hydraulic cylinder and strong hold behind the launcher

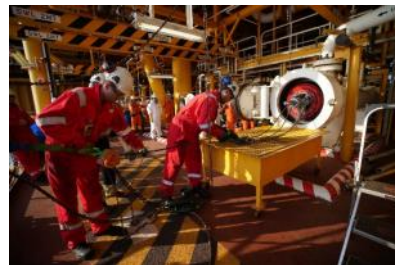
Pig successfully recover to the launcher

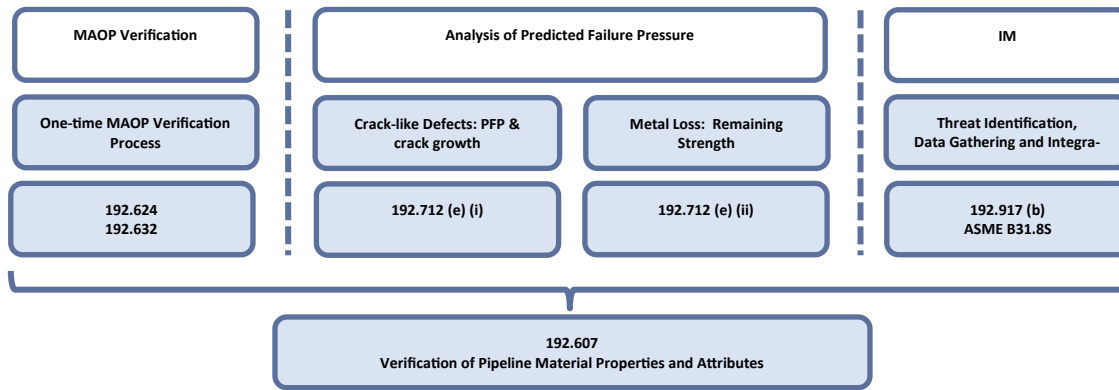
Illustration 1: 192.607 Verification of Pipeline Material Properties and Attributes is a tool to support MAOP Reconfirmation, Feature Assessment, and Integrity Management

Pressure, and Integrity Management related to Threat Identification, Data Gathering and Integration (**Illustration 1**). The efforts associated with 192.607 Verification of Pipeline Material Properties and Attributes (192.607) will be to establish a pipeline segment's:

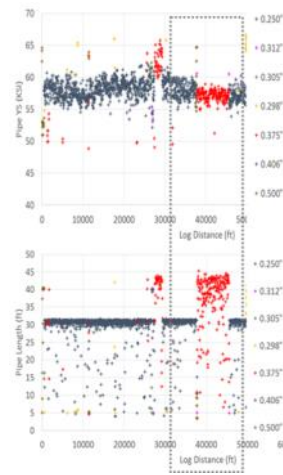
Illustration 3 Pipeline DNA leverages material characteristics to establish populations

ROSEN has developed an engineering assessment called *Pipeline DNA* which incorporates existing records, ILI data, *insitu*-field examinations, material testing, and industry expertise to establish populations, identify outliers, and ultimately the required material properties required by 192.607: Wall thickness, diameter, seam type, yield and ultimate tensile strength, and toughness. When ROSEN's RoMat PGS ILI system is deployed, which provides Yield Strength (YS) and Ultimate Tensile Strength (UTS) for each joint of pipe inspected greater than 3.3 [ft], the populations can be more clearly defined. **Illustration 3** demonstrates how leveraging joint by joint data for WT, JL, and YS can facilitate a sound process to deriving populations. Each population can have the RoMat PGS data (YS and UTS) plotted as a histogram to understand the frequency distribution of YS and UTS. Representing the YS data of a population as a histogram, as in **Illustration 4**, increases confidence in assigning the grade of pipe for the population and is representative of the pipe manufacturing process. These distinct populations can now be examined in-field for validation of records and the results from *Pipeline DNA*.

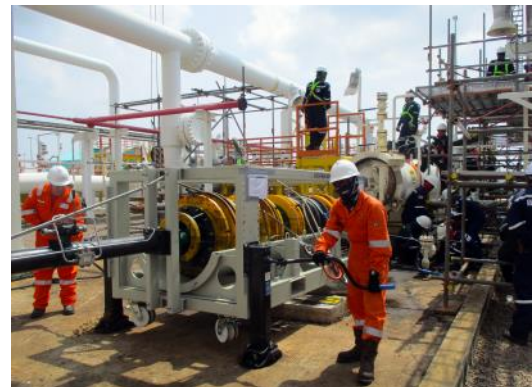
STATS' Remote Tecno Plug®

STATS DNV GL type approved RTPs provides fail-safe double block and bleed isolation of pressurised pipelines while the system remains live and at operating pressure. Dual seals provide a zero-energy zone to enable maintenance work on pressurised systems to be carried out safely and efficiently.

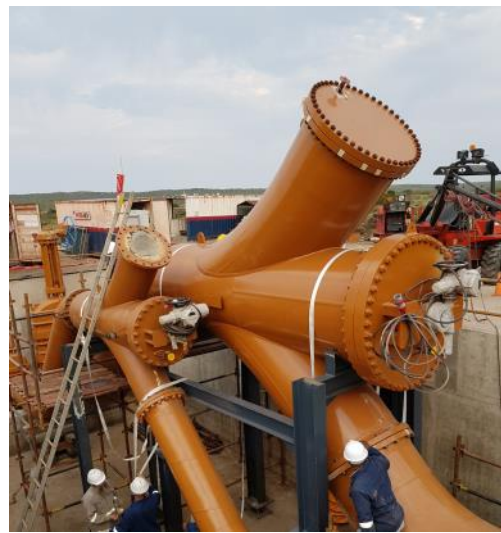
42 inch and 20 inch Pig diverters

Following a technical review of the client project requirements iNPIPE PRODUCTS™ proposed a bespoke solution, which consisted of the design, engineering and supply of 20 inch and 42 inch pig diverters. Site supervision was subsequently provided during commissioning stage.

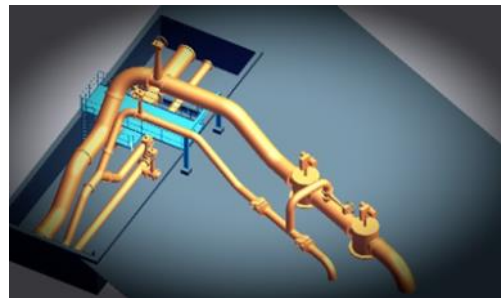
Transfer station

It was required that the pipelines be pigged on a regular basis and this requires being able to pig from the jetty to either of the tank farms. The first alternative considered by the client was to tie into the pipelines with a straight through connection to the existing tank-farm and to construct pig traps and bypass connections on the pipelines to the second tank-farm. However, this option had the following disadvantages:

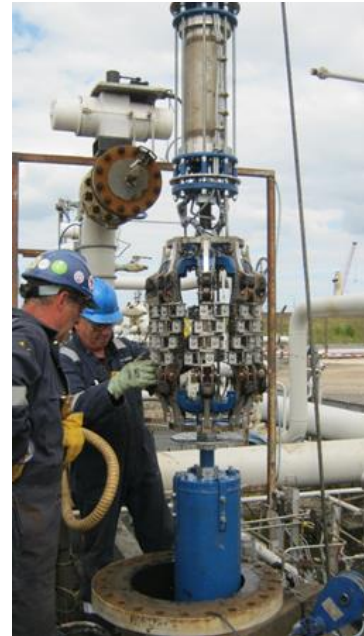
Lowering 20" UT tool

A truck-mounted crane holds the fixed-point of the cable-fairleader over the well. The measuring unit is run on a steel-cable, controlled by a hydraulic winch. Profile runs with gauging plates to ensure free passage or cleaning runs to eliminate inner deposits are also executed like this.

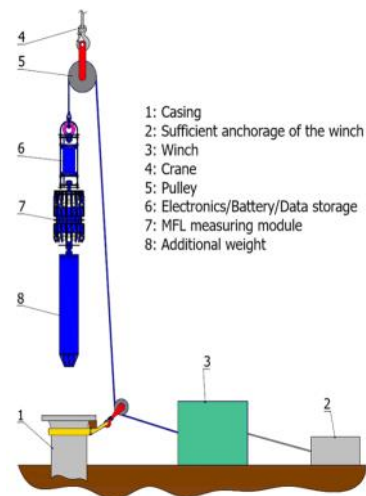
Simplified setup

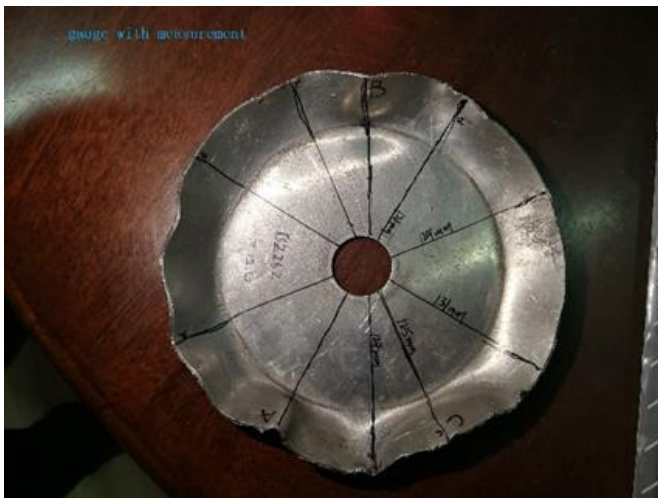
Gauge plate after the pig run

The gauge pig run came back with significant deformation showing an ID change from 154mm down to 114mm, equal to a 26% concentric ID restriction. The restriction prevented any conventional ILI being carried out on the pipeline and i2i were called in to do the inspection.

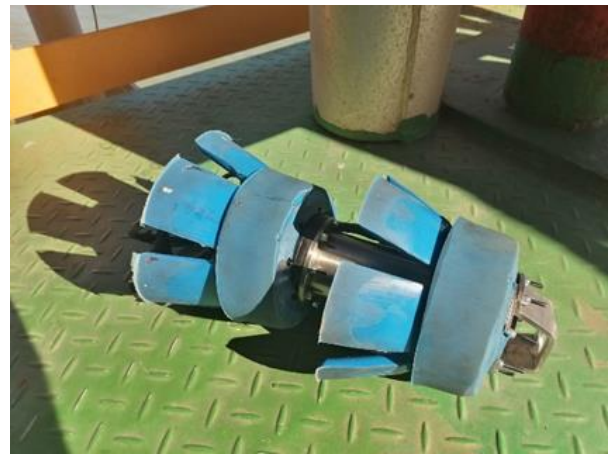
6 inch Pioneer pig after the inspection run

The 6 inch Pioneer tool safely negotiated the pipeline restriction and collected good quality data for the entire length of pipeline. There was no mechanical damage to the Pioneer tool and the run was considered a success. This project demonstrated that the Pioneer tool is a cost effective and low risk alternative to conventional ILI pigging with the ability to carry out internal inspections in difficult pipelines with large internal restrictions.

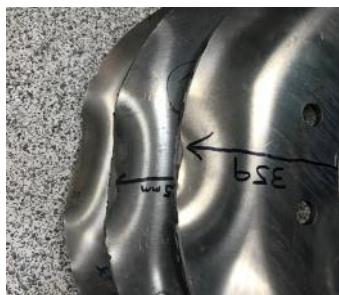
Figure 2: Gauge plates with unexplainable deformation

One specific application of the visual inspection device was to prove a potential restriction/obstacle in an over 50-year-old pipeline, as the sensor arms of a high-resolution geometry tool had been heavily damaged during an in-line inspection, and the gauging discs showed an unexplainable deformation (see Figure 2).

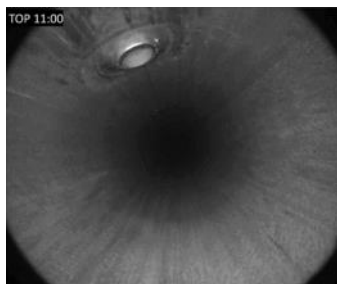
Figure 3: Protruding offtake in an over 50-year-old pipeline

The recorded RoVisual data gave a fast and clear answer - an unknown approximately 50 mm protruding offtake was the reason for these damages (see Figure 3). As a result, the operator removed these offtakes to ensure a safe and successful in-line inspection followed.

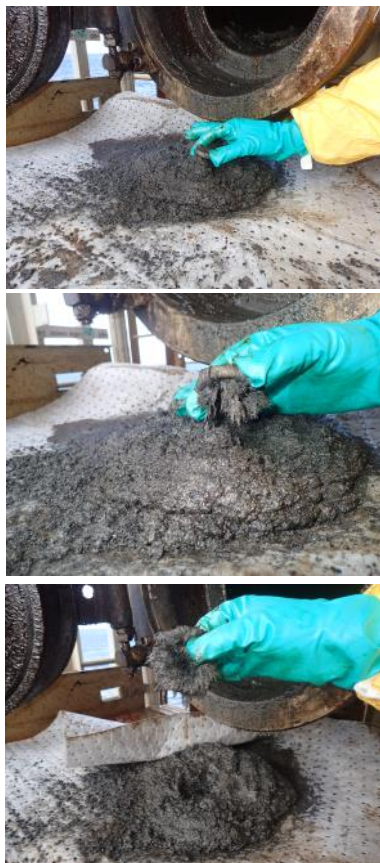
Ferromagnetic debris taken out by the HMCT

In 2018 **Reinhart Hydrocleaning SA (RHC SA)** was asked for a 10” pipeline cleaning job located in the North Sea. Inspection results showed that the 10” water injection pipeline suffered from MIC. The pigging program with ordinary brush pigs were not able to properly clean the pipeline and embank the MIC problem. In the third Quarter of 2018, RHC SA performed a progressive cleaning campaign with in total 6 hydromechanical cleaning tools (HMCT) adapted to the pipeline. After the cleaning program, the pipeline was inspected and the data was compared to the previous inspection result. Based on the positive outcome of the ILI, the client decided to run HMCT’s on a regular basis. A hybrid HMCT was designed by RHC SA

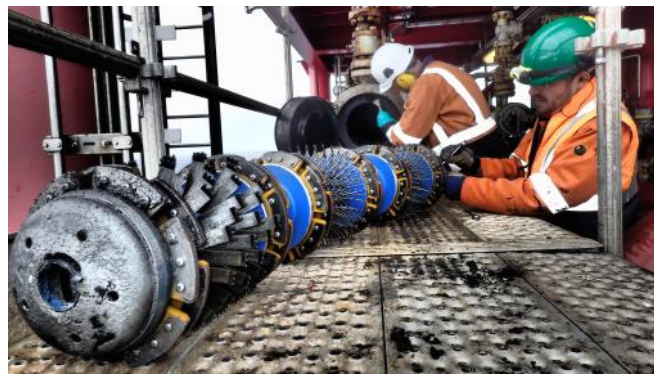
RHC SA Hydromechanical Cleaning Tool (HMCT)

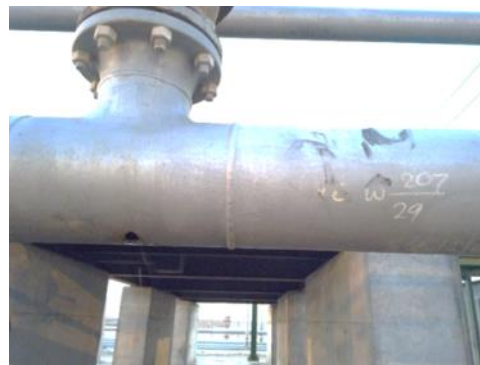
View of tee with through wall defect

The objective of the repair, performed in August 2019 by **3X ENGINEERING (3X)** and its local distributor **SYNERGY**, was to reinforce 2 tees of 8" suffering from internal corrosion and through wall defect.

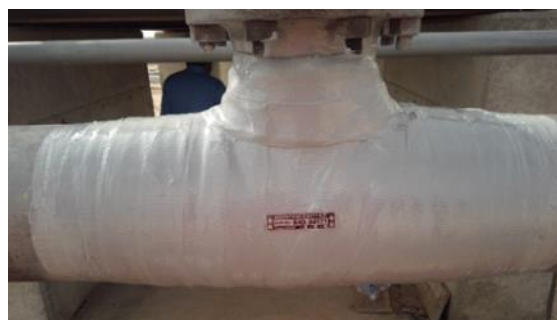
Wrapping completed (12 layers) & ID plate installed ●

- F3XS1 filler with metallic plate was applied on through wall defect to seal the leak (this step was not necessary for internal defect).
- Wrapping process covering the delimited areas was completed using Kevlar[®] tape impregnated with R3XHT+ resin (12 layers for hole defect and 8 layers for internal defect -> both of them with 600mm repair length).
- Reference plate was installed on each repair for traceability purpose.
