## **iNPIPE Case Study: Plugging System for National Grid LNG Tank**

When iNPIPE were approached by National Grid they were challenged to find the safest and most time efficient manner to change a valve on a LNG storage tank situated at Partington. Safety was stressed as being of paramount importance as the LNG tanks held temperatures of minus 160°C.

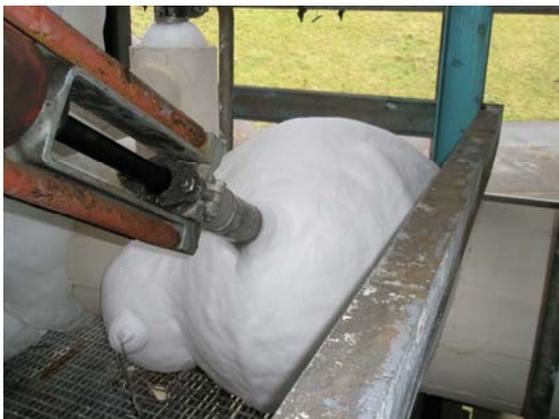
**Image 2**

**The valve in question was covered in ice due to leakage**

iNPIPE responded to National Grid's request by designing a Plugging System (patent pending) consisting of an MP Pipe Plug and Stuffing Box. The concept meant that the MP Plug would be inserted through the valve to isolate the line and provide a safe working environment so that the old valve could be replaced safely.

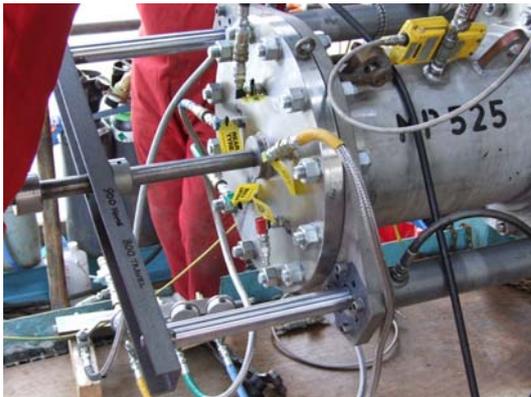
Image 2

Following a site survey by iNPIPE a Plugging System for this particular application was manufactured, pre-tested and under went a Factory Approval Test at our headquarters in Yorkshire

**New iNPIPE Plugging System for V2001**

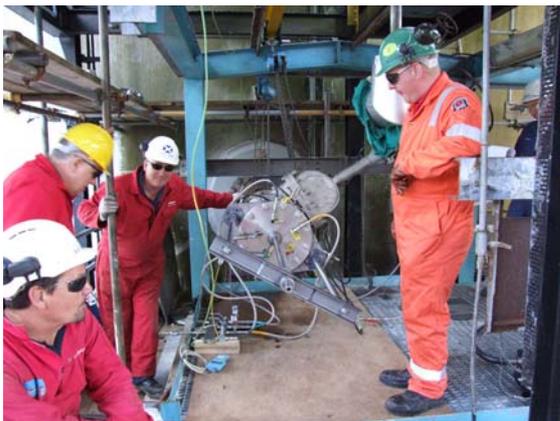
Image 3

On the 16th June 2009 the valve change out took place. The Plugging System was connected to the existing valve and the gas pressure and pipeline temperature continually monitored. Heaters were installed to keep the pipeline at ambient temperature. Once National Grid were satisfied that the gas pressure and temperature were stable iNPIPE were able to open the valve and insert the plug to a pre-determined position located beyond the valve.

**Installation of iNPIPE's Plugging System**

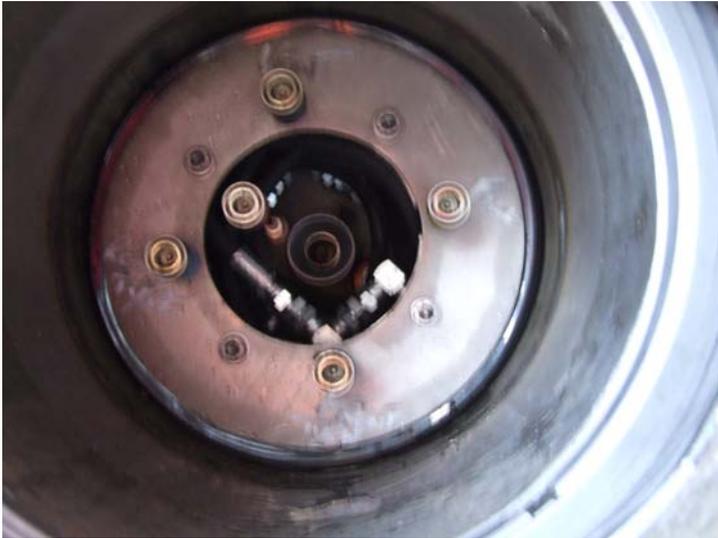
**Image 4**

The plug was then inflated and an inter-cavity pressure applied using Nitrogen gas to prove that the MP Pipe Plug had sealed. With the plug now in place the stuffing box was removed leaving the plug inside the pipe.

**iNPIPE's MP Plug installed through valve**

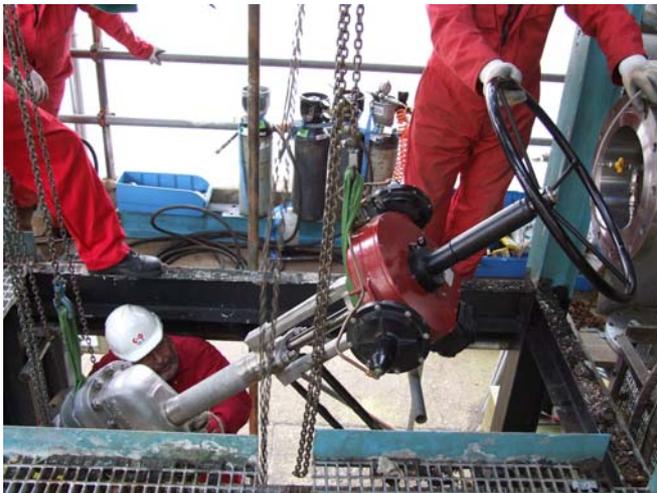
**Image 5**

National Grid and their contractors were then able to remove the leaking valve. iNPIPE contractors then machined the gasket face onto the pipe before National Grid replaced their new valve.

**Contractors installing new valve**

Once the valve had been replaced the stuffing box was reconnected to the valve and then the plug. With the introduction of gas pressurised to 1.7 bar the new gasket and valve under went a low pressure test.

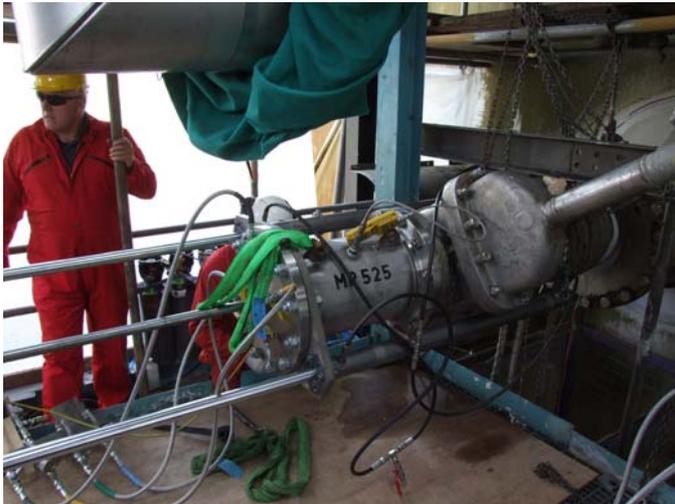
**Image 6**

Before the inter cavity was depressurised safety checks were made and the tyres deflated. One tyre had frozen due to the pipe centre's temperature dropping to below zero. To resolve this matter iNPIPE and the heating contractors advised National Grid to increase the heaters positioned around the pipe to thaw the plug. After a few hours the tyre thawed and iNPIPE were able to deflate. The MP plug was then retraced through the new valve and back into the stuffing box.

**Induction heaters can be seen wrapped around the pipe behind the valve**

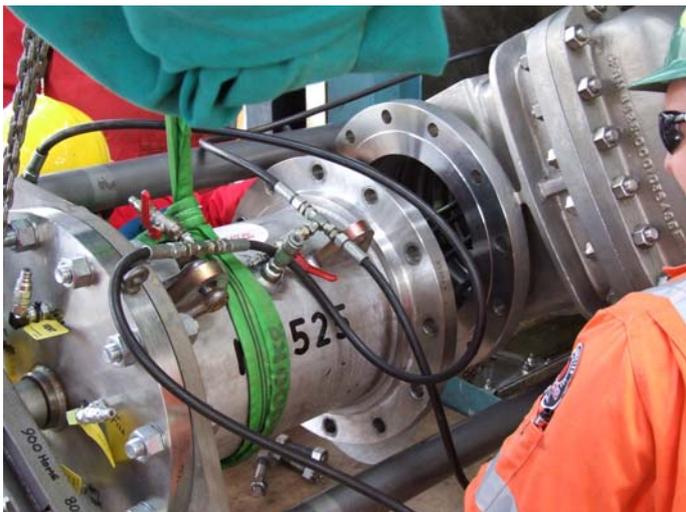
**Image 7**

After the stuffing box was removed, National Grid and their contractors were able to connect a blind flange to the new valve and carry out an initial pressure test.

**iNPIPE Plugging System being removed**
