THE BLUE STREAM PIPELINE INSPECTION PROJECT

AN OVERVIEW OF THE CHALLENGES FACED IN ORDER TO CLEAN AND INSPECT THE 24" x 380 KM PARALLEL NATURAL GAS INTERCONNECTOR PIPELINES BETWEEN RUSSIA AND TURKEY

By: Ron James PII Pipeline Solutions, EURA Regional Sales Manager
William Herron PII Pipeline Solutions, Chief Engineer

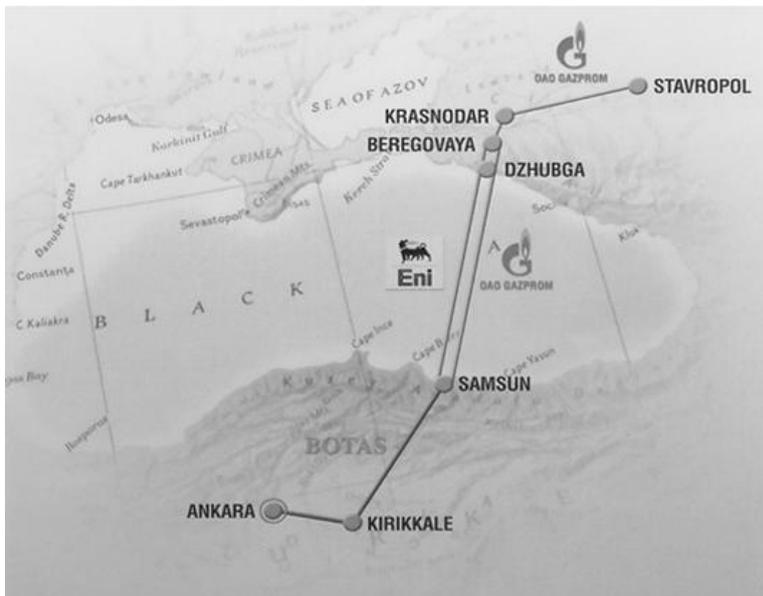
Figure 1- The Blue Stream Pipeline System

The Blue Stream Pipelines are a transport system for the supply of gas from the network of southern Russia to Turkey through the Black Sea, with capacity to transport 16 Gm³/year. The asset consists of a number of gas pipelines totalling approximately 1,250 km, consisting of a 56" pipe, 373 km long across Russia, owned by Gazprom, from Stavropol to Dzhubga, two 24" pipelines across the Black Sea of 380Kms each, from Dzhubga to the Durusu station (Samsun); which is the Joint Venture between Gazprom & ENI (Blue Stream Pipeline Company- BSPC) and a 48", 470Km pipeline linking up with pipeline networks at Ankara, operated by Botas.

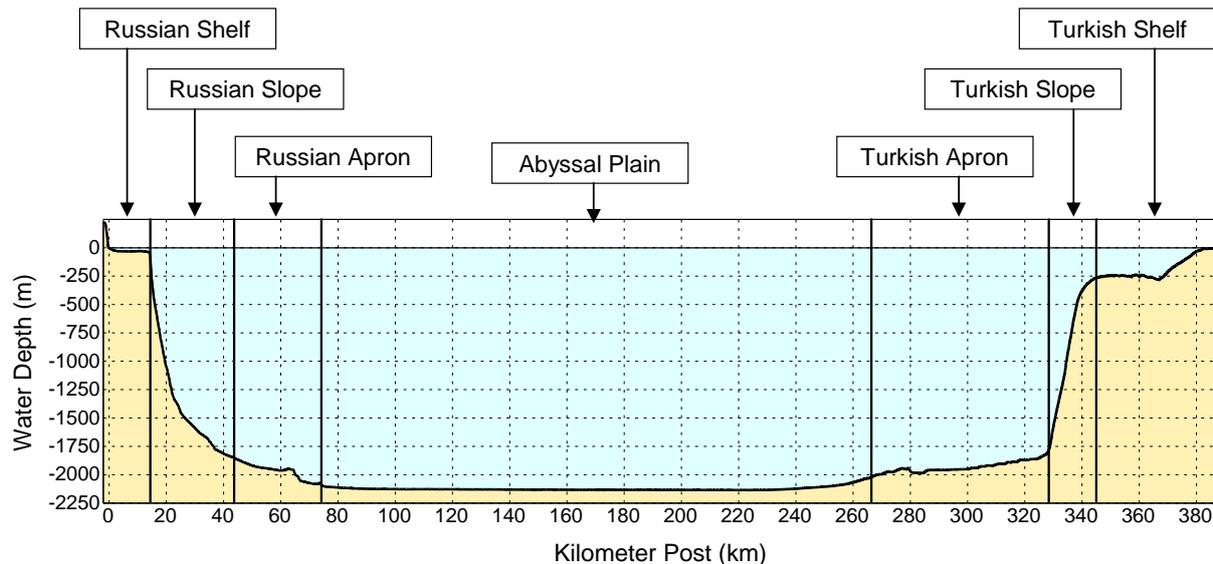
Figure 2 - Profile of the Black Sea along Blue Stream pipeline route, showing the 7 bathymetric provinces.

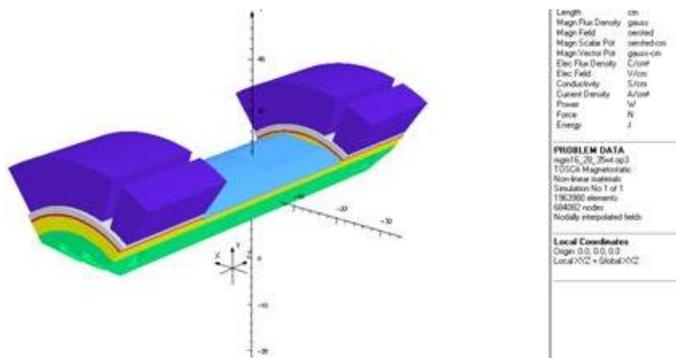
Figure 3- Magnetic modelling of the Flux intensifier return path bar

Enhanced Flux handling techniques used to generate an articulated bar return path design that was superior in handling the magnetic field compared to conventional sweeps brush techniques. This was based on proven concepts previously used to increase the wall thickness capabilities on small diameter tools but not previously used on a segmented body tool. The tool was designed with the most powerful commercially available rare earth magnets in the maximum space volume to achieve the local full bore passing requirement of the thick wall tee.

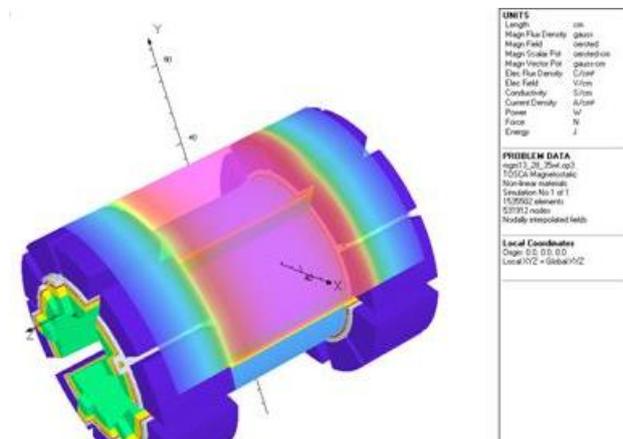
Figure 4- Magnetic modelling of the array of return path bars to check the uniformity of the field distribution between bars and along the axis between poles

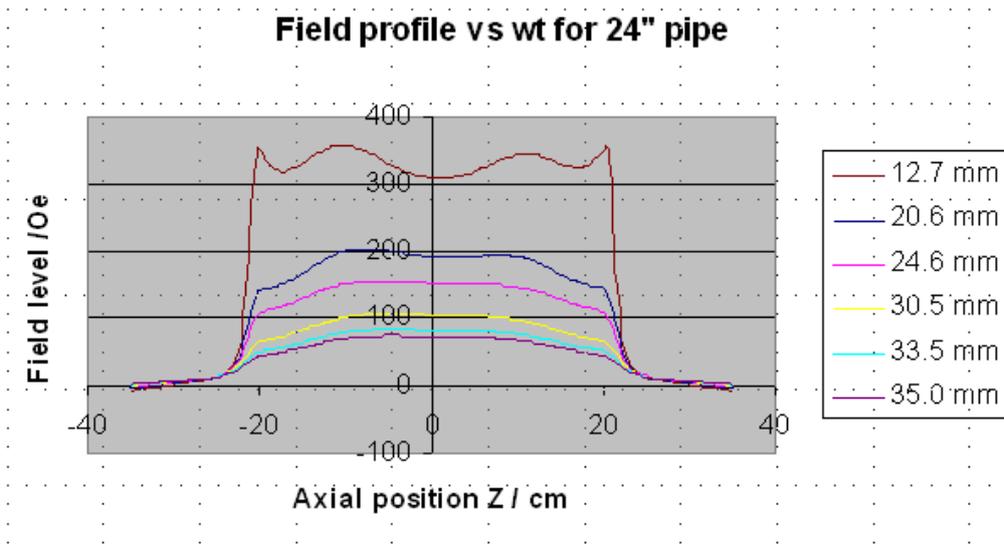
Figure 5- Predicted magnetic field levels

This graph shows the predicted magnetic field levels for the magnetiser arrangement in different wall thicknesses in the axial orientation. It is used to check the stability or flatness of the field levels relative to axial position. This is then used to determine the optimum position for the sensors. As can be seen from the above graph the field levels are relatively flat for the BSPC range of wall thickness allowing us some flexibility where the sensors can be positioned axially.

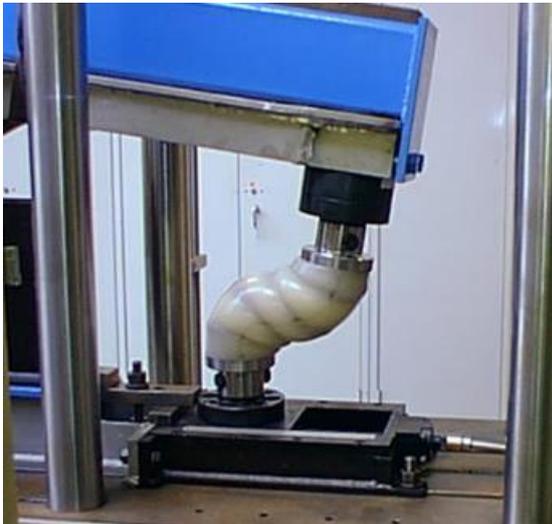
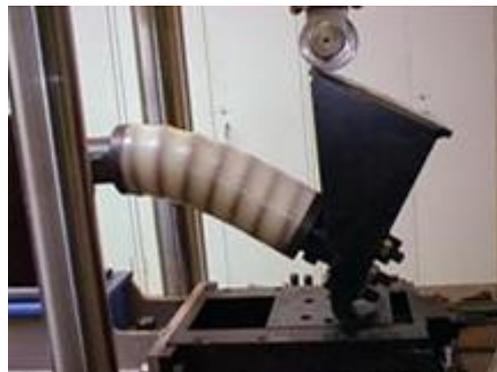
Figures 6 & 7- Testing of Prototype Semi Rigid Tow Coupling

As can be determined from the above, the design of a semi-rigid tow coupling is not straight forward. PII designed several prototype units, manufactured the hardware and conducted a series of prototype tests that were necessary to hone in on the final design. Figures 6 and 7 show some of the tests that were done to validate the design.

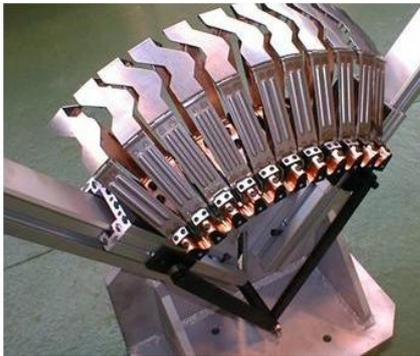
Figure 8- MFL sensor arrangement

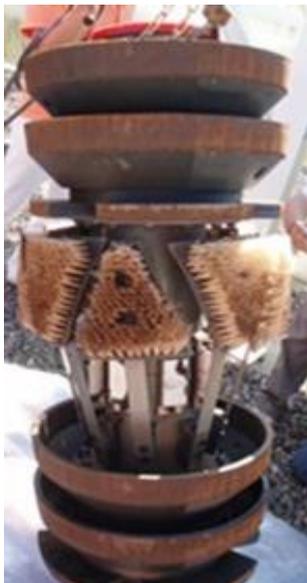
Figure 9- Cleaning Tool

The design of the cleaning tools had to be carefully considered. The removal of any dust or debris in the pipeline is crucial in obtaining a successful inspection; however, the abrasion was a factor for all pig runs and the protection of the integrity of the coating. Figure 9 shows the received cleaner, with minimal wear considering the pipeline length. The quantity of dust and debris was very small due to the quality of the gas and transportation process and the excellent construction of the pipeline.

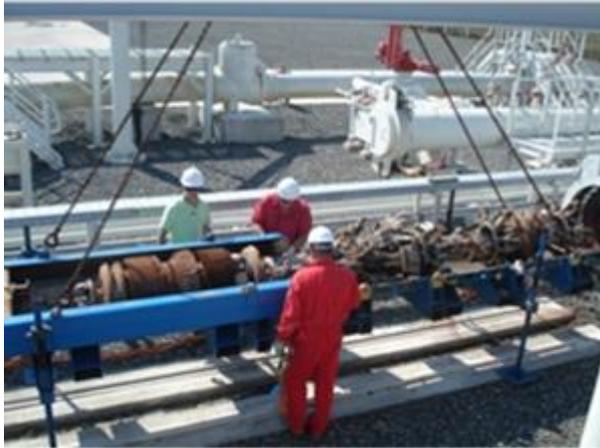
Figure 10 -The MFL pig received in Turkey after 387Km run

The two pipelines were successfully inspected and the results issued to BSPC. Figure 10 illustrates the safe receipt of the MFL tool following the 387Km run. The operation included the safe tracking of the pigs on both of the onshore sections acoustically and magnetically out of the traps and safely into the receive traps. Launching the tools in Russia and receiving in Turkey presented the team with customs and local certification challenges, including the requirement for local operating licences and permits to import and operate the tools in both countries, and to produce all documentation in both languages.

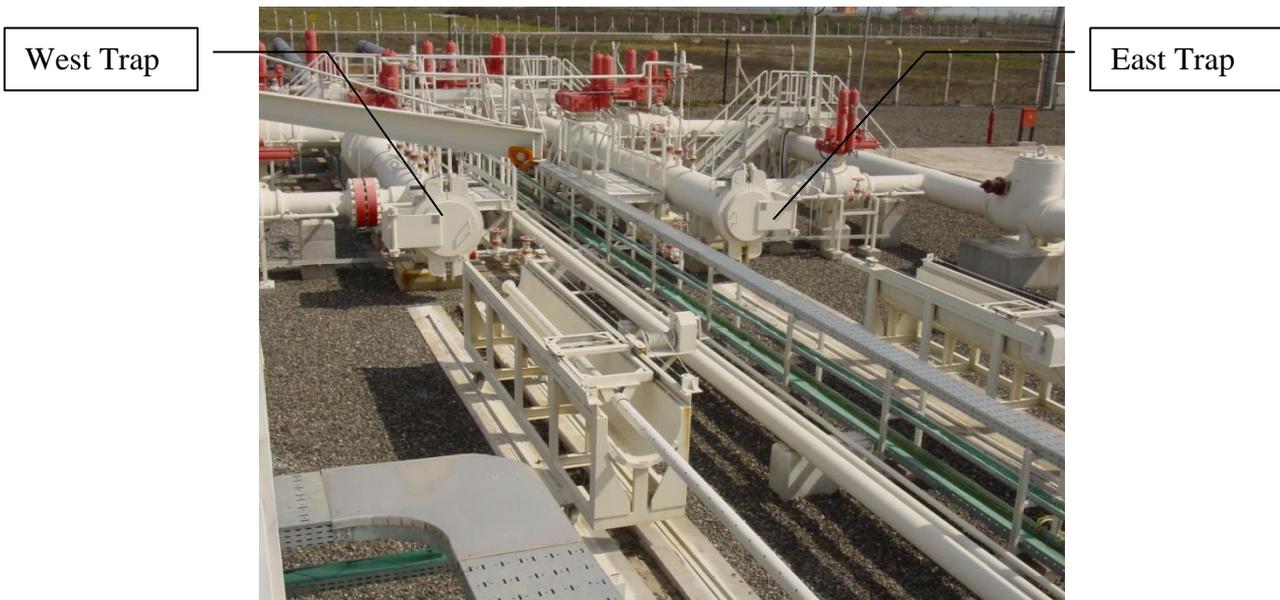
Figure 12- Photograph of the two receive traps in Turkey
