INSPECTION OF PIPELINES THROUGH THICK COATING

K. Reber, Innospection Germany GmbH, Stutensee, Germany
S. Hartmann, Innospection Ltd., Aberdeen
A. Boenisch, Innospection Ltd., Aberdeen

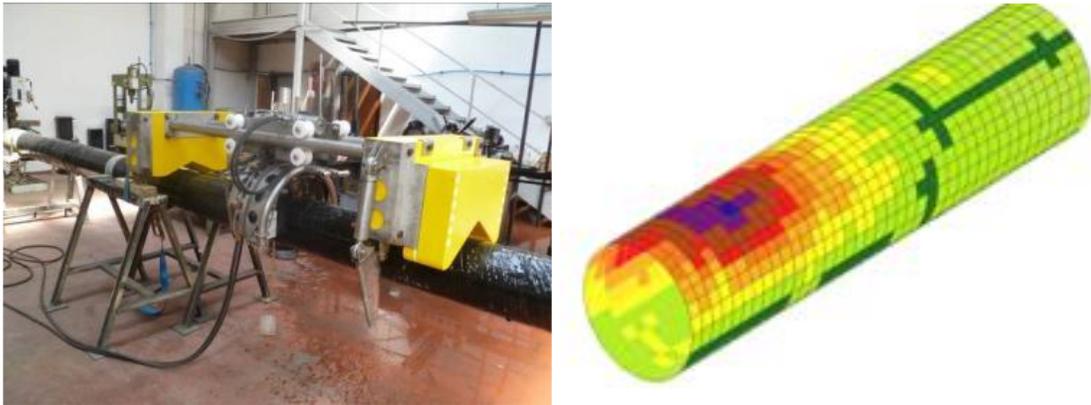
Figure 1: Left Subsea inspection device for PEC. Right: depiction of inspection results (by Impresub [4])

As the relevant portion of the spectrum is also in the lower frequency range this method is also stationary. The thickness of coating that it can penetrate depends on the size of a coil and the nature of the coating. It has been used for the detection of corrosion under insulation (CUI) for thickness of 150mm and thin non-magnetic metallic coating [3]. Figure 1 shows a subsea instrumentation for PEC-Pipeline inspection and a depiction of inspection data [4].

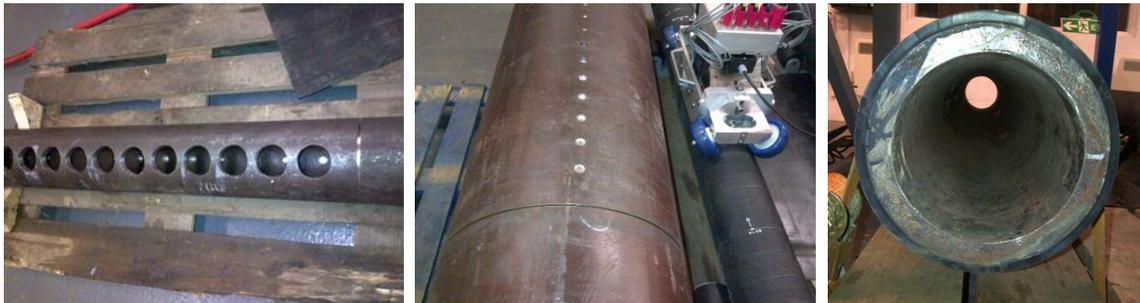
Figure 4: Test pipe for the riser inspection with artificial defects. Internal defects were introduced through a hole on the opposite side.

In an actual project a riser pipe was to be tested for internal and external corrosion type defects. The steel wall thickness varied from 18 mm to 25.4 mm (1"). A polymer coating of 12.7 mm (½") was present. Together with a 3mm lift-off of the sensors from the coating surface this led to some 15mm distance. The test pipe is shown in Figure 4.

For the introduction of internal defects a hole was cut into the pipe and defects were machined through this hole. After the introduction of external defects (center photo) the pipe was coated with a coating similar to the actual riser coating (right photo). It is essential that the coating resembles the original coating in terms of hardness. The movement of the tool on the heavily coated surface will be impeded, if the coating is too soft.
