## **MAGNETIC EDDY CURRENT (MEC™) AS A NOVEL TECHNIQUE FOR THE INTERNAL INSPECTION OF CRA-LINED PIPE**

K. Reber, Innospection Germany GmbH, Stutensee, Germany  
A. Boenisch, Innospection Ltd., Aberdeen, UK  
Stefanie Asher, Ph.D., ExxonMobil Upstream Research Company, Spring, Texas, USA

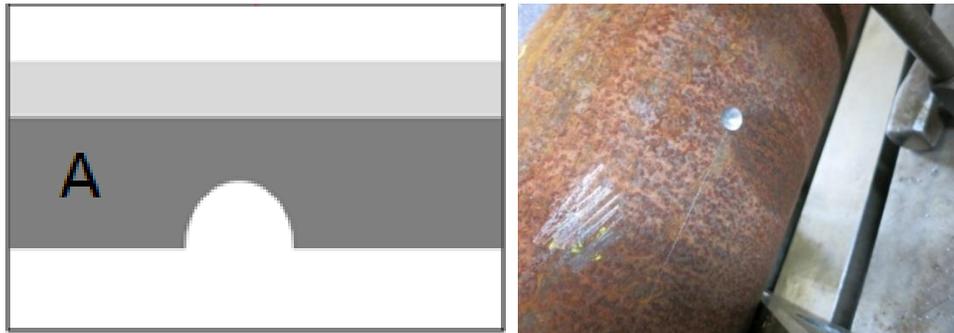
**Figure 2: External defects**

This defect type consists of metal loss on the external side of the carbon steel as shown schematically in Figure 2.

The depth ranges from 10% of the carbon steel wall thickness to 80%. The spherical defects are machined by mechanical cutting. The diameter of these spherical defects ranges from 3 mm (0.125") to 24 mm (~1"). All defects are round-bottomed holes.

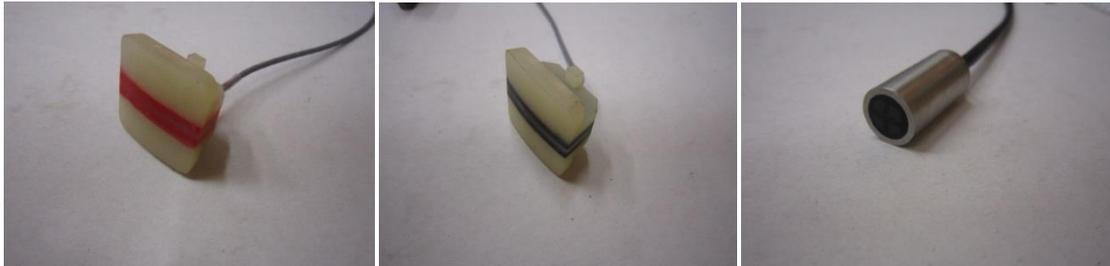
**Figure 8: Sensors to be tested for signal quality and detection capabilities**

Three different types of sensors are tested. They are shown in Figure 8. Two of these are regular MEC™-type sensors shown in the left and center of Figure 8 and in addition a multi-differential crack detection sensor (right).

The MEC™-type sensors are mounted in the magnetisation unit. They also have a certain capability of detecting cracks, but are optimised for metal loss. The MEC™-type sensor can be run in differential and in absolute mode. This results in two independent sets of data. The crack detection sensor (right) does not require a bias magnetic field. It will detect surface breaking cracks.

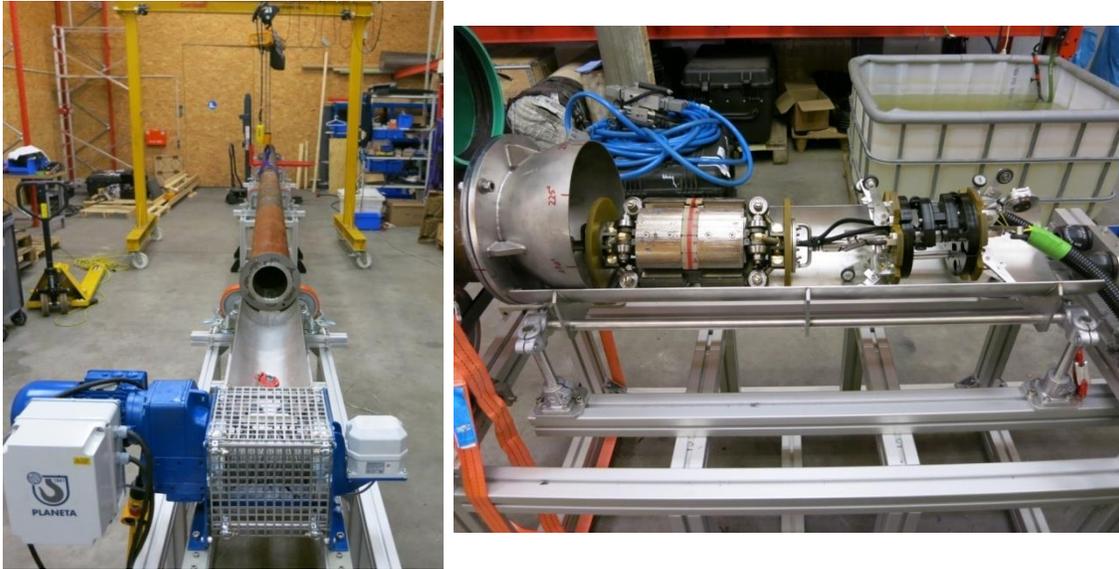
**Figure 9: Left: Set-up of the test spool, Right: Prototype inspection device**

The prototype tool consists of two bodies, the magnetisation unit and an additional sensor carrier as shown in the right of Figure 9. The sensors are connected to a data processing unit via an umbilical as seen on the right of the image. In the picture the tool rests in a tray for easy launching and receiving. A cone-shaped cylinder simplifies the tool entry into the pipe.
