WORLD FIRST PRESSURISED SUBSEA PIPELINE REPAIR FACILITATED BY NON-PIGGABLE AND PIGGABLE ISOLATION TOOLS

By: Dale Millward, STATS Group, UK

Project Description and Challenges

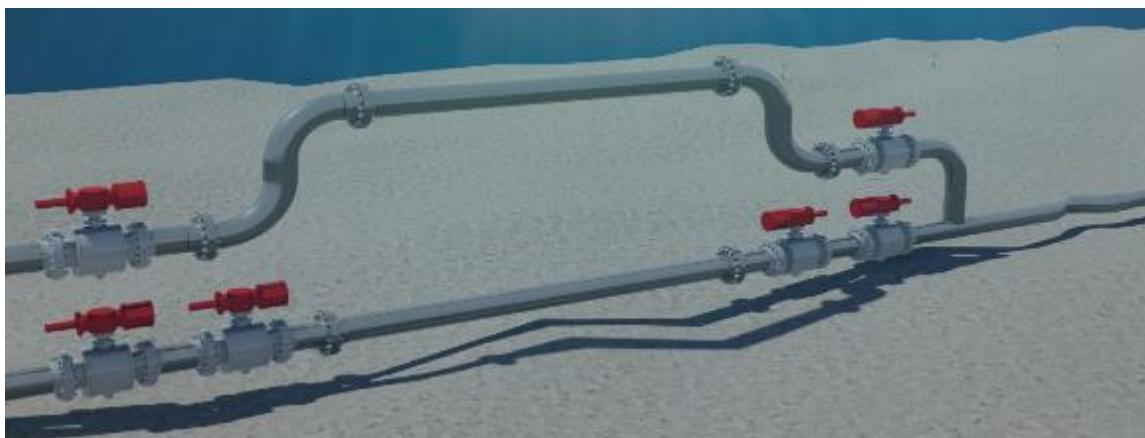
Due to the damage caused by the anchor drag, it was not possible run any pigs through the pipeline, therefore the Remote Tecno Plugs had to be installed into the pipeline locally at the subsea damage location. As the North PLEM was severely damaged and the pipeline beyond the North PLEM was unpiggable due to the extent of the damage, the Remote Tecno Plug could not be deployed via the PLEM.

Figure 2: Damaged pipeline downstream of North PLEM

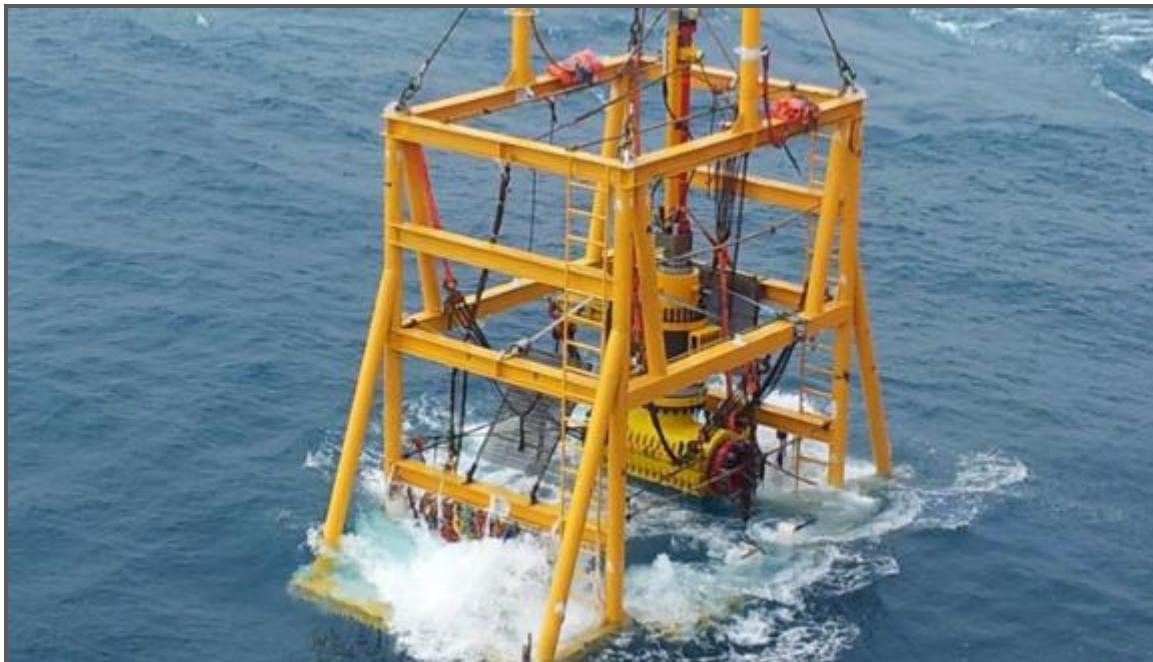
Figure 4: Mechanical clamp and hot tap machine deployment

The South PLEM was not damaged by the anchor drag incident allowing the isolation valves within the South PLEM to provide the initial upstream DBB barrier. Therefore, a DBB barrier downstream of the damaged North PLEM needed to be installed to allow a section of the pipeline to be safely removed creating access for a piggable Remote Tecno Plug. This was done by installing a mechanical hot tap fitting onto the pipeline (50m beyond the damaged pipeline section) and hot tapping into the pressurised pipeline.

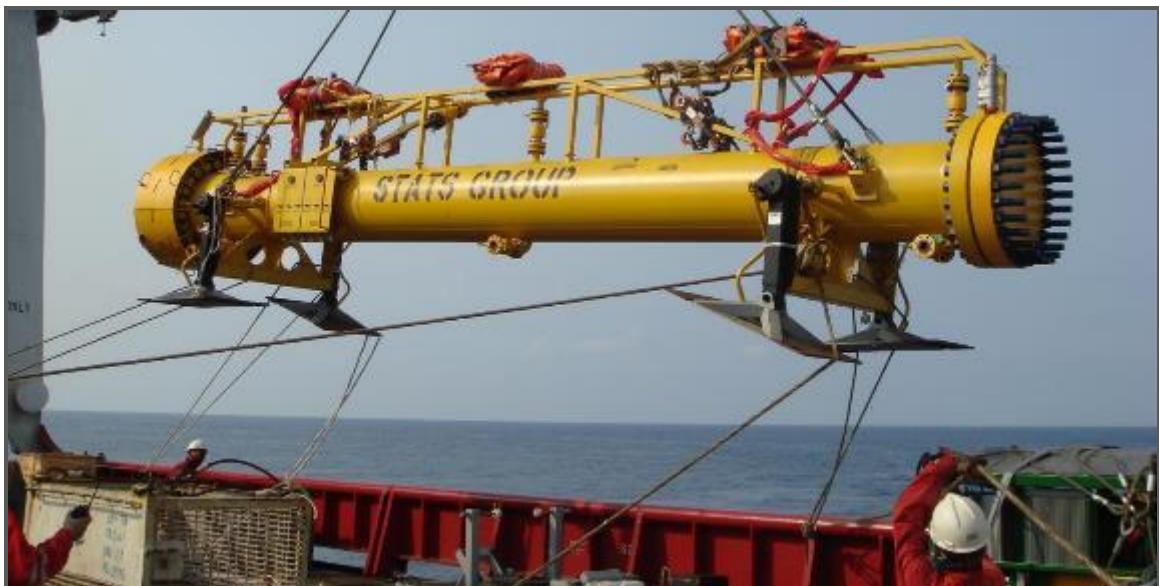
After the damaged pipeline section was isolated upstream by the PLEM valves and downstream by the BISEP, it was depressurised and flooded so a short section of the pipeline could be safely cut and removed by the divers. A subsea launcher, containing two Tecno Plugs, was then deployed from the vessel to the seabed and connected to the cut pipe end.

Figure 5: Flangeless Subsea Launcher deployment

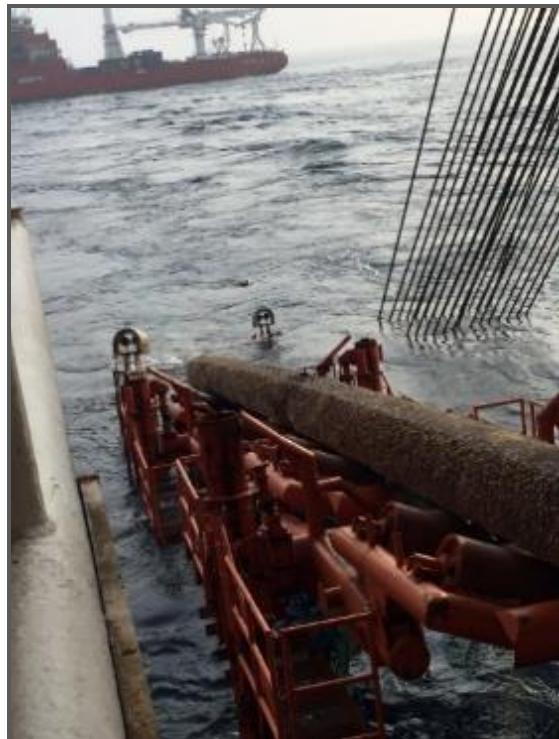
This left a bare pipe end into which a Pipeline Retrieval Tool (PRT) was installed for the pipeline recovery. To enable the pipeline to be recovered safely from the seabed (90m depth) onto the pipe lay barge, the catenary section was pressurised with 30bar nitrogen locked in between the first and second Tecno Plugs. The 50bar gas pressure in the 273km downstream pipeline section was securely isolated by the first Tecno Plug - located 700m away - in the pipeline section that remained on the seabed throughout the pipeline recovery.

Figure 8: Pipeline recovered to lay barge

The pipe lay barge then installed 400m of new pipe onto the recovered pipeline. The new pipeline end laid on the seabed was terminated with a new tie-in flange and a laydown head.

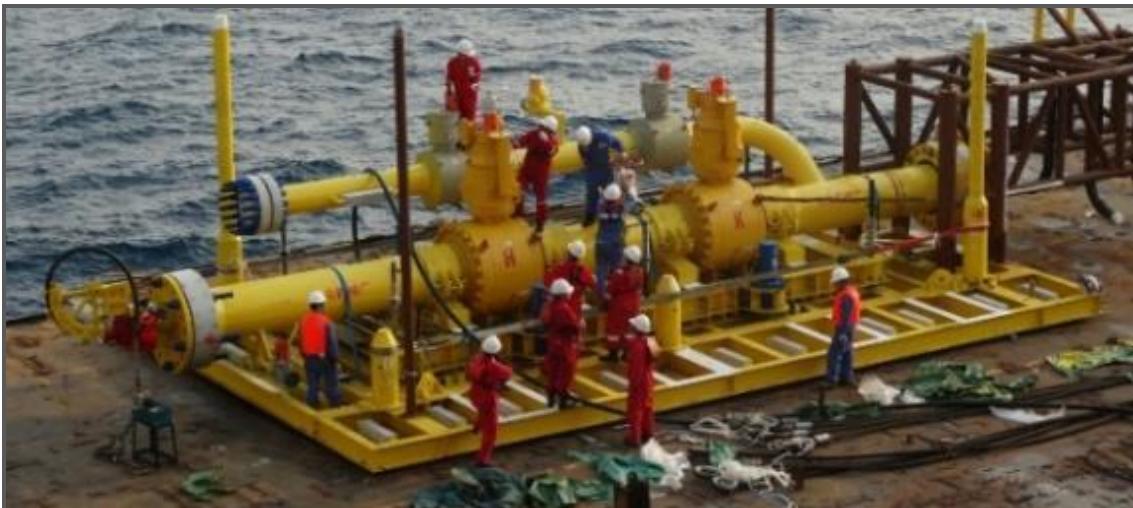
Two new PLEMs were installed by the DSV while the pipelay barge welded new pipeline sections to the existing pipeline and laid them back onto the seabed. Throughout the entire pipeline isolation period all four Tecno Plugs in the pipeline were monitored, remotely from the DSV.

Figure 9: Pipeline End Manifold (PLEM) deployment

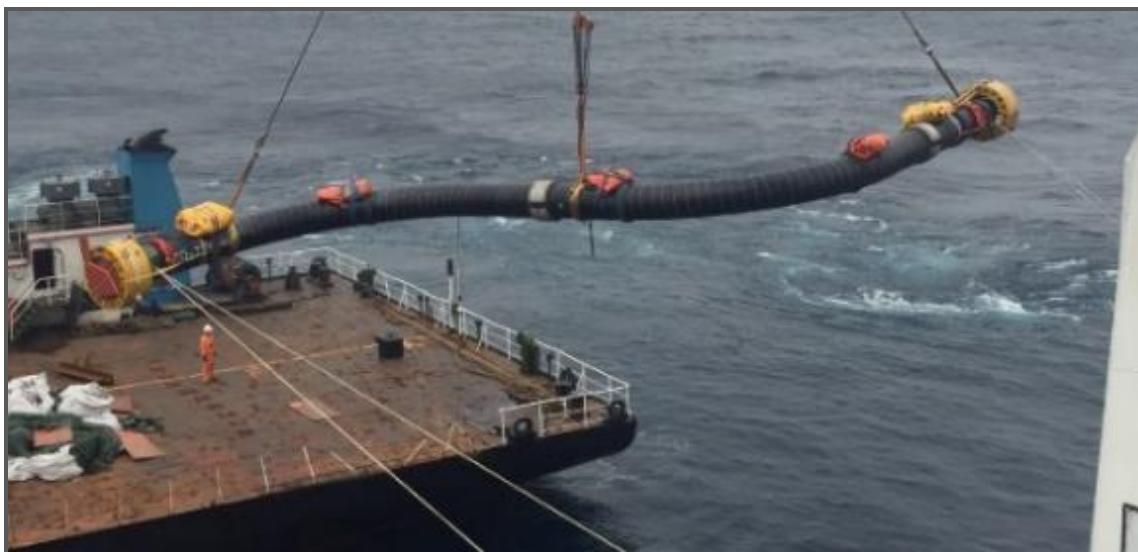
Figure 10: 25m tie-in spool deployment

The repair was completed by connecting the two PLEMs together with a final tie-in spool. Following leak testing and dewatering of the final tie-in spool the subsea pipeline isolation valves were opened and gas production was resumed.
