OPERATIONAL PIPELINE PIGGING—CONGO RIVER CROSSING (CRX) PRE-COMMISSIONING

By: Michael Bowes, CEng Halliburton, Pipeline and Process Services, UK/Global

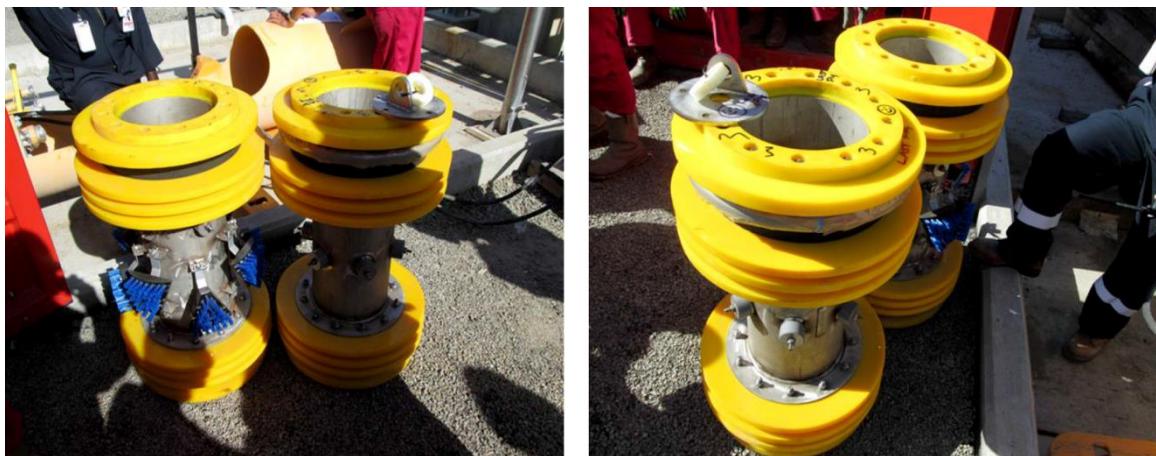
- One bidirectional (bi-di) brush pig
- One combined bi-di brush/gauge pig
- One bi-di gauge pig

Figure 1—Segment C 22-in. bi-di pigs

Operations on Segment C commenced in March 2013. The scope was to run a series of pigs to flood, clean, and gauge 22-in. production pipeline from the LNG pig launcher/receiver (PLR) to the temporary subsea receiver head installed at the end of the pipeline at SPP. The pig train consisted of the following (Figure 2):

All pigs were separated by 500 linear meters of seawater filtered to 50 microns, and the final gauge pig slug was treated with a chemical cocktail consisting of biocides and oxygen scavenger at 500 ppm to provide protection to the line for 24 months.

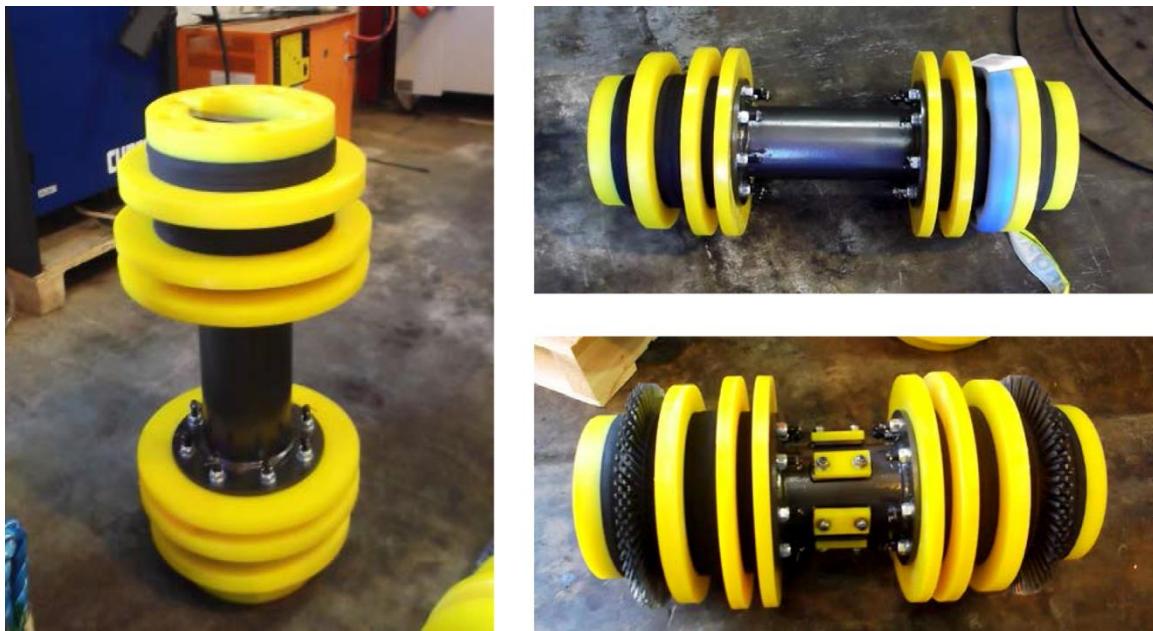
Once all of the foam pigs were received, they were taken out of the SPP receiver, and the following bi-di pig train (Figure 4) was launched without risk:

- One bi-di pig
- One bi-di brush pig
- One bi-di gauge pig

Figure 4—Segment W 12-in. bi-di pigs

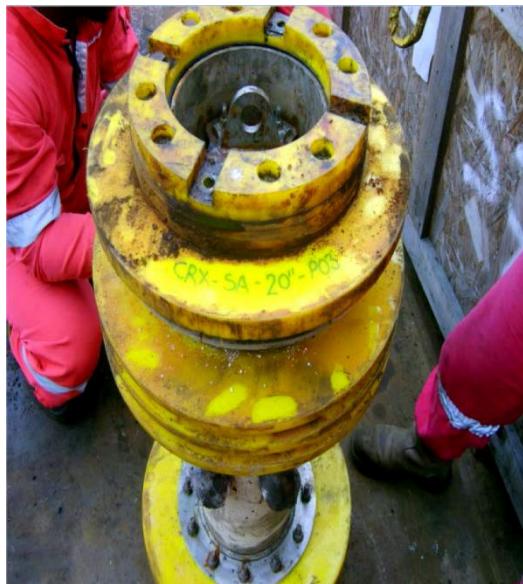
When the subsea structures were prepared for installation in 2014, the subsea PLRs on Segment A and B pipelines were recovered, and the pigs were removed (Figure 6). There was an unexpected volume of dirt collected by the pigs, necessitating a fast-tracked pigging operation before the installation of the subsea structures.

Figure 6—A 20-in. bi-di pig recovered from Segment A
