MAKING SIMPLE SMART AND SMART SIMPLE: COST EFFECTIVE, LOW RISK PIPELINE INSPECTION

By: Paul Clayton, i2i Pipelines, Manchester, UK

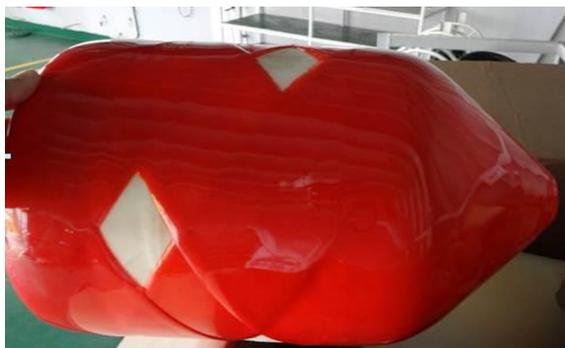
Figure 1: Operator’s normal pig

Previous operational pigging conducted by the operator had been extensive but very unsuccessful. Not only were their pigs considered to be “tumbling” in the line, they were getting damaged either in the line or during receive in the pig valve at the FPSO.

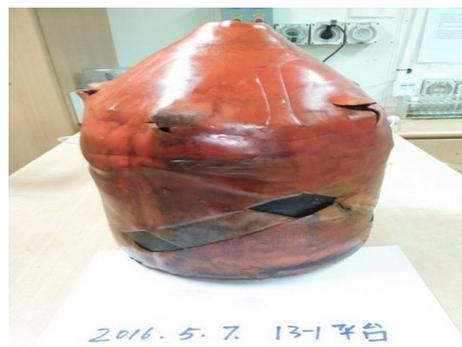
Figure 2: Operator’s pig at receive

The operator considered that the pipelines were quite clean and reached the conclusion that the receiving procedure needed to be reviewed as the pigs were constantly damaged.

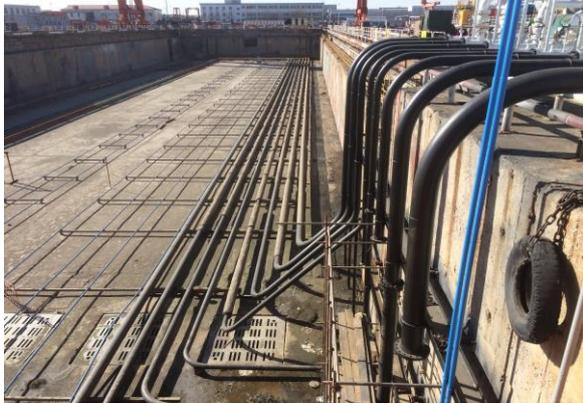
Figure 3: Operator's test loop located in a dry-dock.

After an initial review, i2i produced a design of pig as a “dummy” to be tested in the pipeline whilst also producing an operational SmartFoam™ tool to be run in the test loop that contained a large number of defects machined in by the client. The pig was tested at a pigging loop in China against client manufactured defects in a “blind-test” scenario. For this specific test, the inspection technology passed with a POD of 97%. Deposit samples, including wax, were also introduced into the test loop to determine anomaly detection and sizing in an un-cleaned pipeline.

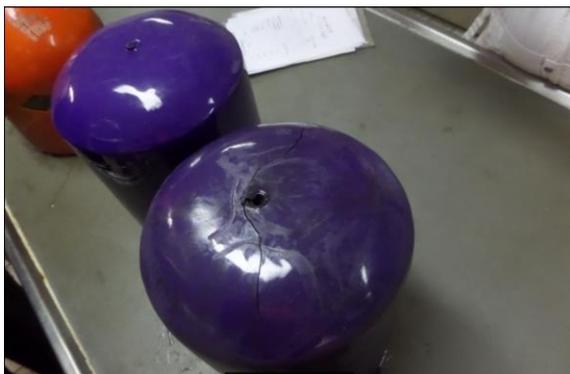
Figure 4: Dummy pigs before/ after trial run.

The final stage before a fully operational run was to test the design under conditions including being received in a pig valve. For this stage of the operation the dummy pig was run in the offshore pipeline and successfully received in the pig valve. There was no evidence of tumbling in the pipeline and the pig was received as expected and in the correct orientation. The internal basket mark called “the spider” on the pig was a clear confirmation that the pig had not tumbled during operation and had been received correctly.

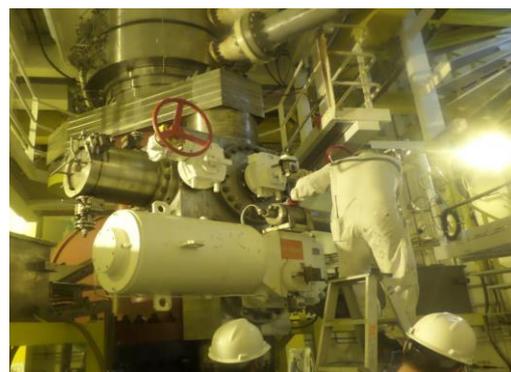
Figure 5: Pigging valve receiver on FPSO.

The tool was run and received in the first pipeline in September 2017. At the time of issuing this paper the operation to inspect the second pipeline is still ongoing due to some damage on the dummy tool at receive in the pigging valve on the FPSO.

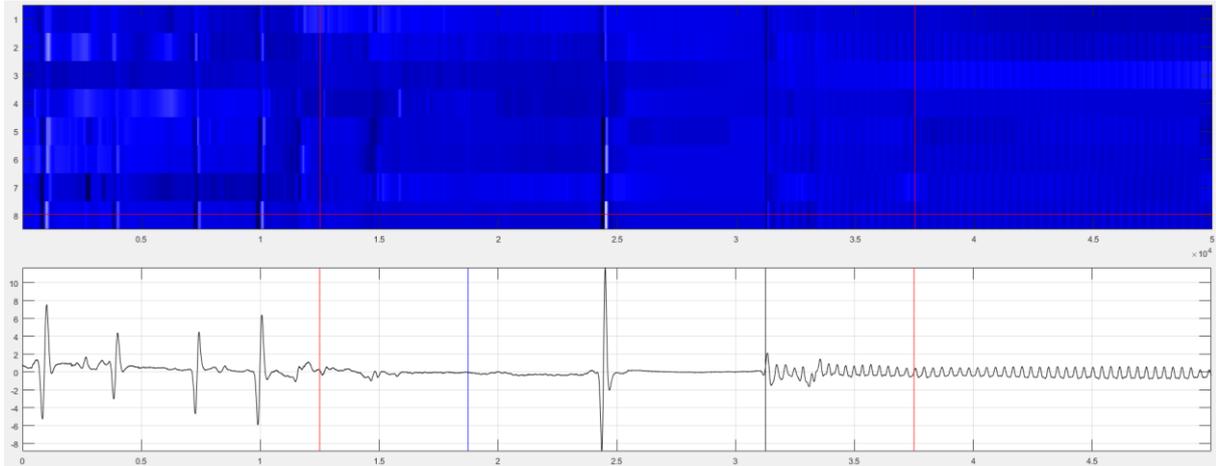
Figure 6: Data showing fixtures at end of rigid pipeline and transition into flexible riser at FPSO.

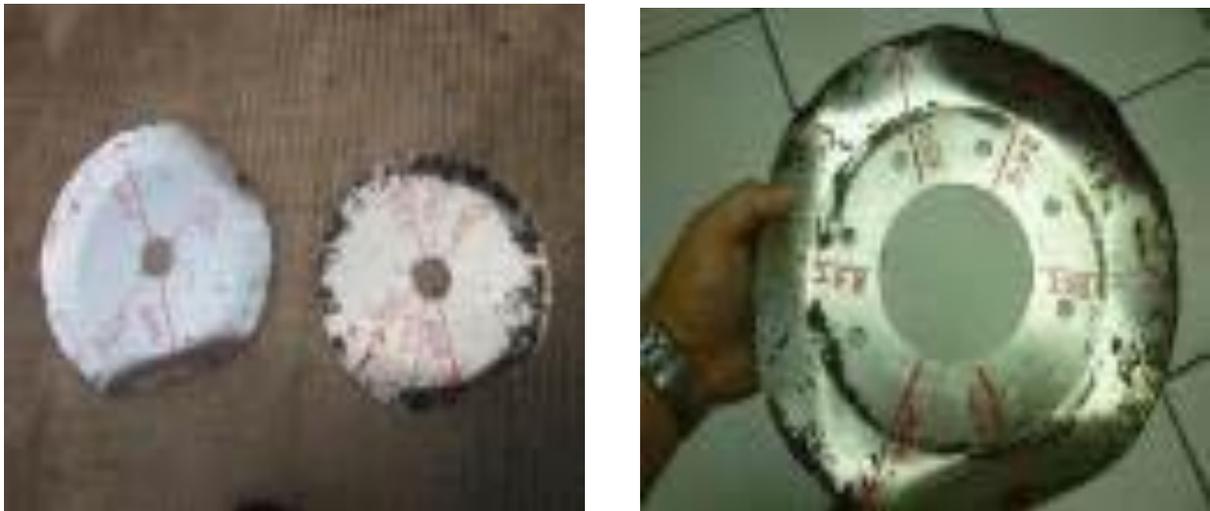
Figure 1: Examples of damaged gauge plates

The challenge for this particular pipeline was the fact that the line was known to be suffering from a large quantity of dents. This was originally identified from the running of basic bi-directional pigs fitted with traditional aluminium gauge plates during normal operational pigging on narrow bodied pigs.

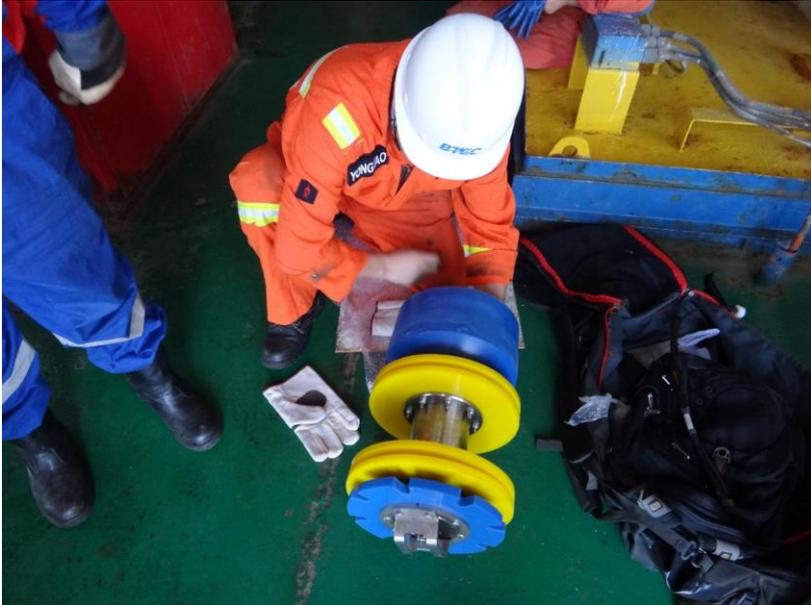
Figure 2: Pioneer™ tool offshore prior to launch

The Pioneer™ tool was launched by our agent's technicians after just a half day of training in the commissioning, loading and running of the tool demonstrating the simplistic operational use that underpins the ethos of the tool.

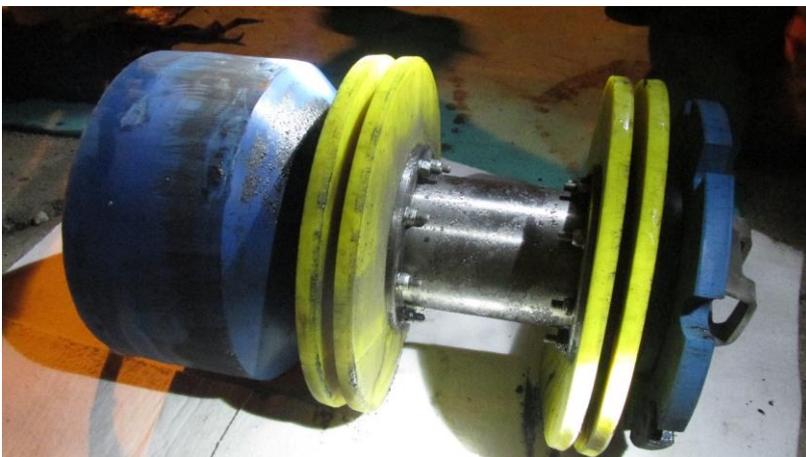
Figure 3: Pioneer™ tool at receive onshore in good condition

Due to having to use an undersized body and battery pack for the Pioneer™ tool because of the constraints around the dents in the line, the tool gathered data for approximately 31km out of the 50km before the batteries ran out. However, after a quick overnight re-charge and a quick return offshore the tool was re-run at an increased flow rate and gathered data for the complete pipeline. The tool also had the IMU dis-abled to help mitigate power consumption.

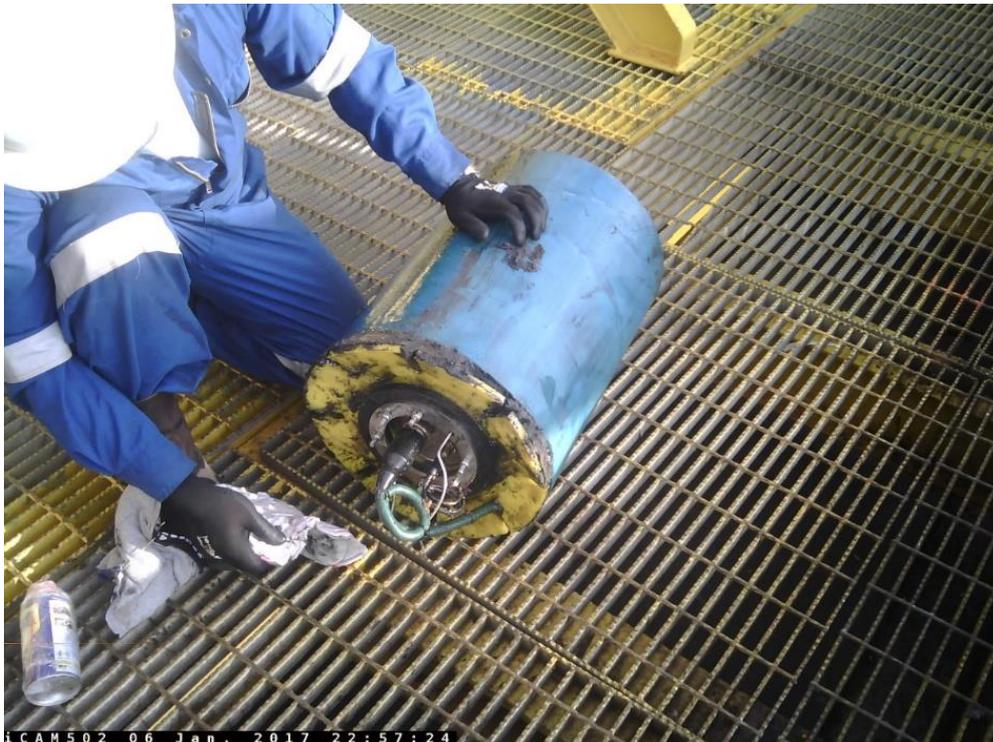
Figure 1: SmartFoam™ tool equipped with rear mounted DDMD at receive

Following a detailed technical assessment, it was considered that the optimum inspection solution for the application was with SmartFoam™ and a tool was mobilised with a technician. The chosen design was an undersized foam pig fitted with the DDMD (Dent and Deposit Mapping Disc).

The addition of the DDMD brings another level of intelligence to the tools whilst still maintaining the underlying aim of simplicity and inspection without disruption. Furthermore, whilst having the initial aim of debris monitoring, the DDMD also facilitates accurate dent detection and measurement in a far more sophisticated manner than the traditional slotted gauge plate and in a far less complicated and cost-effective manner than a calliper tool. Furthermore, a local technician was trained to operate the tool in just half a day demonstrating how simple the tools are to operate.

Not only did the SmartFoam™ tool successfully inspect the pipeline through the existing wax deposits, the addition of the DDMD enabled the wax deposits to be mapped and quantified through the pipeline and a total volume of wax calculated. As a consequence, the operator would be able to formulate an appropriate strategy for both cleaning and wax-mitigation going forward.
