SMART UTILITY PIG TECHNOLOGY IN PIPELINE OPERATIONS

By Barry Nicholson, Weatherford Pipeline & Specialty Services, Edinburgh, UK

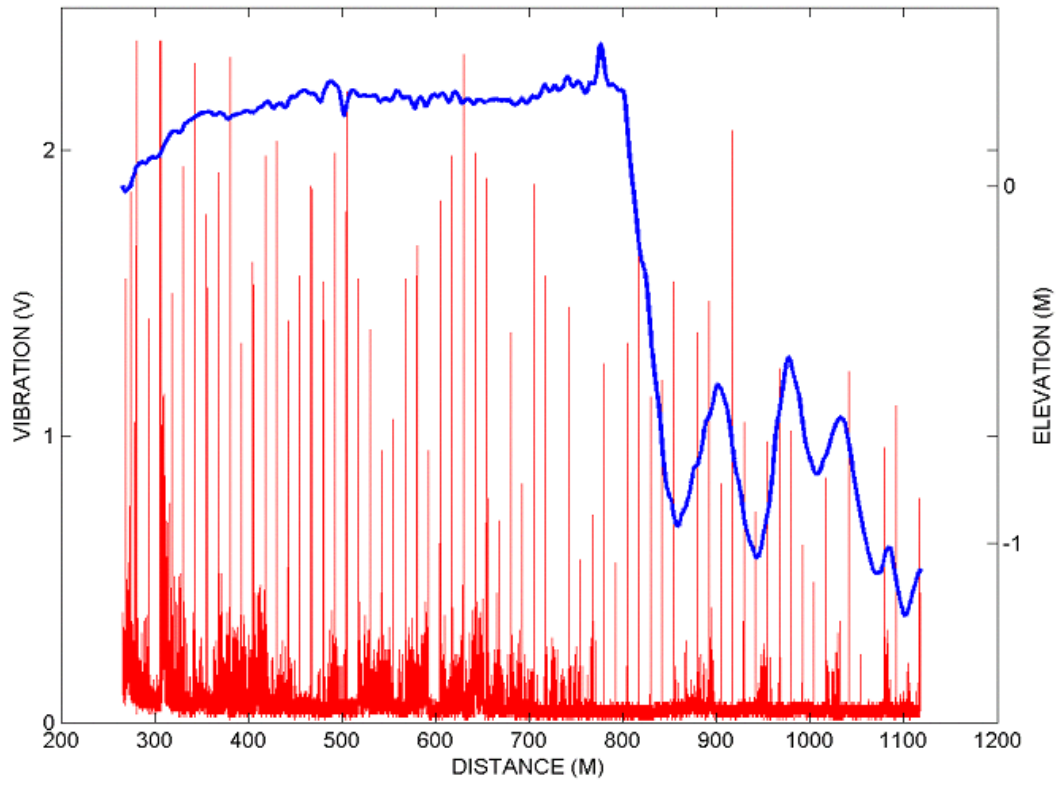
Figure 13 – Vibration Signal Against Elevation Highlighting Corrosion at Low Spots

A corrosion assessment inspection of a 16" offshore oil pipeline was carried out in 2003. A previous intelligent pig inspection identified corrosion across the first 1000m of the pipeline. However, the presence of wax in the pipeline at the time of the intelligent pig survey resulted in no data being acquired for the remainder of the pipeline, and the operator was concerned that the corrosion may extend further downstream. The vibration data acquired in the two *SAAM* inspections was analysed in order to eliminate transient effects and identify permanent anomalies most likely to be indicative of corrosion. These were compared with the results of the intelligent pig inspection to determine the characteristic vibration signal at regions of corrosion. A strong correlation was identified between clusters of metal loss features identified by the intelligent pig, and increased smart utility pig vibration [Fig. 12]. The elevation profile of the pipeline, calculated from the inclination data, also highlighted a correlation between the locations of corrosion and elevation low spots in this region [Fig. 13]. The information gained on the type of vibration signal indicative of corrosion at the beginning of the pipeline allowed the vibration data for the remainder of the pipeline to be analysed for further anomalies indicative of corrosion. This analysis confirmed to the operator that no significant corrosion occurred later in the pipeline, and also provided a baseline of the pipeline's internal condition against which to compare the data from future inspections, in order to monitor for increases in corrosion.
