## ORMEN LANGE PIPELINE INSPECTION – A CLIMB TO SUCCESS

This paper presents a case study of a complex inline inspection (ILI) activity with multiple significant challenges that required innovative solutions to achieve an outcome of a safe and successful activity within required schedule and budget.

The Ormen Lange gas field, operated by A/S Norske Shell, is located in the southern part of the Norwegian continental shelf approximately 120km north-west of the Nyhamna gas and gas condensate processing plant in Gossa Island, Norway. The water depth in the field area ranges from 800m to 1,100m.

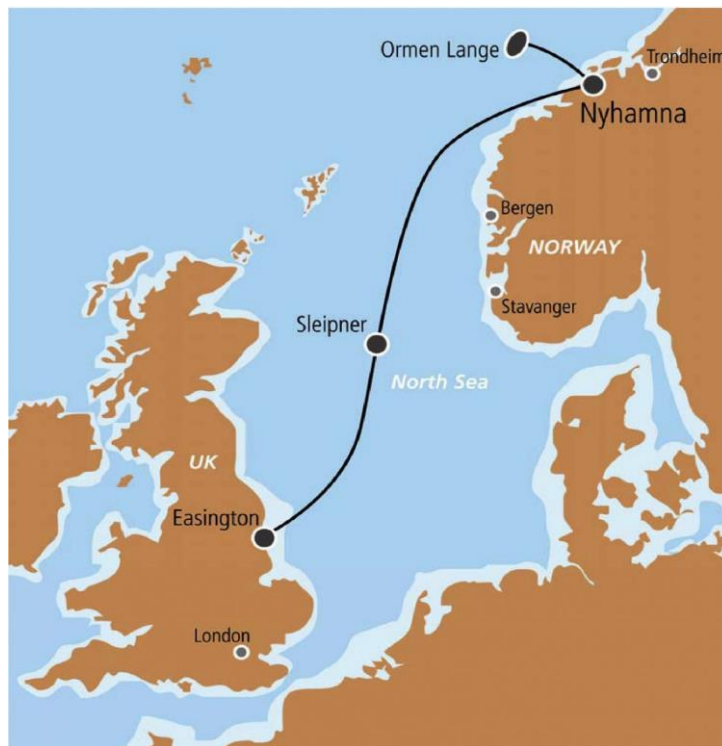
**Figure 1: Ormen Lange & Langede Pipelines**

A/S Norske Shell operates two subsea pipelines, each 30-inch diameter and 120 km in length, located off the west coast of Norway. These pipelines transport a mixture of natural gas and gas liquids from the Ormen Lange subsea field to the Nyhamna onshore processing facility. From Nyhamna, the processed gas is transported through the 42-inch/44-inch 1,166km Langede pipeline to the United Kingdom.

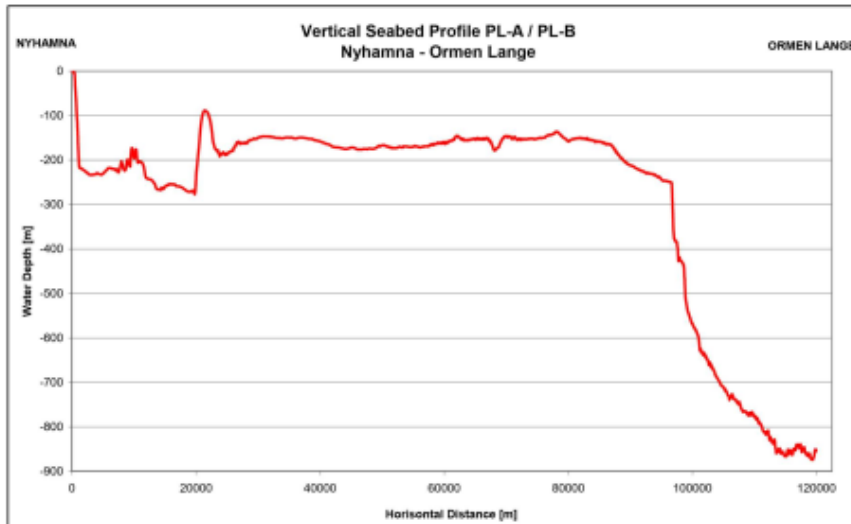
Figure 3: Vertical Seabed Profile Ormen Lange Pipeline

There was significant uncertainty regarding the transport mechanism of sand fines within the pipelines due to variations in pipeline profile and gravitational effects. Initial process design experiments suggested that fines would be transported by liquids within the pipeline. However, subsequent modelling predicted that up to 105 tonnes of sand deposits could have accumulated in each pipeline, resulting in a potential high case total accumulation of up to 210 tonnes across both pipelines. This volume if present and not well mitigated presented a high risk of creating a total blockage during pigging operations resulting in a high adverse consequence of a lengthy unplanned pipeline outage. This was considered by Ormen Lange stakeholders as an unacceptable outcome.

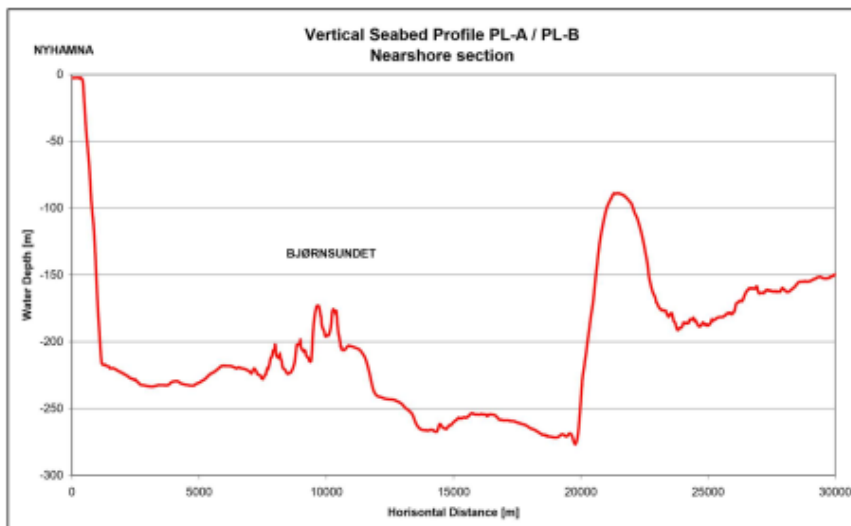
Figure 4: Vertical Seabed Profile Nearshore Section

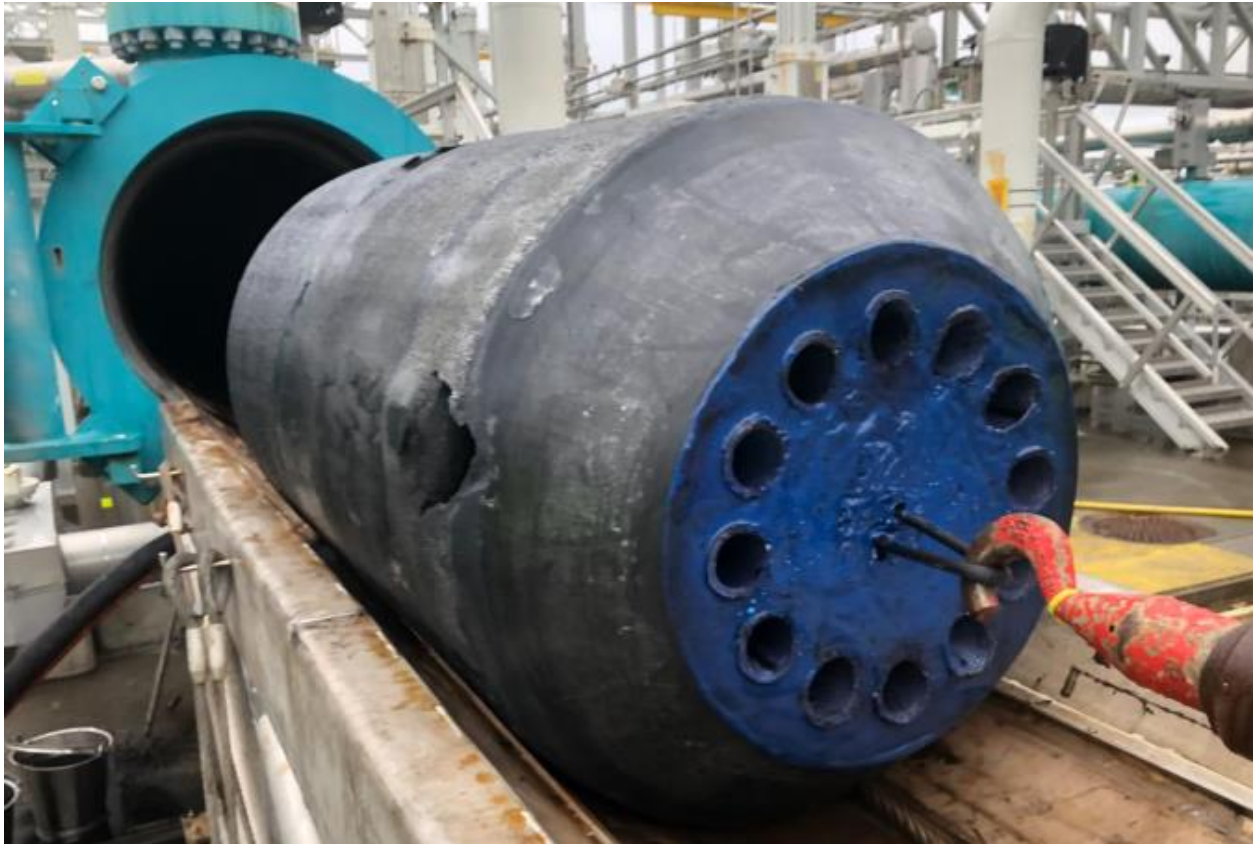
**Figure 6: 98% Foam Pig Post run**

A dummy Pathfinder foam pig, sized at 676 mm (98% of the pipeline ID of 690 mm), was run first to prove piggability. The dummy Pathfinder is identical in construction to the operational Pathfinder but is run without the embedded sensor system and electronic data pack being installed. Upon receipt, the condition was reviewed and assessed. This provided assurance to confirm or otherwise safe passage of the operational Pathfinder.

The undersized dummy Pathfinder was run at an average velocity of 4.4 m/s, though the velocity increased with pressure drop across the pipeline. The pig body sustained minor superficial damage, leading to the decision to proceed with the Pathfinder pig.

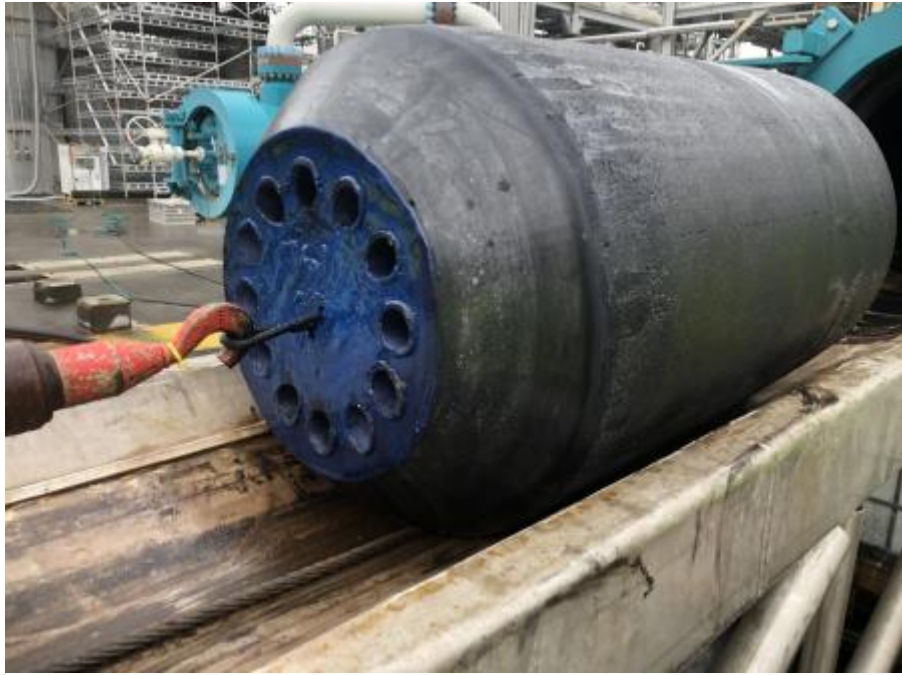
The full-size operational Pathfinder, with an outer diameter (OD) of 717 mm, was launched and received with a run time of 27 hours and 20 minutes and an average velocity of 2.44 m/s. The pig was equipped with 12 bypass holes (50 mm each), to mitigate any potential for debris build up in front of the pig. The pig was received in good condition with no damage and minimal wear. Data acquisition was 100% and of excellent quality.

**Figure 7: Pathfinder post-run**

Analysis of the data collected from the operational Pathfinder run confirmed the minimum internal diameter in accordance with pipeline end termination (PLET) connector drawings. Data indicated approximately 56m<sup>3</sup> of debris was present between 50 km and 123 km, predominantly in Pipeline A. It was considered that 56m<sup>3</sup> was a worst-case scenario due to envisaged potential for Pathfinder to bulldoze a proportion of debris for a period before riding over it which effectively would then measure this proportion as new (additional) debris. No credit was taken for this potential effect as it could not be confirmed or quantified.

Based on these findings, a recommendation was made to reverse the pig run direction for the campaign from A to B to B to A, thereby minimising the distance of transportation of debris and preventing transfer of the higher amounts of debris present in Pipeline A into Pipeline B.

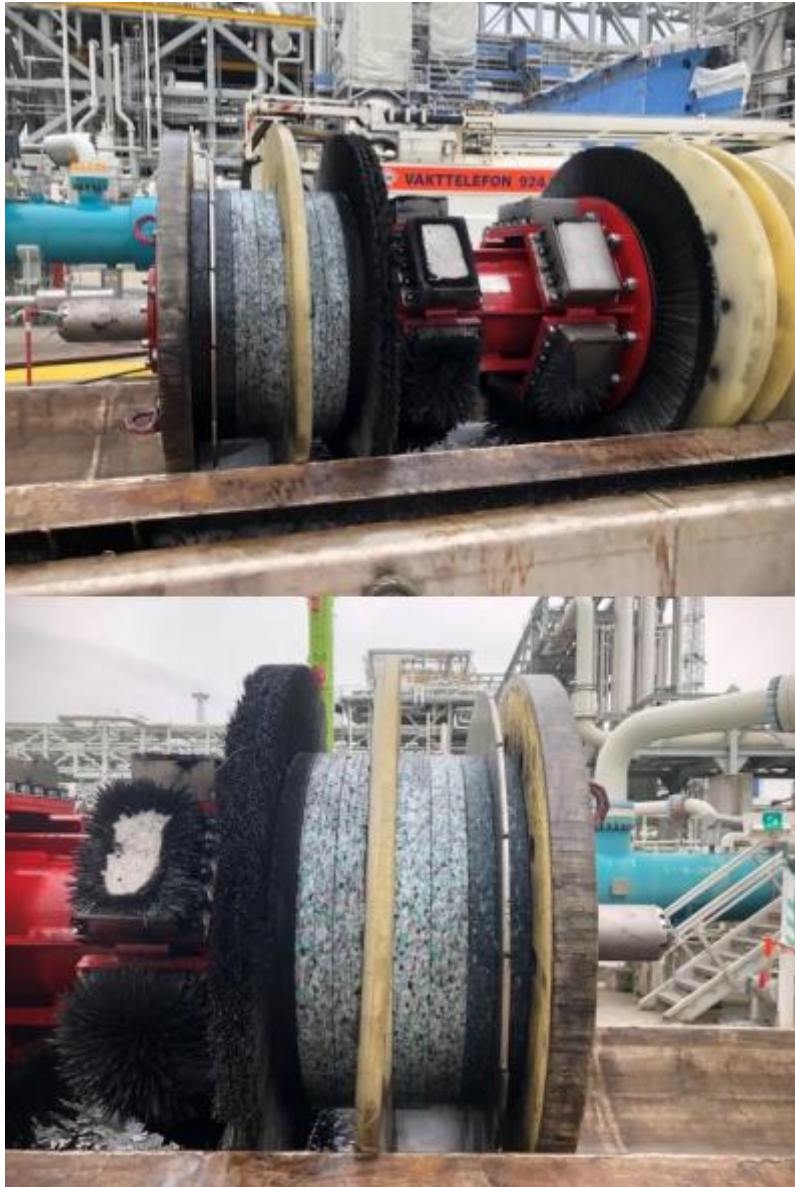
- The gauge pig was assessed to be in good condition with minimal wear and limited debris accumulation.
- Due to contamination and potential of Health, Safety, and Environmental (HSE) risks to personnel, the receiver required flushing. This contamination made precise debris quantification challenging and increased reliance on pig behaviour data recorded by the Pipeline Data Logger (PDL) for assessing debris levels.

**Figure 13: Gauge Pig Post-run**

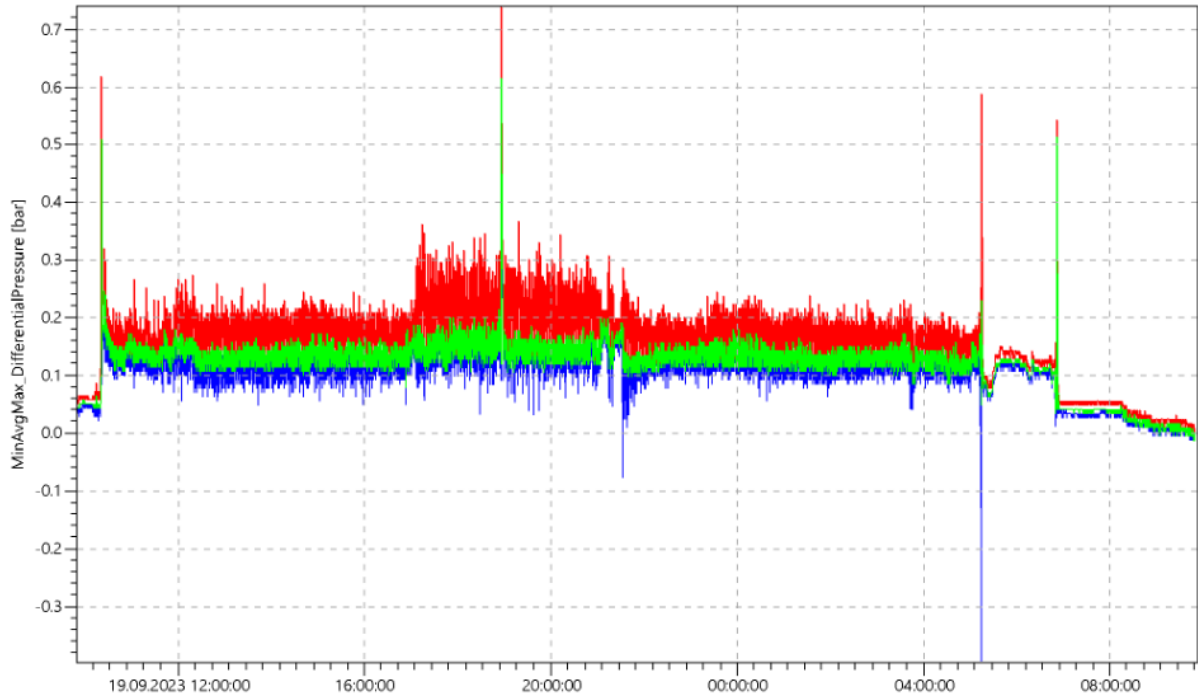
The PDL data from the first gauge pig run did not reveal any significant DP spikes that could not be accounted for by known pipeline features. Based on this analysis, the decision was made to continue with the cleaning program as planned.

**Figure 14: PDL Recorded Differential Pressure**

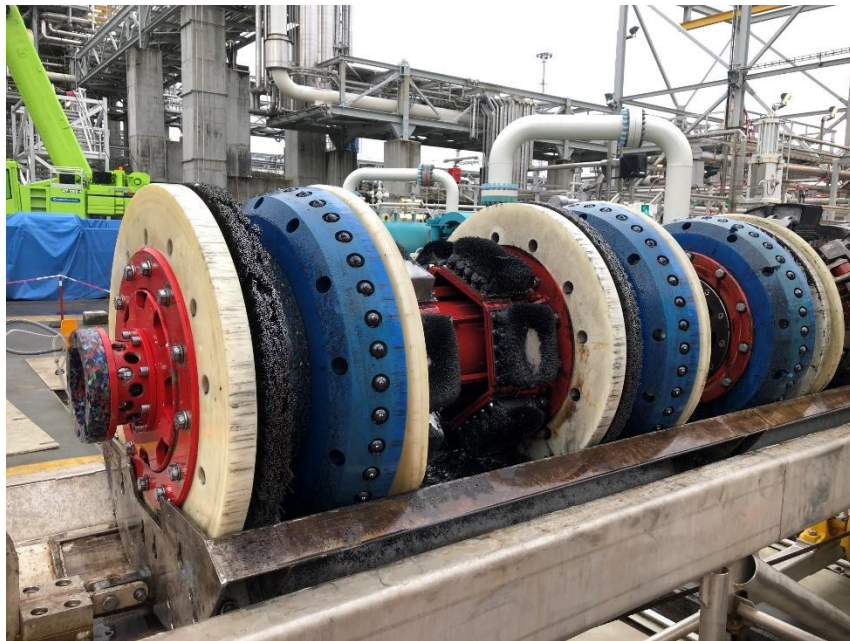
**Figure 19: Run 7 HDCP**

Following a decrease in the amount of ferrous debris recovered the decision was made to proceed with the MFL A + IEC inspection. This decision was based on the improved condition of the pipeline and the reduction in debris, indicating readiness for the next phase of inspection.

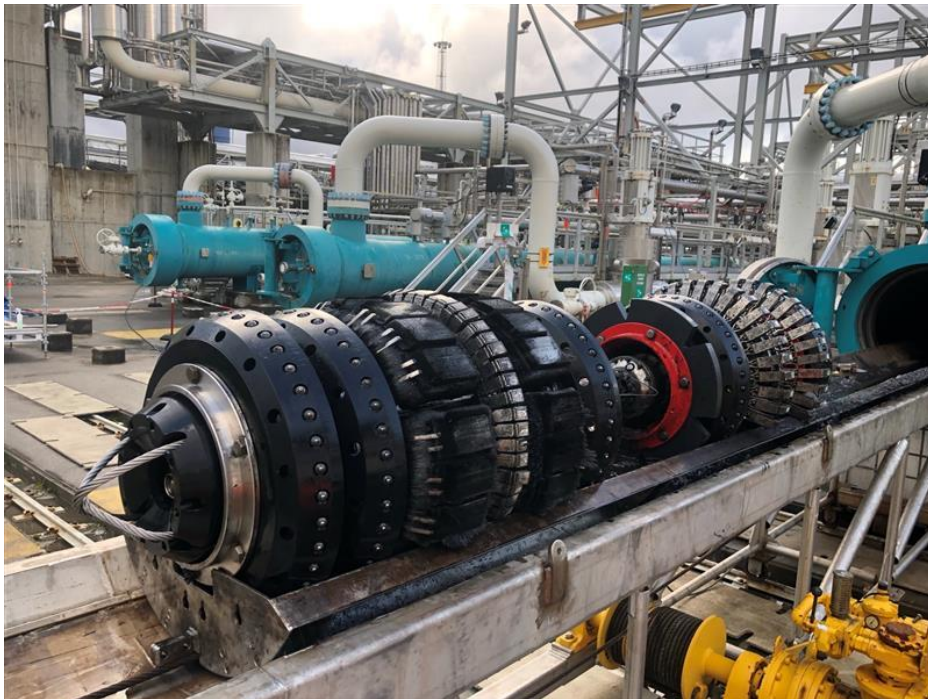
On October 1, 2023, the ROSEN RoCombo MFL-A + IEC) ILI tool was successfully run through the pipeline. The results from the ILI run were utilised to determine the integrity of the pipeline following the completion of the cleaning campaign.

**Figure 20: MFL-A / IEC Inspection Tool**
