# Design, Testing and Development of a Camera Pig to Support the Cleanliness Assessment of Pipelines for CCUS.

Edward Bartlett ENI and Shaun Peck, EV Offshore Ltd

PPSA Aberdeen – 20/11/2024

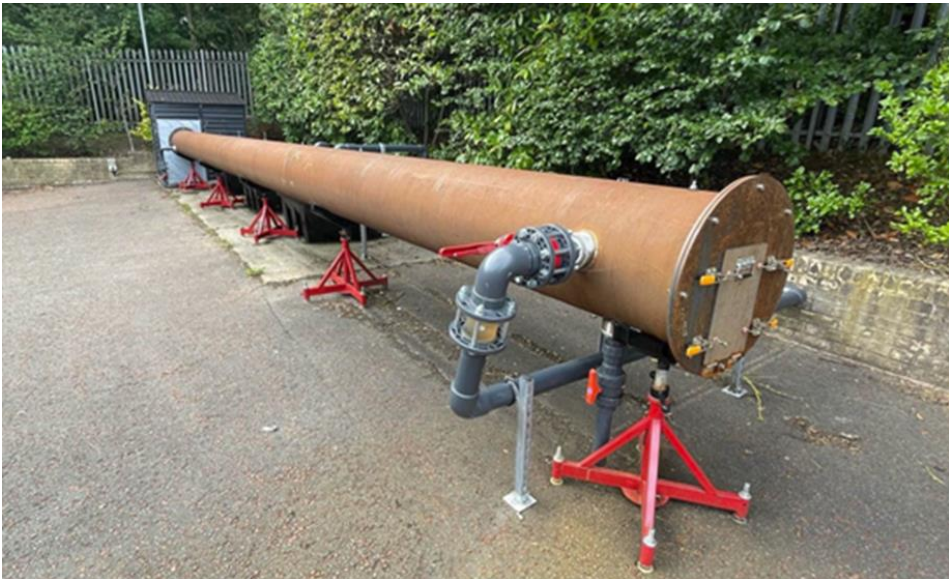
Fig c – test run at 49ft/min (0.25m/s)

- Tested Optis® Infinity in EVs Test Pipe with linear actuator
- Benign conditions
- Distance to side wall would be greater

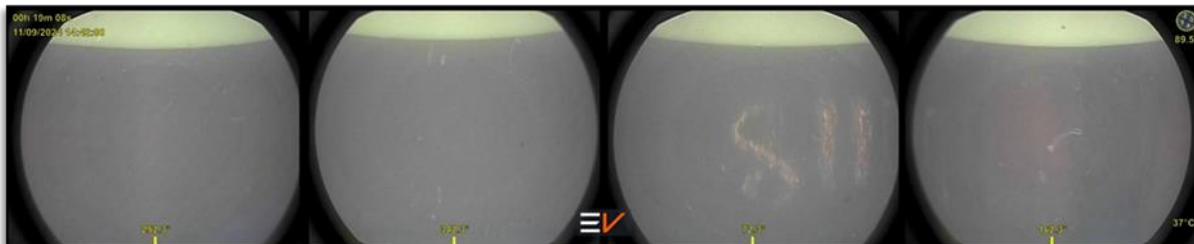
Camera at rear, 0.17m/s
