TETHERED INTERNAL CRAWLER-UNLOCKING NEW POSSIBILITIES FOR UNPIGGABLE PIPELINES

By, Dr. Mike Weberstadt, NDT Global/TSC Subsea

1 CASE STUDY 1: End-to-end inspection of unpiggable offshore crude oil loading lines

2 CASE STUDY 2: Targeted Internal Inspection of Offshore Riser with Tethered Robotic Crawler

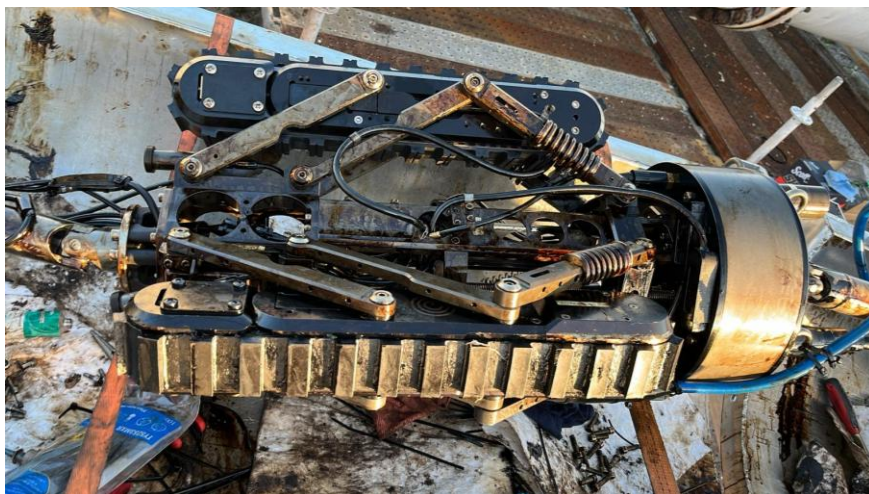
Figure 2 TRITON crawler

- Two Triton crawlers will be used in the system to enable vertical movement while propelling the ART Scan Module. These crawlers are track-based inspection robots designed specifically for pipeline assessments. They are equipped with high-torque motors and tracks to ensure stable movement through complex pipeline geometries.

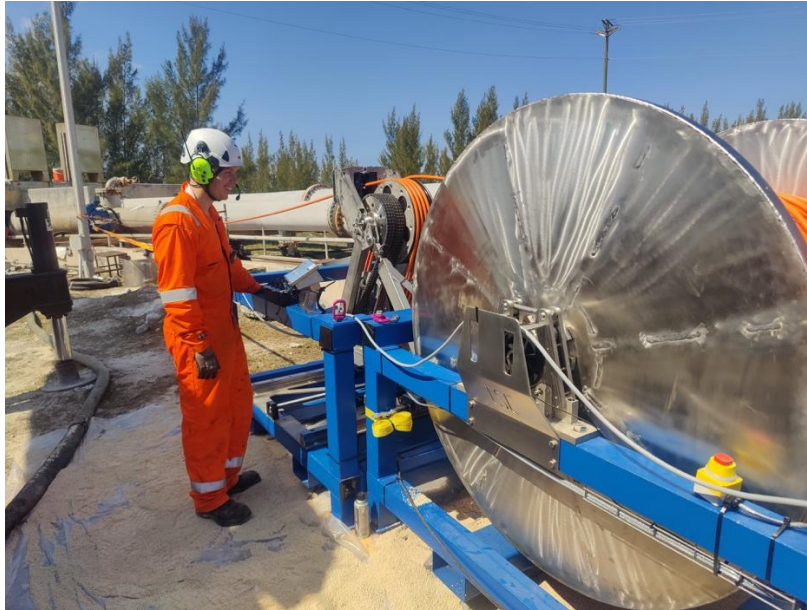
Figure 3 winch system

- The ART Scan Module (Acoustic Resonance Technology) is an ultrasonic testing (UT) tool used for pipeline inspections. It utilises ART to detect internal anomalies such as corrosion and other integrity issues by analysing resonance frequencies.
- The fibre cable winch is a motorised system that deploys and retrieves a hybrid cable containing both power and fibre optic lines. It ensures reliable power delivery to the subsea tool train and facilitates high-speed data communication with the topside system. With tension control to prevent cable damage, it is constructed from corrosion-resistant materials to withstand harsh environments and supports remote operation for real-time monitoring and control.

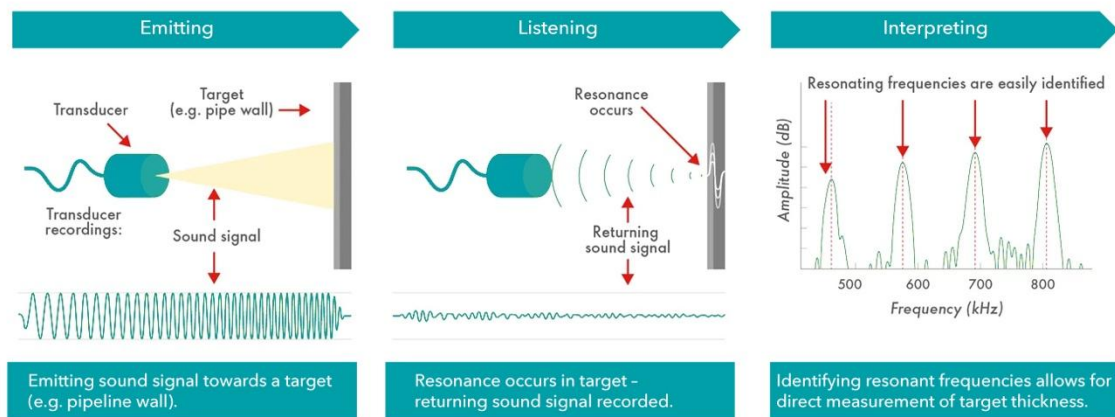
Figure 4 Acoustic Resonance Technology (ART)

In contrast, Acoustic Resonance Technology (ART) operates on a fundamentally different principle: it induces acoustic resonance within the pipe wall and analyses the resulting frequency response to determine wall thickness. Because ART does not require direct contact or a clean surface, it can penetrate through sludge, wax, and other contaminants commonly found in unpiggable pipelines. This non-contact capability allows ART to deliver reliable, high-resolution data even in the most challenging internal environments, where traditional UT methods would fail or require extensive cleaning and preparation.

Conventional ultrasonic testing (UT) relies on high-frequency sound waves transmitted through a couplant, typically a gel or liquid medium, to detect wall thickness and flaws in metallic structures. This method requires clean, debris-free surfaces to ensure effective signal transmission and accurate readings.

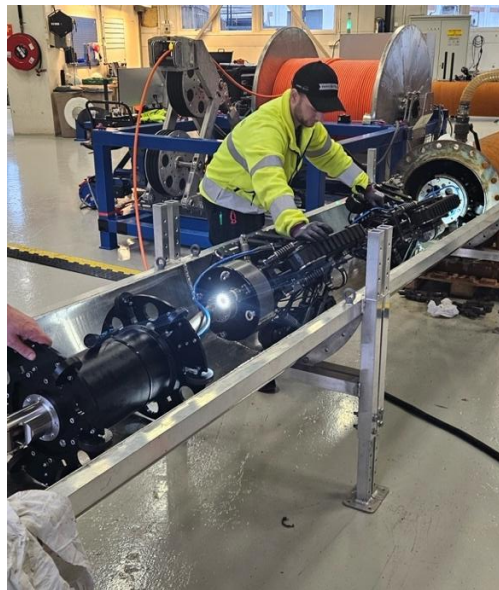
Figure 5 FAT setup

FAT was conducted under simulated pipeline conditions to validate TRITON's mobility through bends and inclines

Testing of the Triton ART Scan tool is essential to ensure that all functional requirements are met prior to mobilisation to the operational site.

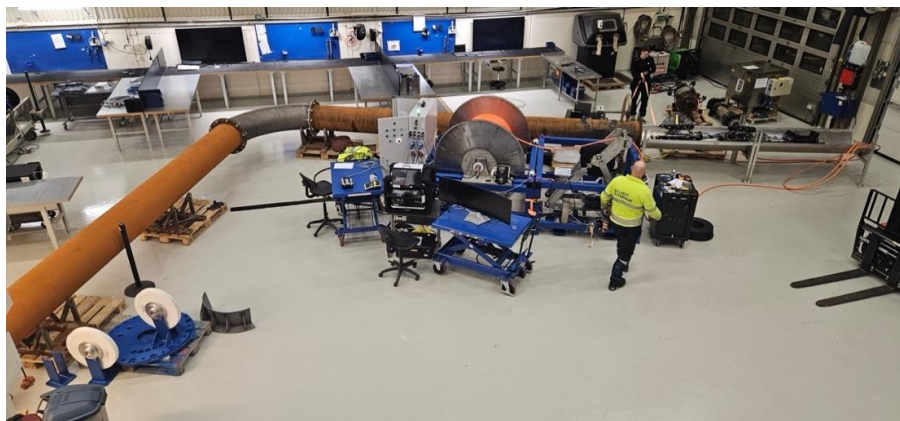
Figure 6 FAT Rig Setup

The test loop consists of two 6-metre sections of 20-inch diameter pipe. This setup is used for both dry and wet testing of the inspection equipment, including mechanical pull tests and full system evaluations. The actual pipeline to be inspected includes a 3D bend, which will be replicated during testing to assess the crawlers' ability to navigate the bend while maintaining stability and load-handling performance.

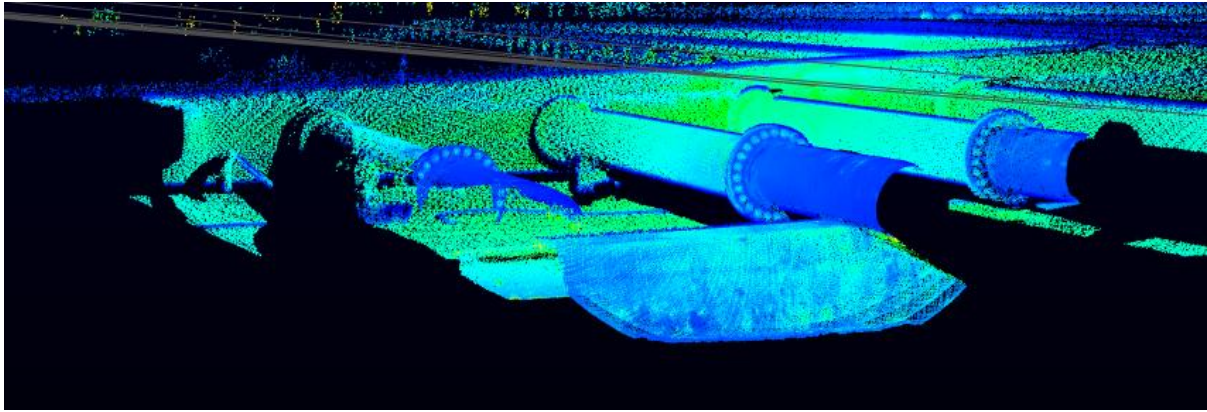
Figure 7 LIDAR site image

A 3D LIDAR scan of the site was conducted to:

- Verify fit-up for all hardware
- Confirm crawler clearances
- Minimise onsite risk and downtime

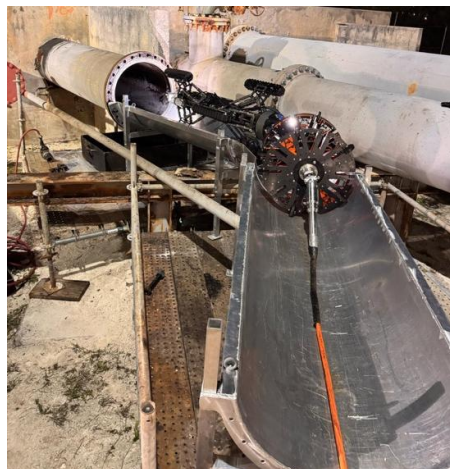
Figure 8 TRITON first run setup

- Crude oil was drained below the entry point.
- A flanged spool piece was removed to allow entry to the pipe
- TRITON was first deployed without the ART scan module for a visual and laser scan inspection and to prove the crawler's navigation capabilities.
- From the visual and laser scan, it was clear that there was sludge and debris located at the six o'clock position, but the team were confident that the ART Scan could overcome the challenge without cleaning or flushing the pipeline.
-

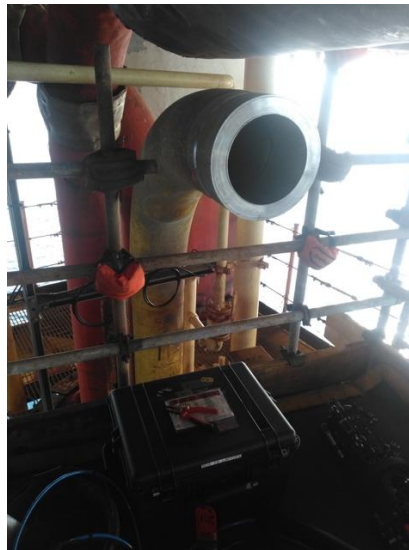
Figure 10 Offshore riser entry/exit

- Complex geometry and access constraints required a system capable of navigating bends and performing 360-degree scans.
- Internal conditions included anti-corrosion fluid at elevated temperatures, adding operational complexity.

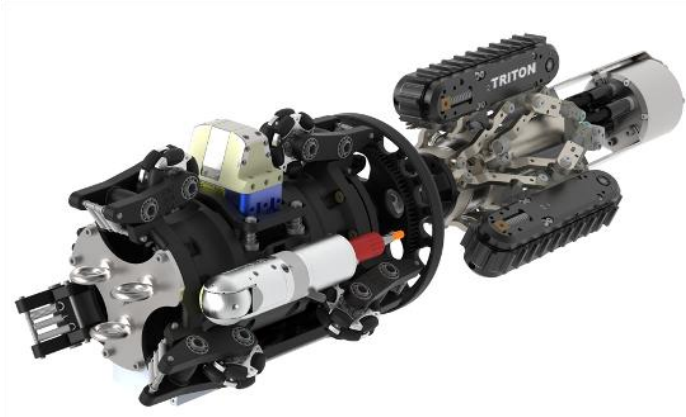
Figure 11 TRITON with ACFM Probe

- TSC Subsea deployed a tethered TRITON robotic crawler, engineered for diameter adaptability and bend negotiation.
- The system enabled 360-degree probe rotation whilst applying constant probe pressure.
- Alternating Current Field Measurement (ACFM) was used for surface-breaking crack detection of the welds, and Subsea Phased Array (SPA) enabled volumetric weld inspection and corrosion mapping of the suspected areas.

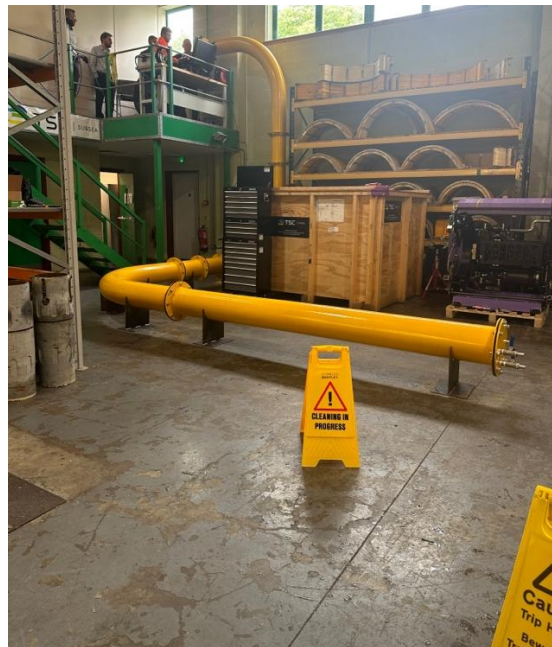
Figure 12 FAT Setup

A full-scale riser mock-up validated crawler navigation and NDT performance. ACFM and SPA successfully detected all test defects within tolerances. System mobility was proven in both dry and flooded conditions.

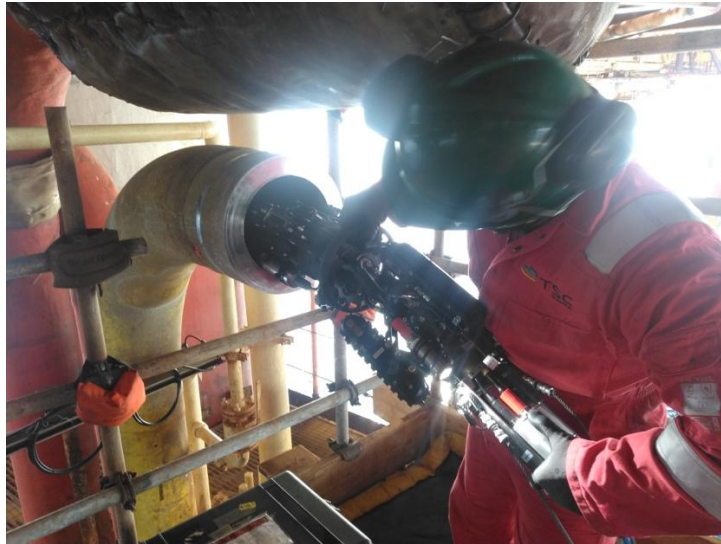
Figure 13 TRITON entering the riser

Robotic engineers and NDT specialists mobilised offshore. The TRITON crawler inspected all 10 welds, with ACFM and SPA confirming no reportable defects.
