REDEFINING LOW FLOW PIGGING AND INSPECTION

By Neil Stewart (Jee), Sean Tucker (Jee), Ben Bergius (NDT Global), Matt Roberts (Serica Energy)

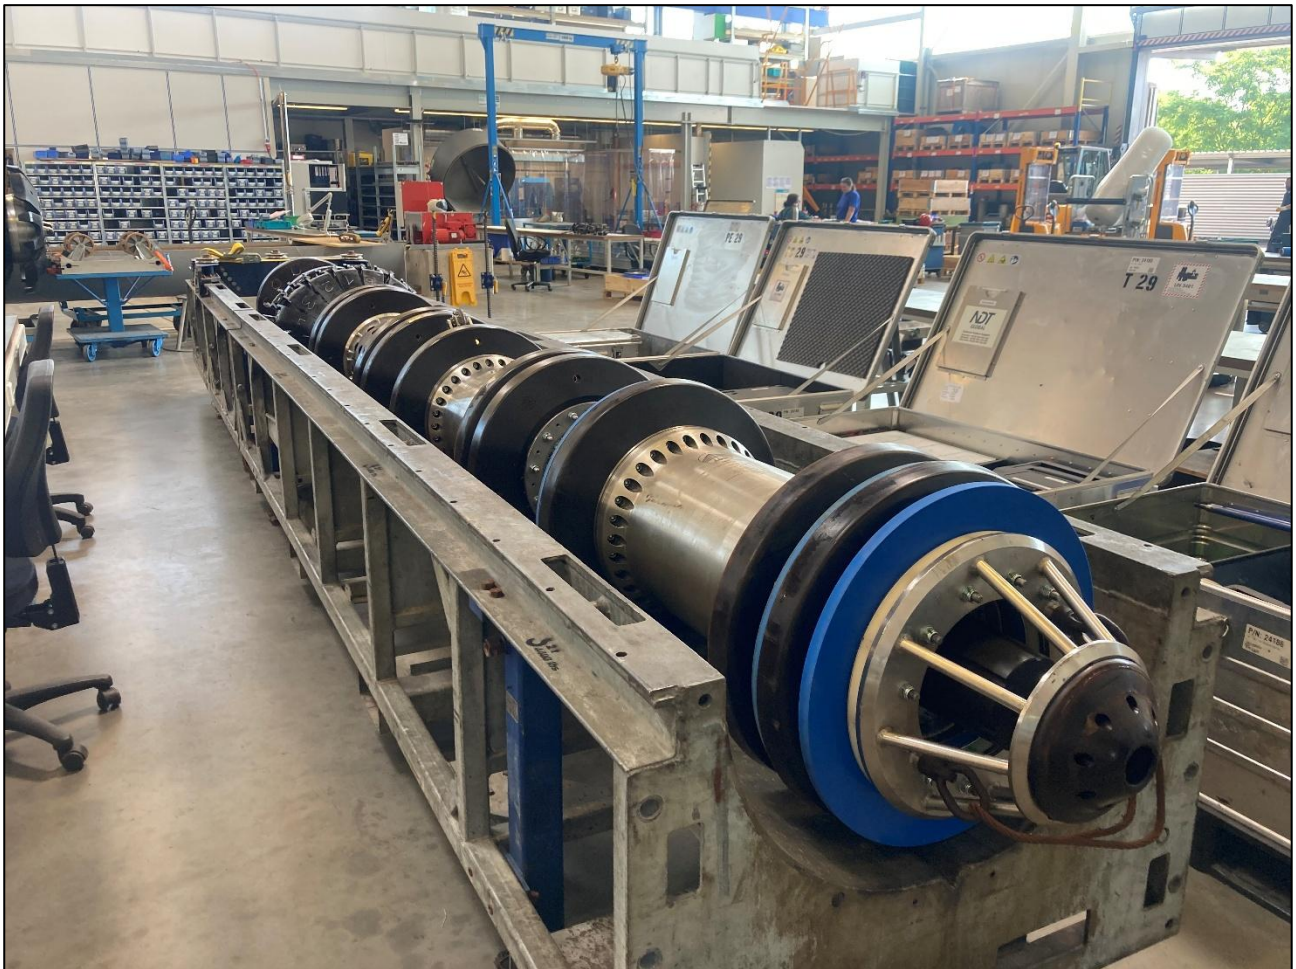
Figure 5-1 ILI tool at inspection

The tool was built, prepared and tested by NDT Global by the end of Q2 and prior to the shipment of the tool Jee visited the NDT Global premises in Germany to perform a pre-mobilisation inspection of the tool to verify the tool was built as per design and as tested.

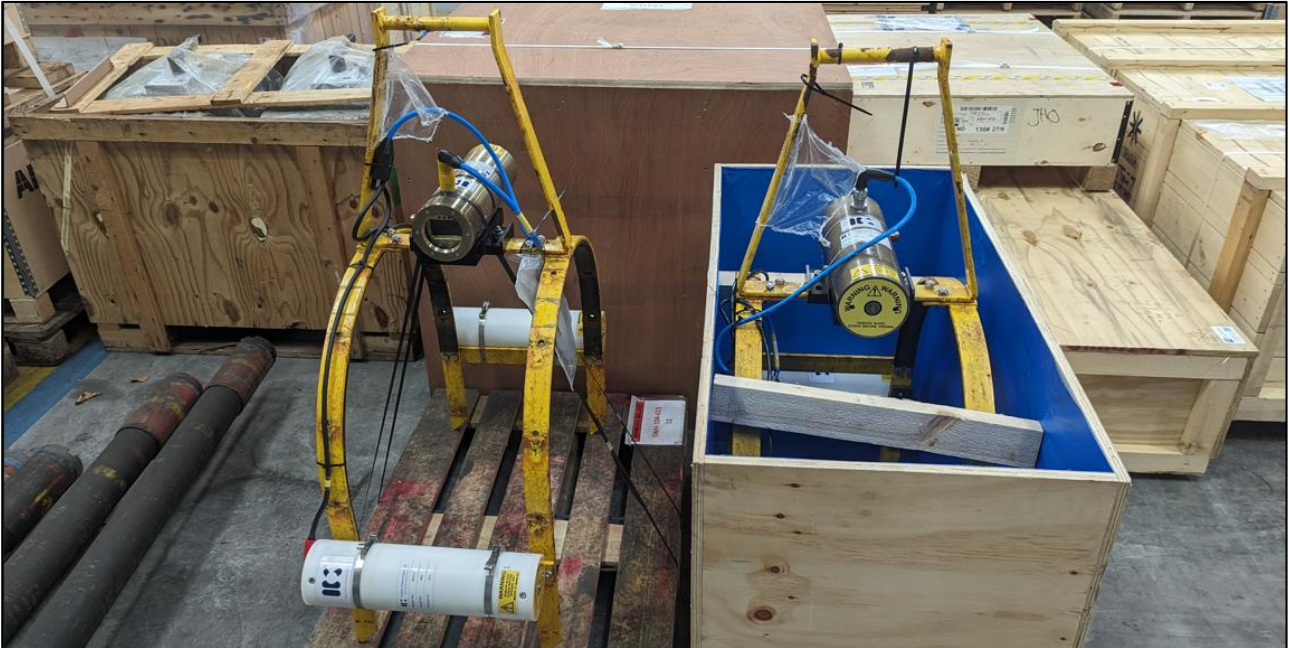
Figure 5-2 Subsea activation unit

The supply of the subsea activation module was subcontracted via NDT Global and consisted of a cradle which would be placed over the pipeline housing an electromagnetic transmitter with the corresponding receiver housed in the ILI tool. The system had previously been used successfully on the tool and pipeline in 2015 to allow inspection of the Unity riser. In preparation for the inspection the system was refurbished and a second unit was manufactured to provide redundancy and ensure tool switch on.

The subsea activation units were mobilised and deployed at KP8.805 and KP8.905 in July, with them being placed 1.4 m away from procedure target location for the primary and 0.4 m for the secondary. The units were deployed in a delayed activation mode to preserve battery life and were set to switch on once deployed and the vessel had left the field.

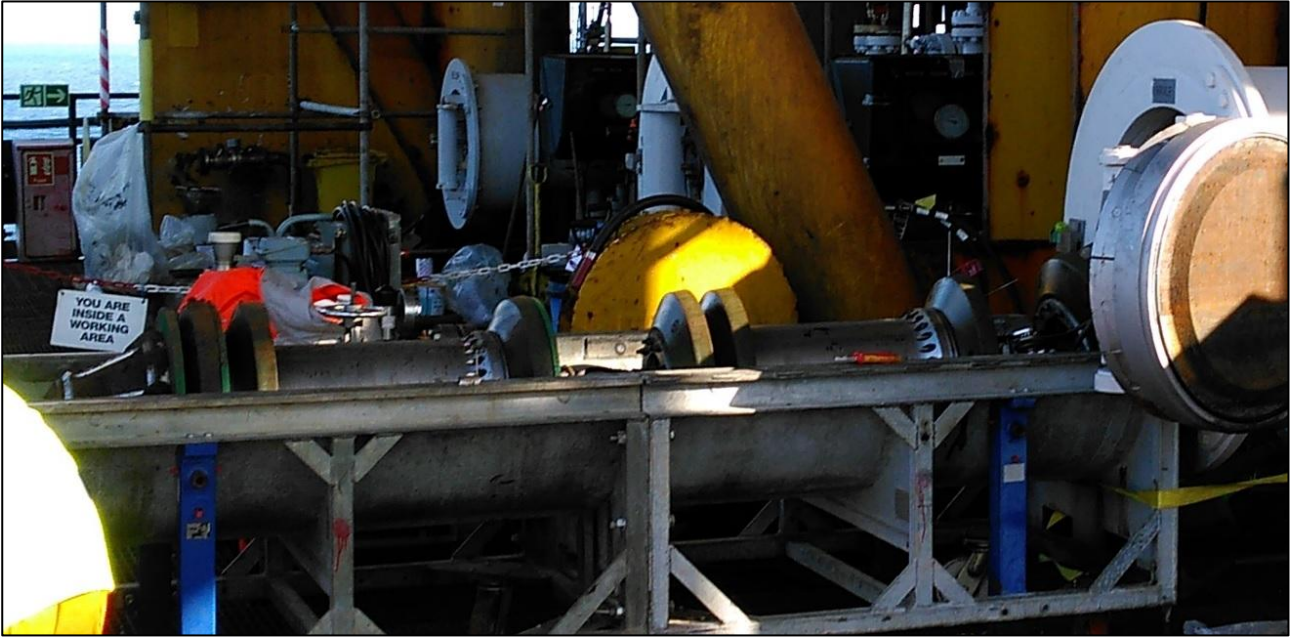
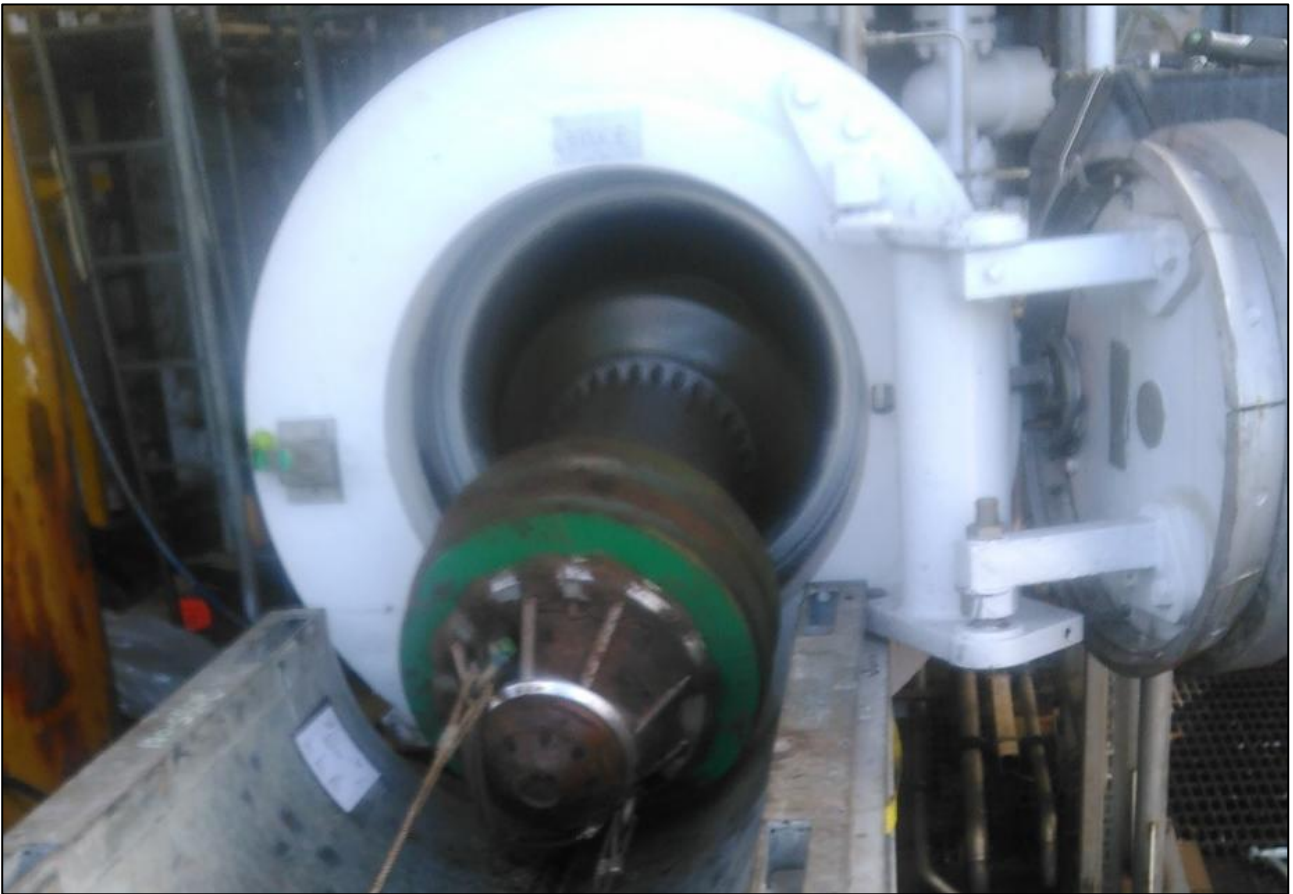
Figure 5-3 ILI tool recovery

The tool was received onboard the Unity platform on the 13th of April 2023 but not recovered from the pig receiver until the 5th of July 2023 due to the requirement to wait for a pipeline shutdown to allow recovery. Tool data was not downloaded until the tool was returned to Germany due to the total depletion of the batteries.
