## **Inspection of water injection pipelines and future needs**

By: Mikael Georgson and Roger Hunsbedt

Statoil ASA

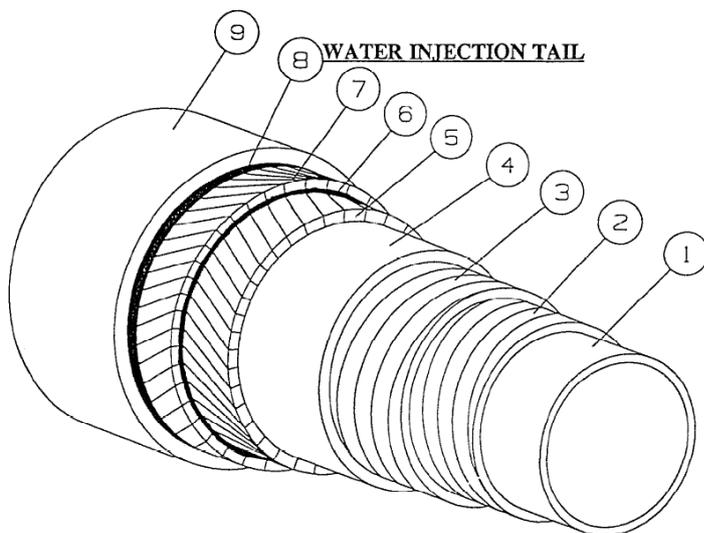
The next inspection was planned to be performed in October 2010. The in-line inspection and cleaning project started up in 2009. The smooth bore flexible jumper, located 7.8 km from Snorre A, was early in the project identified as a risk. This was due to a damage of the original installed flexible smooth bore riser caused by the pigging operation in 2001.

**Figure 2. Smooth bore flexible layer by layer**

The main challenge was to clean the pipeline without causing damage to the smoothbore flexible jumper. Any significant damage to the smooth bore flexible HD PE would most likely cause a total burst of the flexible jumper. This would result in a longer shut down period of the Vigdis water injection system.

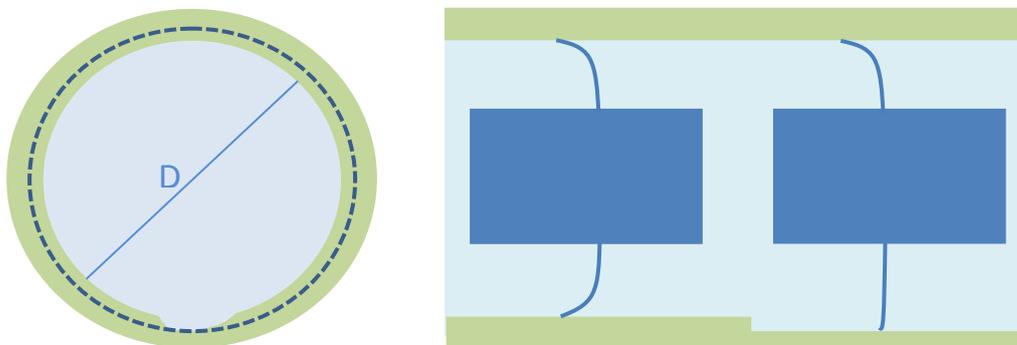
**Figure 10. Illustration of brush sizes for cleaning of different diameters. The smaller brush diameter, indicated by D in the figure, is the same as the inner diameter of the pipe. The dashed line shows the diameter of the larger brushes, capable to clean in the corroded area.**

The cleaning pigs for removing scale were available with two different brush sizes diameters. The smaller diameter should clean the non-corroded pipe section whereas the slightly oversized brushes aimed at removing material at the six o'clock corrosion. This is illustrated in the picture below. The inner diameter is marked with D and this is also the rough diameter of the smaller brushes. In order to remove the debris at the corroded part at six o'clock in the pipeline, larger diameter brushes were used. This is indicated by the dashed line. In the non-corroded pipe the oversized brushes will bend and be less efficient, however in the corroded section it will be more aggressive to scale and debris.

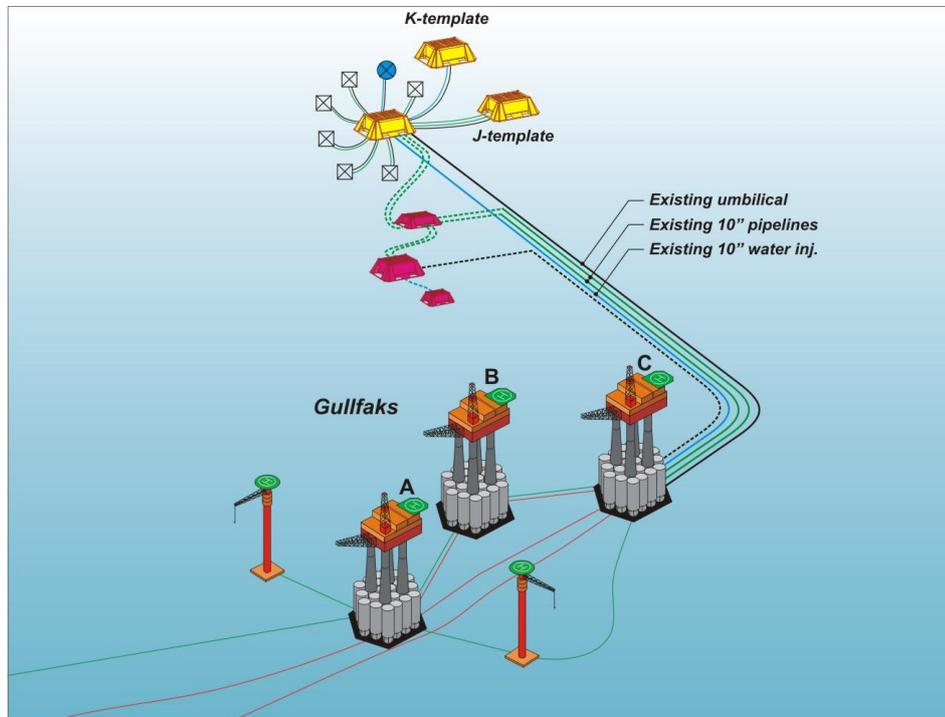
The Tordis 10" x12" pipelines were inspected in August 2010. The pipelines are laid in parallel from Gullfaks C to Tordis Central Manifold, with a pigging loop at the end manifold. Corrosion was found in both pipelines, mainly channelling corrosion in the bottom of the pipelines.

When looking at the quality of the inspection data, residual scale was identified in the area of interest; 6 o'clock position. For one of the pipelines this led to an increased uncertainty level of the ultrasound wall thickness measurements. This again led to decreased calculated capacity of the pipeline.

Again we identified a challenge; remove the scale in the corroded area. We choose the same methodology as for the Vigdis water injection and better brushes.

The results from the re-inspection in February 2011 showed no residual scale amongst the corrosion in the 6 o'clock position. Hence no further degrading of pressure capacity was necessary.
