VERIFICATION OF ILI INSPECTION RESULTS WITH THE USE OF AUTO UT DATA

Holly Plummer, Ian Murray, Derek Balmer, Steve Farnie
November 19th, 2014

A CASE STUDY OF AN OFFSHORE PIPELINE

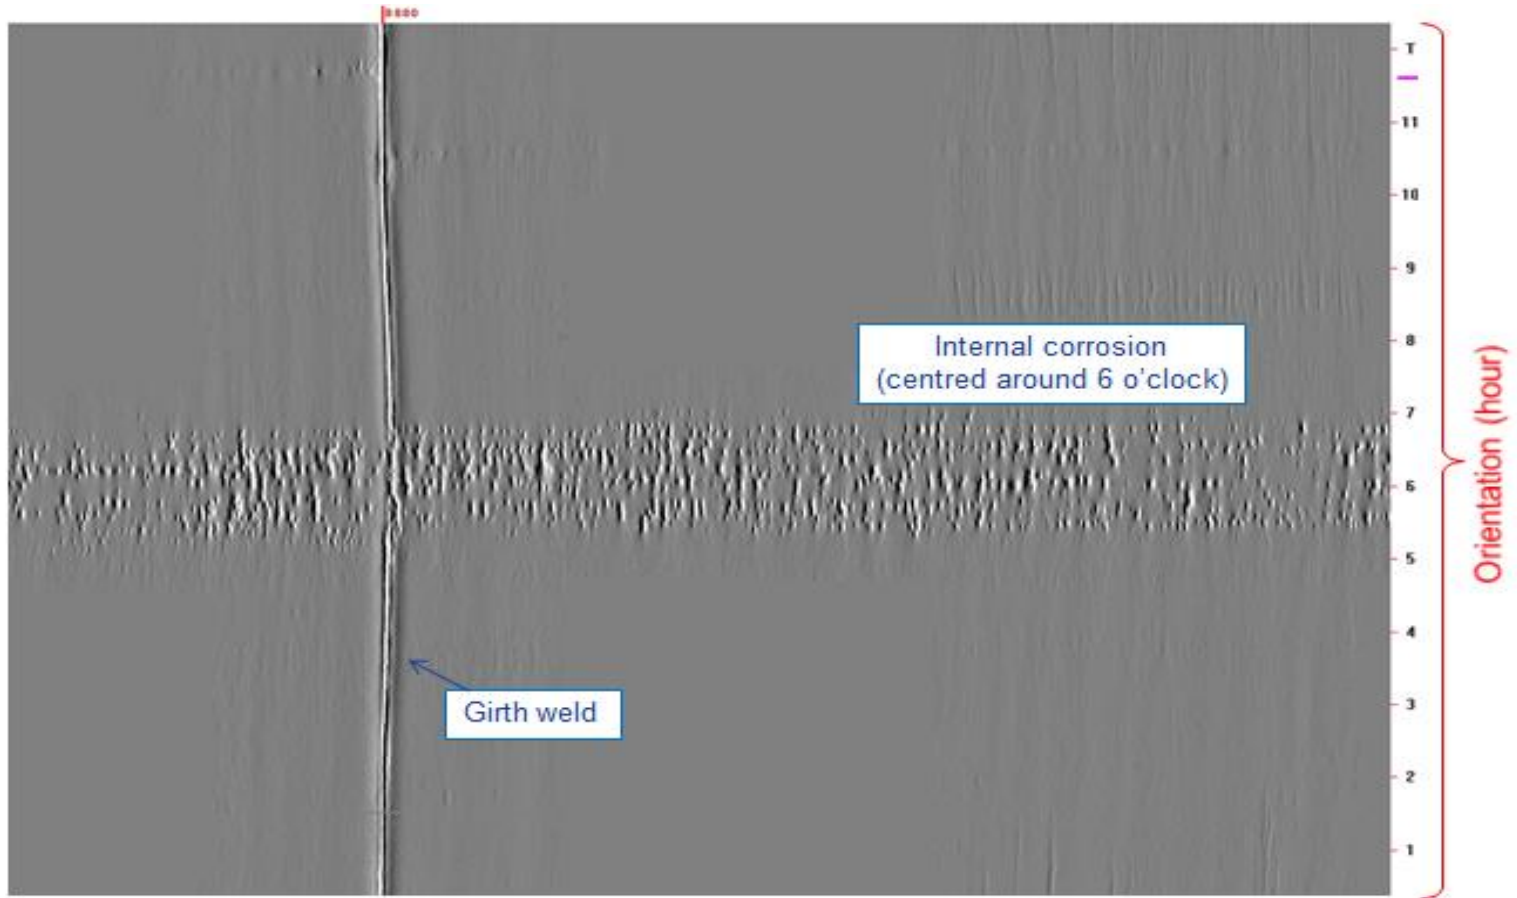
The Pipeline Data Example

The pipeline has >600,000 corrosion features throughout its length

- Predominantly **internal** and at bottom of the line (6 o'clock)
- Previous Corrosion growth studies found Corrosion was active and **growing**
- Features typical of pitting and areas of general corrosion
- Recent studies had predicted features required repair within 5 years

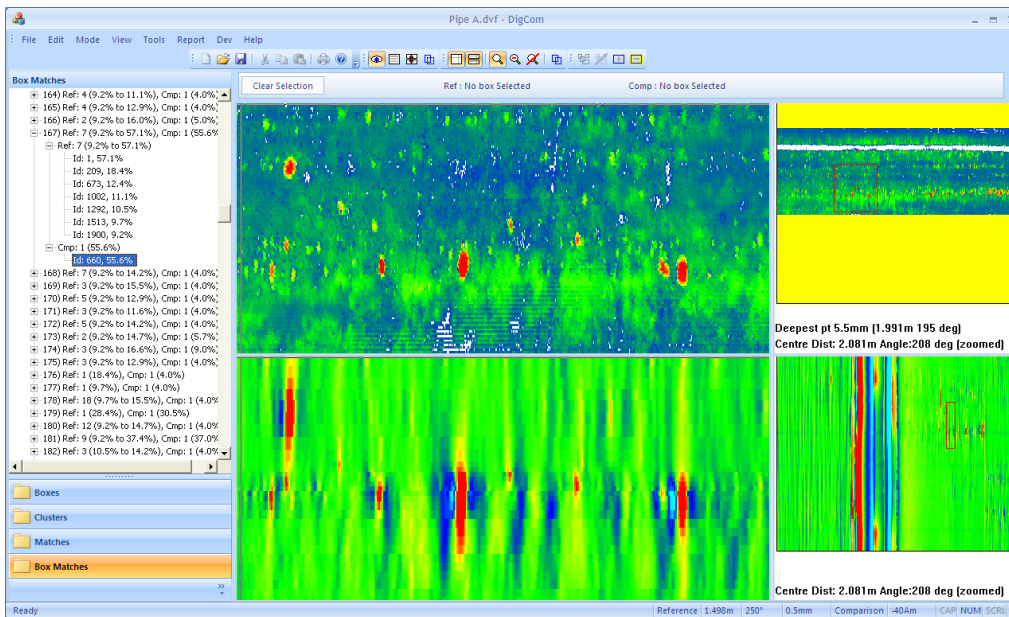
The Software and Assessment DigCom

Comparison of AUT and MFL data was performed in DigCom software

- Comparison of depths and investigation of the full profile and interactions within complex corrosion features
- Maps ILI data directly onto the in-field scan using weld number and relative distance
- Visual process allows the ILI data to be aligned and scaled
- Point to point match for high degree of confidence

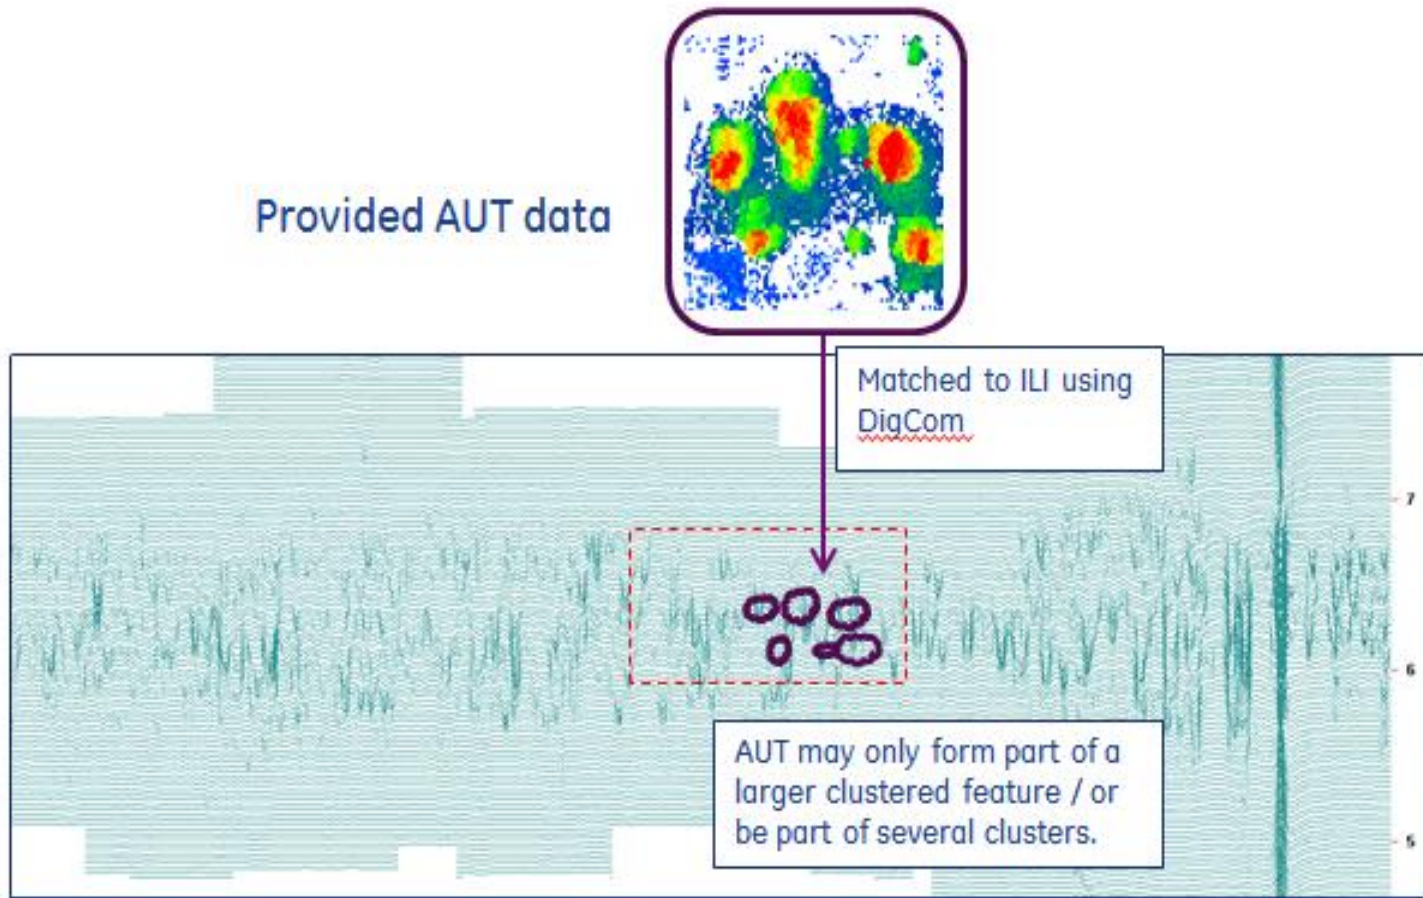
The Software and Assessment Data Matching

- >500 defects matched
- Sample taken from 9 spools throughout the line
- Sample included a range of feature depths
- Sample is considered representative
- 80% confidence interval is $\pm 5.96\%$ wt, therefore the ILI contractual sizing specification was exceeded
