Evaluation of a High Resolution GEOPIG to detect and Size Slab Erosion

By, Stephen Westwood, BJ Pipeline Inspection Services, Canada

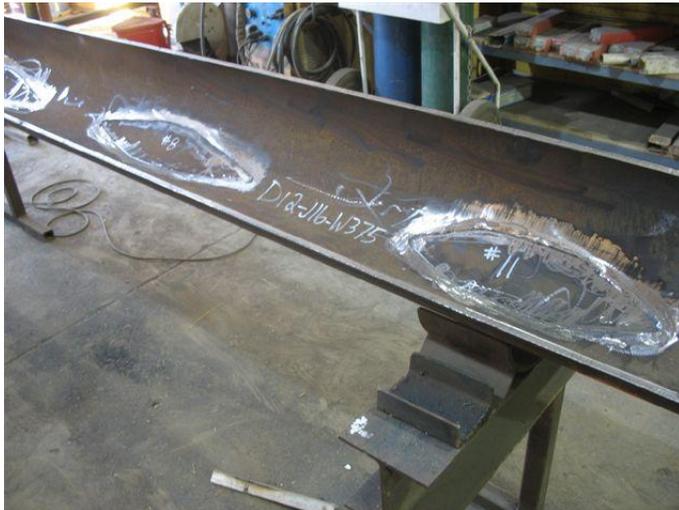
Two sets of pulltests were performed, the first set was on large defects to determine the sensitivity of the tool and the second was on a specially built spool to simulate slab erosion. The large defects were created by cutting coupons out of the pipe and welding them back in a known offset from the internal pipewall. These are shown below in Figure 4.

Figure 4 Showing Defects welded back into Pipe Sample

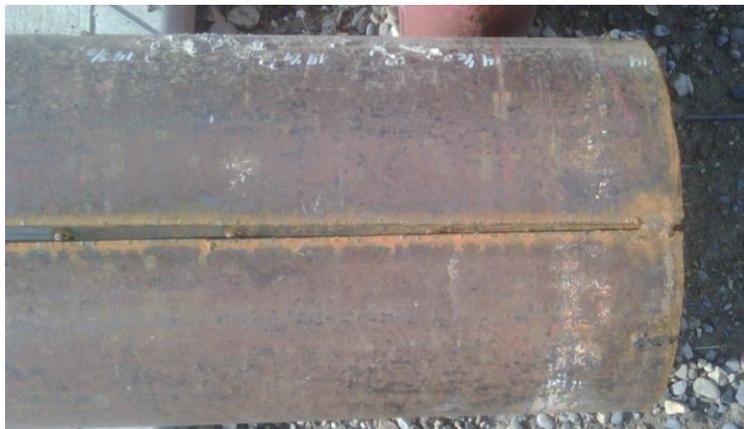
To perform these tests a special test spool was constructed in 22mm 14" pipe. To mimic slab erosion a quarter section of the pipe was cut out and welded back in at a taper to simulate the internal diameter changing.

Figure 9 Showing the Taper in the Defect Piece

The internal diameter of the test spool was calculated by measuring the external diameter along the centreline of the tapered piece from this diameter twice the nominal wall thickness was subtracted. The variation in internal diameter along the length of the spool is shown in Figure 8. Figure 9 shows a close up of the taper.

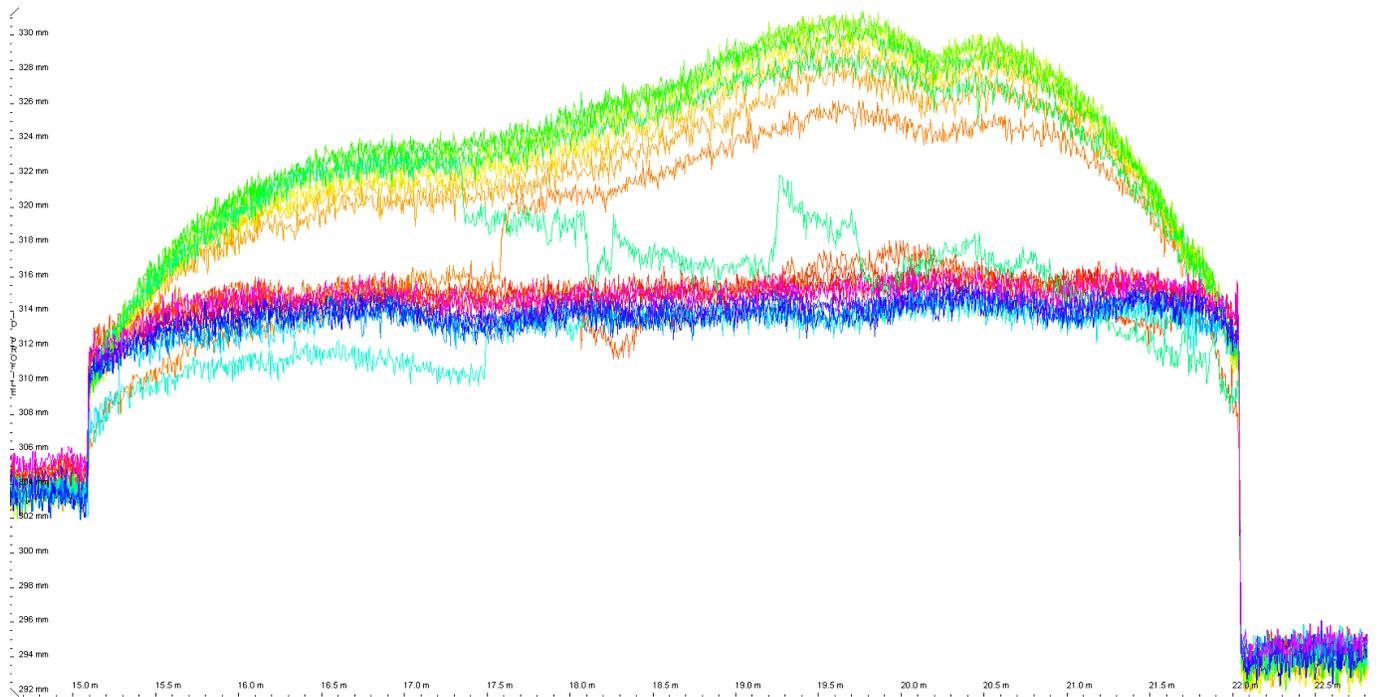
The Geopig as well as measuring the maximum internal diameter can measure the internal diameter at numerous point around the circumference of the pipe. This is illustrated in Figure 12 below which show 21 different diameter measurements along the length of the defect spool. This demonstrates the ability of the tool to accurately measure the circumferential extent of the slab erosion. The trace that is acting erratically is because that caliper arm is riding in the gap between the taper. The wiggle at 3 metres is present in the radius measurement but is cancelled in the diameter plot.

Figure 12 Illustrating the ability of the Tool to determine the circumferential extent of slab erosion
