# DESIGN, TESTING AND DEVELOPMENT OF A CAMERA PIG TO SUPPORT THE CLEANLINESS ASSESSMENT OF PIPELINES FOR CCUS

**Edward Bartlett – Pipeline CCS and Leak Prevention System Custodian, ENI**

**Shaun Peck – Global Support Engineering Manager, EV Offshore Ltd (EV)**

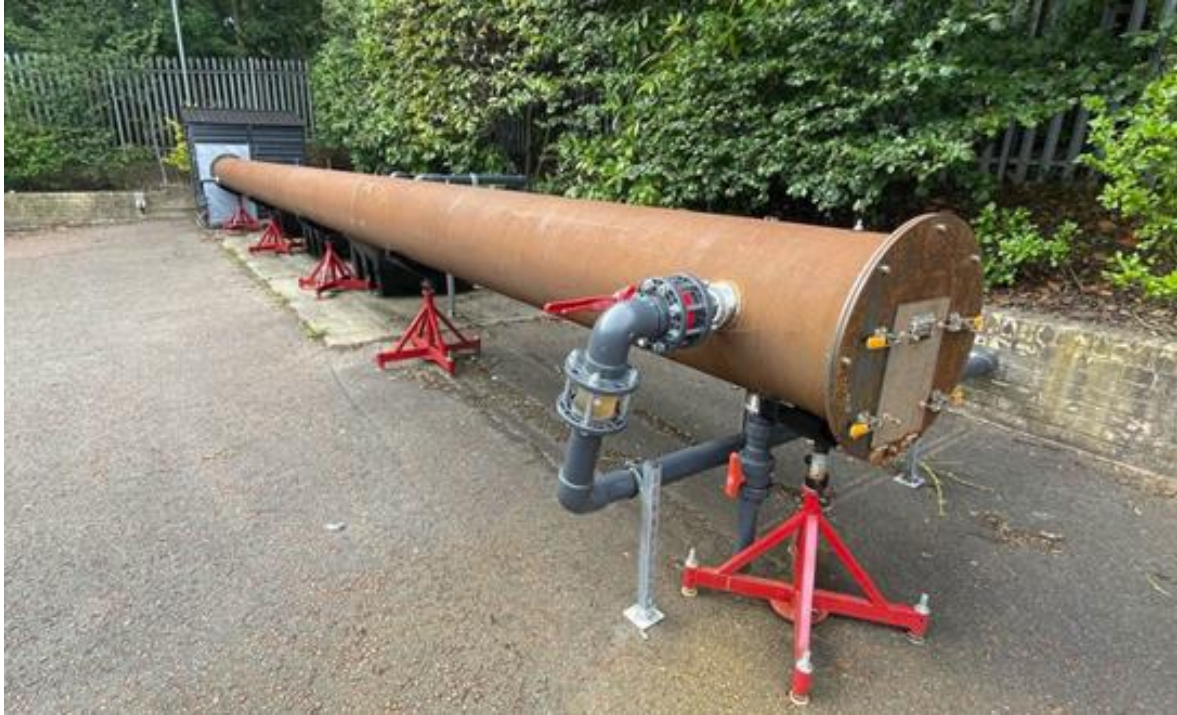
Optimising the camera to adapt to the increase of speed which the tool would be travelling at was a critical factor and a balancing act with what was possible with the available hardware, the constraints of sizing and compromises of camera functionality. As part of the development, EV utilised a piece of test equipment which had been commissioned for a slightly different purpose, to assess for a phenomenon known in the downhole sector as stick 'n' slip, this is when the downhole tool will be subject to irregular stop and start motions due to friction forces in high deviation wellbores (Figure 3).

**Figure 3 – EVs Horizontal Test Pipe Facility**

This test system is a 40ft section housing a linear actuator which the camera systems can be fixed within and ran at varying speeds within varying fluid turbidity.

With this, EV were able to optimise the camera operating parameters to give clear unblurred images at speeds up to 0.5m/s. The conditions within pipeline are relatively benign with regard pressure and temperature compared to the 125°C and 15kpsi the downhole cameras usually work in. This gave us the opportunity to push certain parameters harder than would normally be allowable to overcome issues at higher speeds and more challenging fluid conditions (Figures 4 & 5).

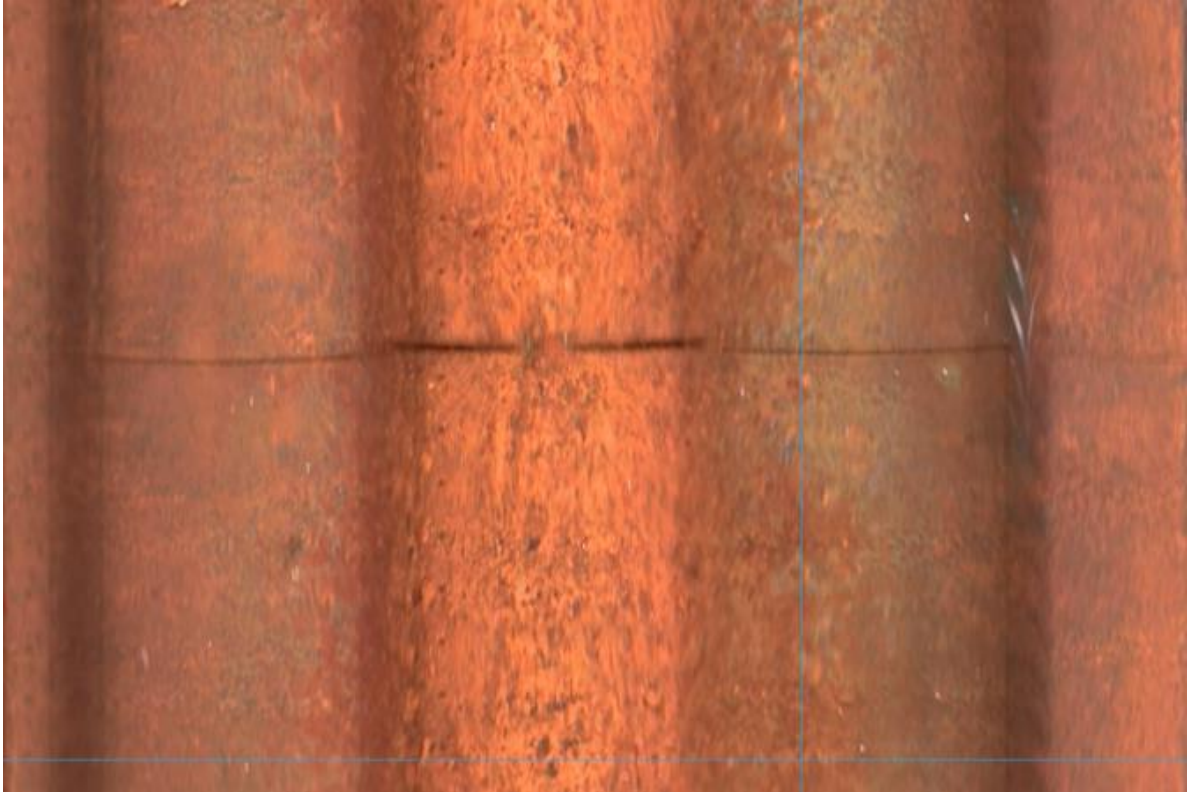
**Figure 4- Optis® Infinity Ran at 0.2m/s without Optimisation**

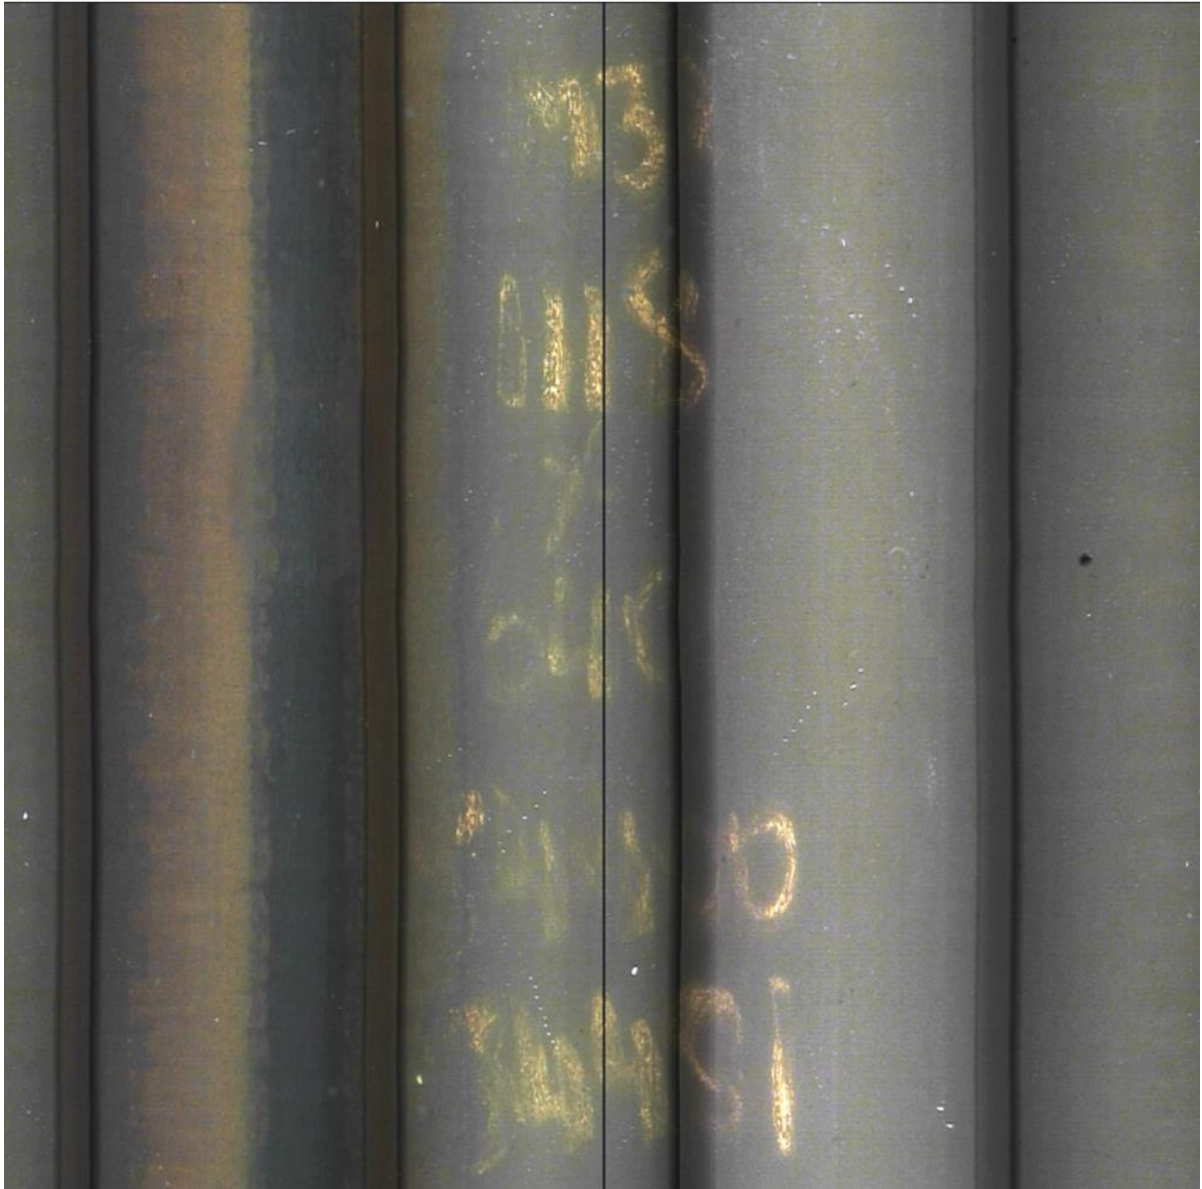
Finally, as a potential deliverable to ENI, EVs stitching software was used to generate the image stitch, showing a section from the test loop (Figure 13).

As can be seen this gave a very clear image of a section the pipeline ID.

- Image stitching improves the image clarity by analysing a feature over a number of captured frames and creating a composite image using the best parts from each frame.
- Within this Image processing, techniques are used to locally enhance contrast and automatically detect the key areas of interest.
- This isolates the camera movement from particulates to create a static image and reduces the interference from particulate seen in a video.

**Figure 13- Stitched Image at 0.2m/s**
