## **THE CHALLENGES OF MFL/DEFORMATION/IMU ILI FOR SMALL-DIAMETER, DIFFICULT-TO-INSPECT PIPELINES**

**By: Mark Briell, KMAX Inspection, CANADA**

### **Abstract**

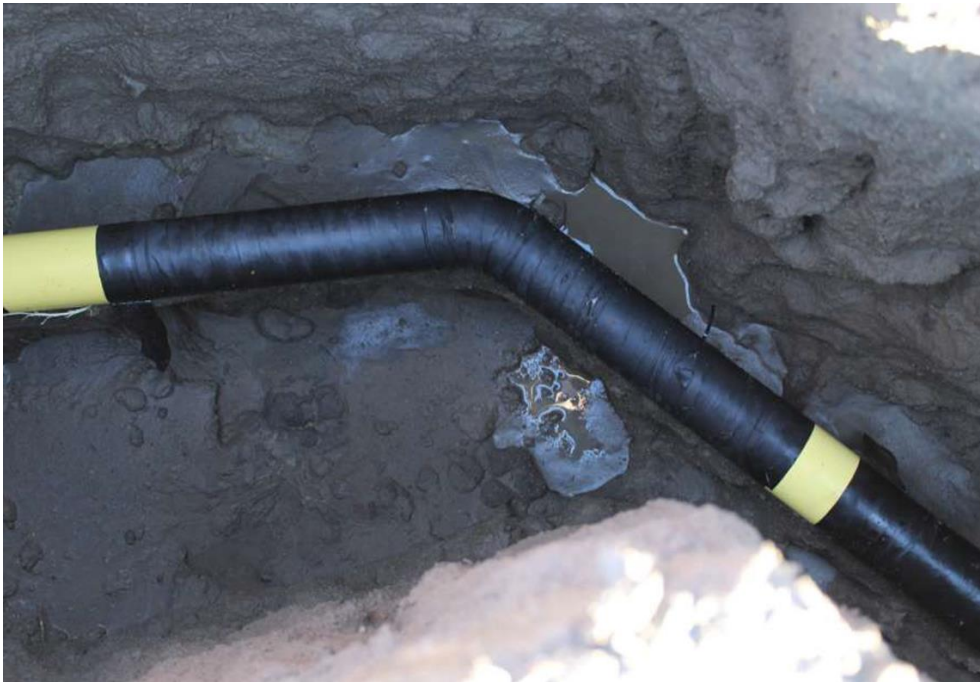
*Figure 1 A confirmed 1.5d, 45 deg. bend in the pipeline.*

- The pipeline in question was a 3-inch, 2-mile natural gas pipeline.
- It had never been inspected by an inspection tool.
- The nominal wall thickness was 0.156 inches (ERW pipe).
- The pipeline was constructed in 1962.
- There were no launcher or receiver facilities installed on the pipeline.
- The pipeline typically operated at a low pressure of around 100 psi.
- A confirmed 1.5d (45-degree) bend was present in the pipeline.

- The cleaning/gauge pig's initial pass left ferrous debris, necessitating a second pass.
- The pump truck's inability to produce enough pressure to move the pig past the weld led to two options: Obtain a pump with higher pressure or reconfigure the pipe at the receiver (chosen due to time constraints).
- The absence of a flow meter caused confusion during the ILI tool run.
- The operator assumed water was flowing, but the water level in the tank remained unchanged.
- A system check revealed that the valve at the receiver had not been opened.
- Once the valve was opened, water flowed through the pipeline.
- The ILI tool successfully passed through the 1.5d bend without pressure spikes or stopping.

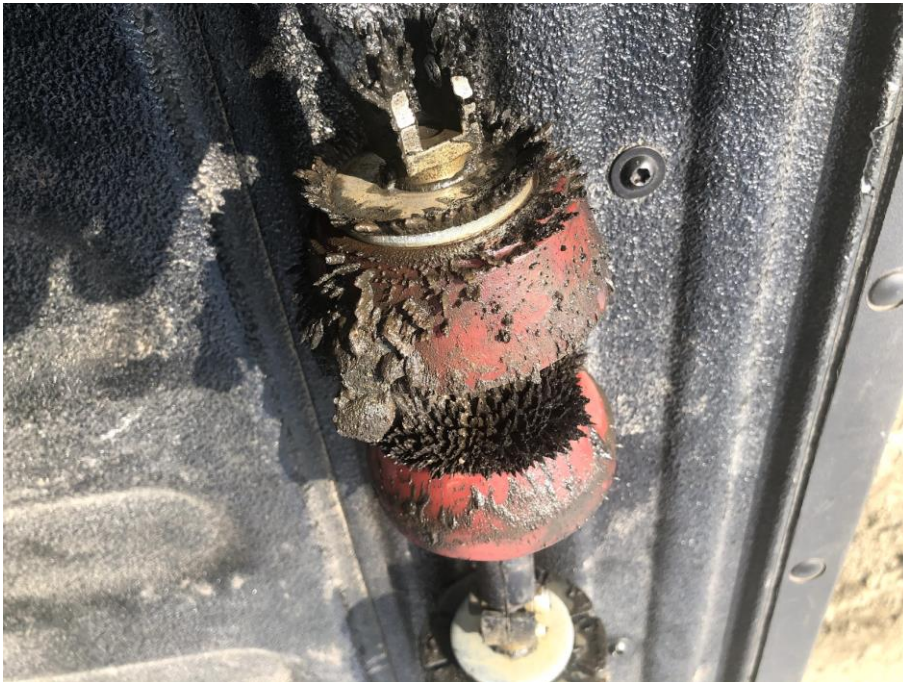
**Figure 2 Debris on Magnets of Cleaning Pig**

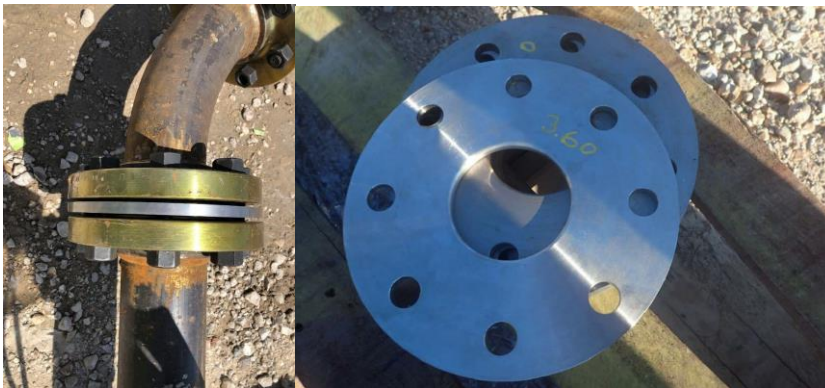
**Figure 3 Machined Rings Inserted Between Flanges**

- KMAX developed a simulation using machined rings inserted between flanges. The smallest ring (3.55 inches) allowed their standard magnetic flux leakage (MFL) tool to pass through without any issues.
