Innovations in In-Service Robotic Inspection of Unpiggable Natural Gas Pipelines at River Crossings for Which There are No Existing Launching and Receiving Capabilities

PPSA Seminar
20 November 2024

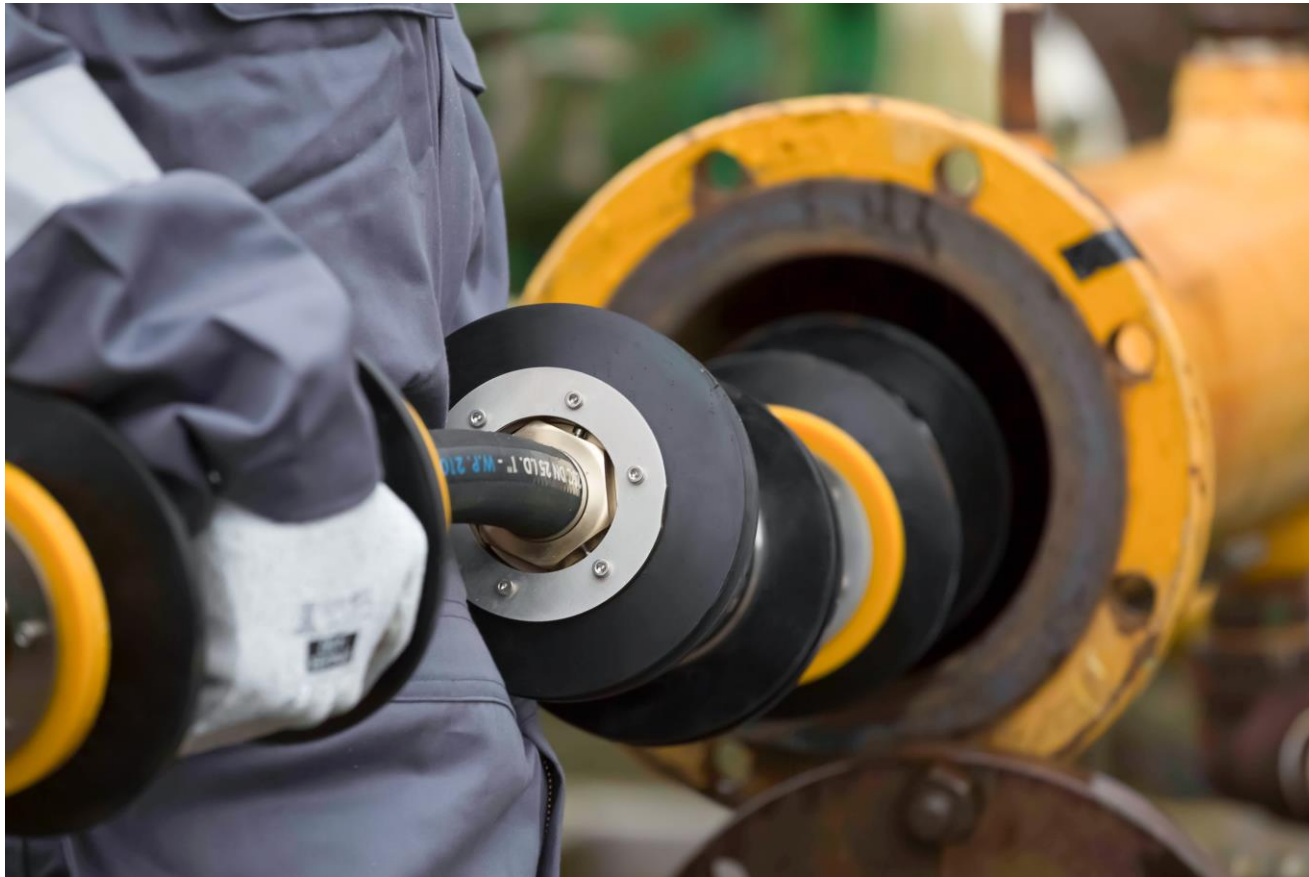
Free-swimming Inline Inspection (ILI)

- Piggable vs unpiggable
 - Lack of Launcher/Receiver
 - Inability to shut down the line
 - Unknown pipeline conditions
 - Difficult to track tool underwater
 - Potentially costly retrieval

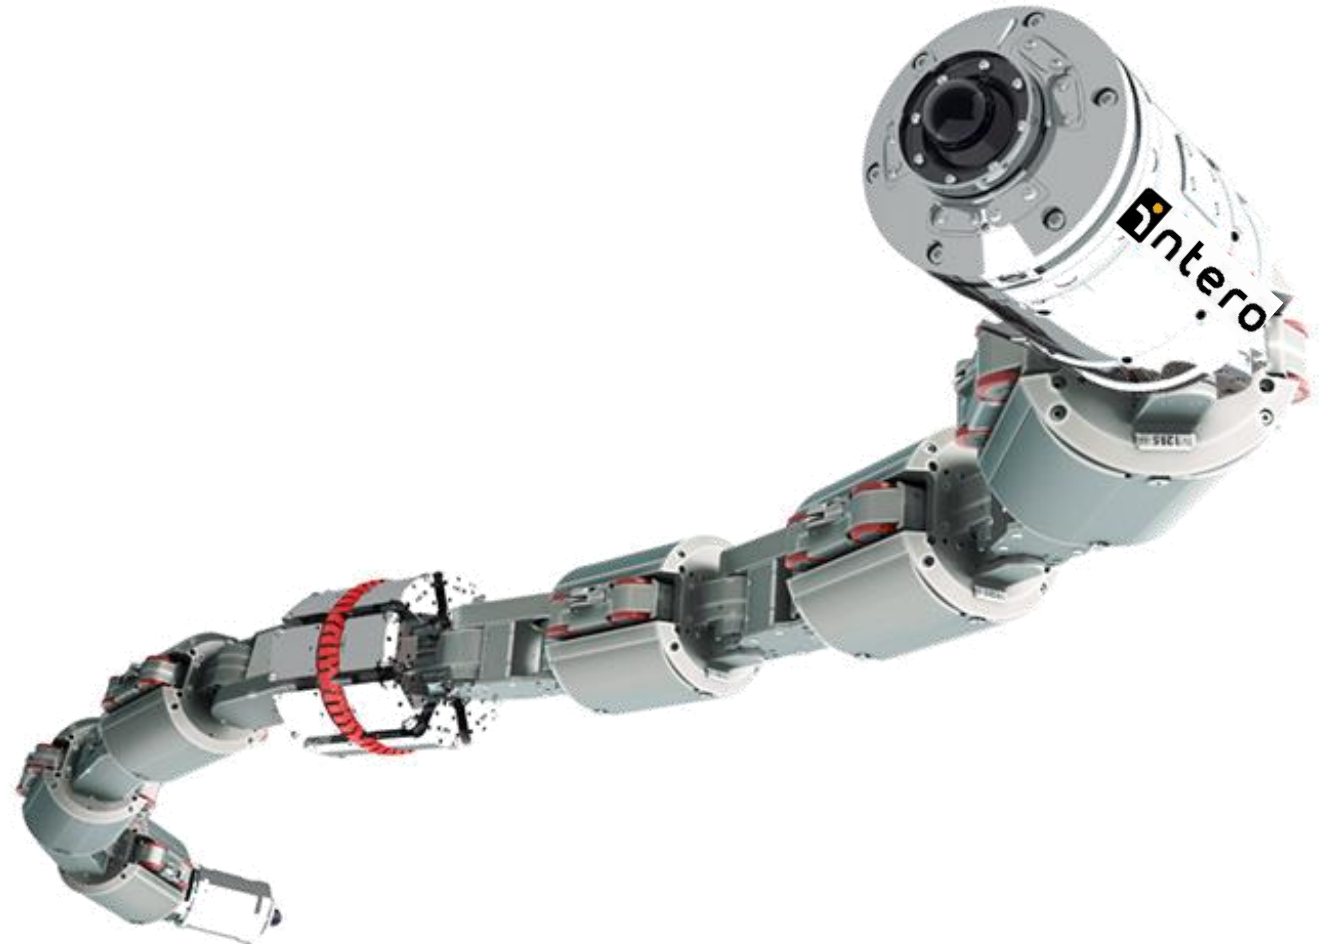
Pipe Explorer Robotic IRI Summary

Non-tethered

Self-propelled

100% controlled

Constant 300 m/hr, no speed excursion

Bi-directional

Up to 50bar in-service inspection

Mitered elbow (no radius)

Barred/Unbarred tee navigation

20% bore reduction

Camera, MFL, and Laser sensors

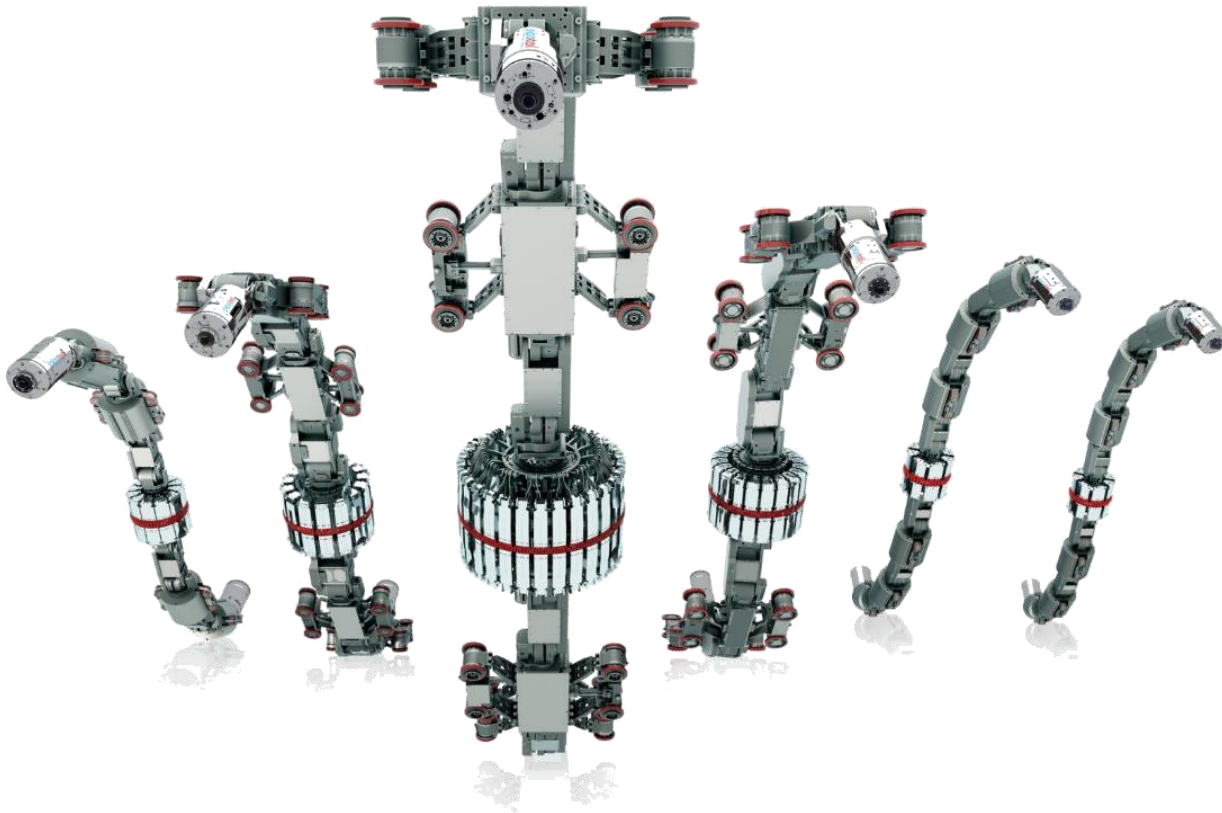
Pipe Explorer Robotic Fleet

Pipe Explorers available in sizes from 6" (DN150) to 36" (DN900):

Pipe Explorer 6

Pipe Explorer 8

Pipe Explorer 10/14

Pipe Explorer 16/18

Pipe Explorer 20/26

Pipe Explorer 30/36

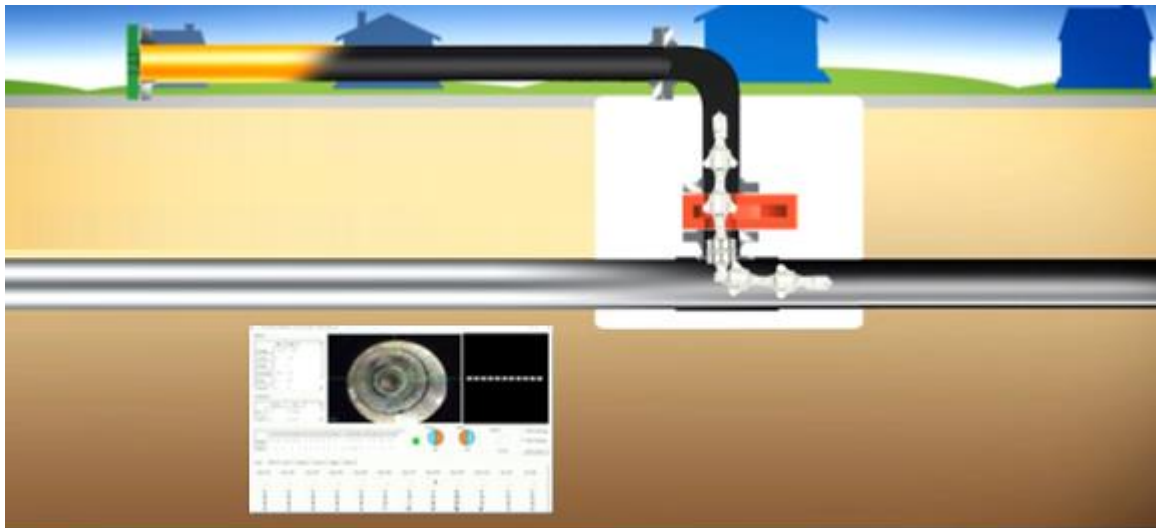
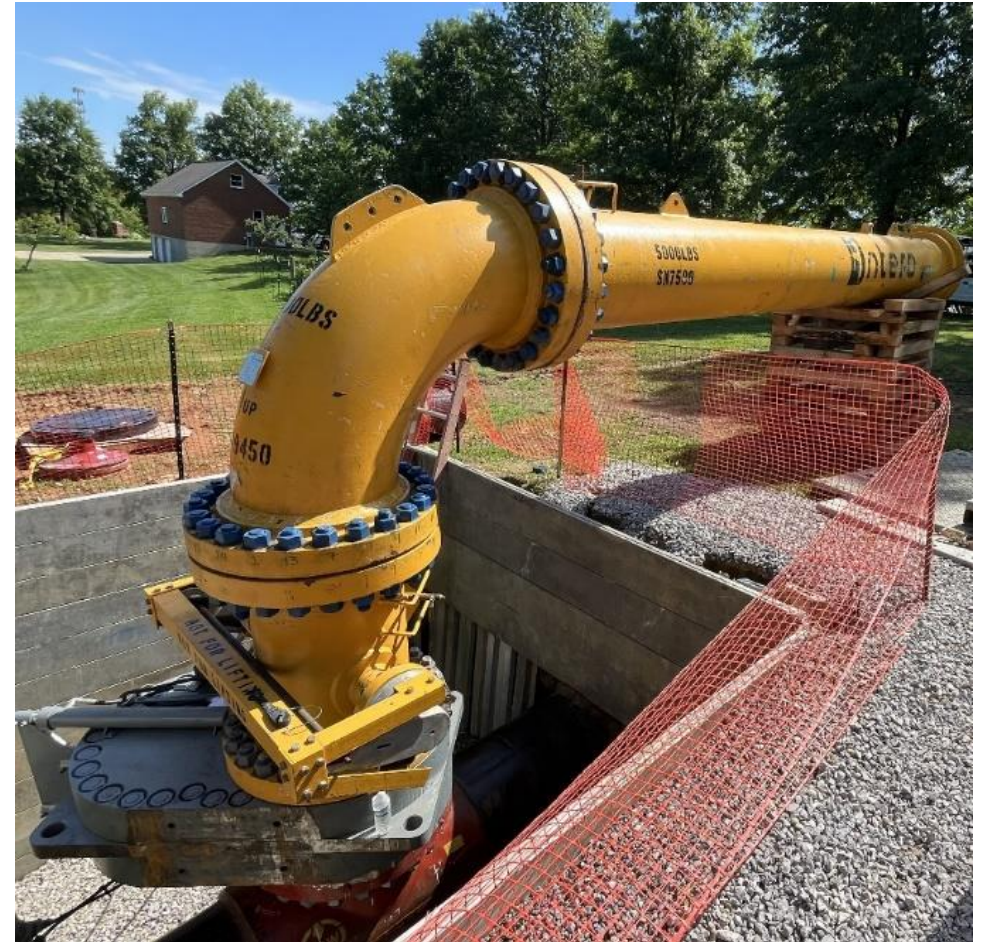
Live Gas Launching

Pipe Explorer entry and exit through hot tap fitting

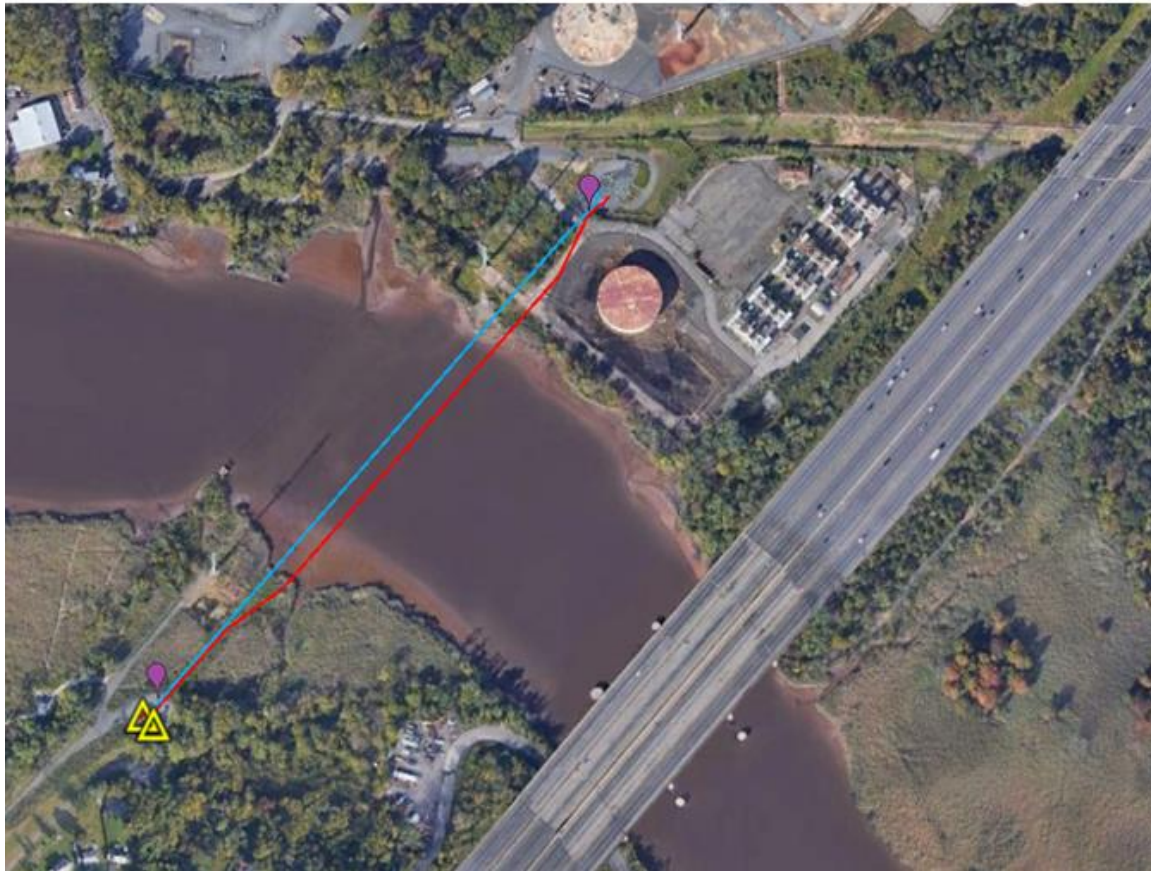
Case Study – 24” River Crossings

24in TDW #600 Stopple fitting

2in TDW TOR or Mueller SAV fitting installed 4-5ft from Stopple

24in pipe

Above Ground Marker (AGM)

- Installed in the 1950's, but never inspected
- Took approximately 6 hours (each)
- Zero downtime
- Pipeline remained in service (50% bypass)
- 40bar operating pressure
- Redundant data scan
