Pigging Industry News

the newsletter of the Pigging Products & Services Association

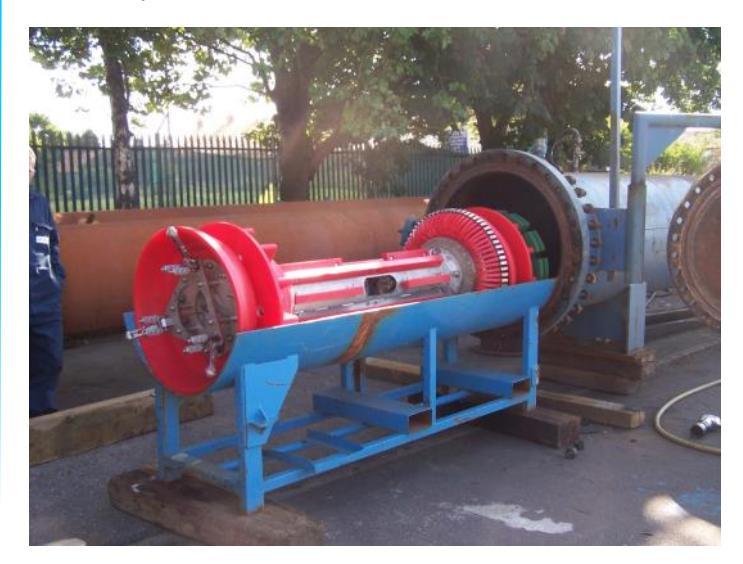
Pipeline Engineerings's 30" PECATTM

The PECATTM is deployed as a single standalone unit, as opposed to being built up as different modules. It comprises a data logger within the body of the pig, around which a series of spring mounted debris sensors are deployed. The sensors are supported on the end of caliper arms. The combination of the caliper arms and the debris sensors provide both a measure of the residual bore, and the offset from this residual bore to the internal surface of the pipe (the pipe ID). This then gives a true measure of debris volume and its distribution along the length of the pipeline. The PECATTM can be constructed to reflect a preferred pig configuration (disk, cup, and in whatever combination). It is also designed to measure and pass debris deposits of approximately 20% of the pipe ID.

PECAT[™] can be run in a bore-finder mode to assess levels of residual debris. Alternatively, it can be deployed as part of its routine cleaning offering to allow the effectiveness of a cleaning programme to be gauged as it is implemented. This enables PE to change the cleaning programme dynamically as it progresses, and to evidence when a required level of cleanliness is reached. These assessments are made using in-house developed software and data analytics.

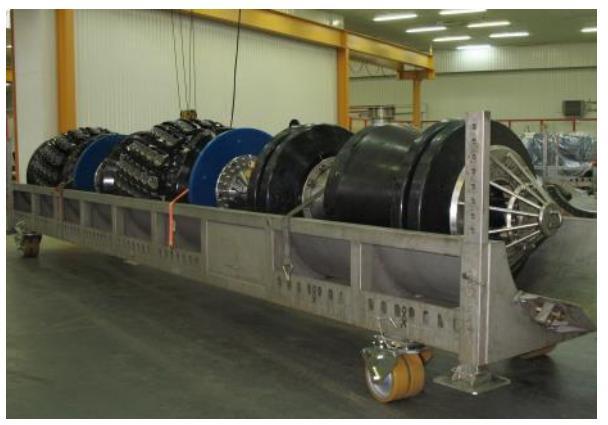
Transneft Diascan, JSC's new Ultrasonic inspection tool

In 2015 **Diascan** developed a new generation inspection tool – an inspection complex "Ultrasonic inspection tool 40-DKP.00-00.000" for detection of arbitrarily oriented defects. The inspection tool covers the following diameters: 40", 42" and 48".

The inspection tools for detection of arbitrarily oriented defects are high resolution tools and are designed to detect defects in pipe wall and welding seams (longitudinal, girth and spiral). The tool has two ultrasonic measurement systems: with straight ultrasonic beam (wall measurement (WM) method) and slope beam (crack detection (CD) method) with CD sensors oriented in nine directions relative to pipeline longitudinal axis. Due to this the tool is capable of detecting crack-like axial and circumferential defects, as well as defects in spiral welds and other defects in any orientation relative to pipeline longitudinal axis. Moreover, in comparison with previous versions the tool has 1.5 times higher WM measurement system resolution.

Tool diameters	40"÷48"
Pipeline product	Liquid
Temperature	-15°C ÷+50°C
Max. operating pressure	14 MPa
Operating velocity	up to 2 m/s
Min. bend radius	3D
Pipe wall thickness	4 ÷ 29 mm
Max. length of inspected pipeline	200 km

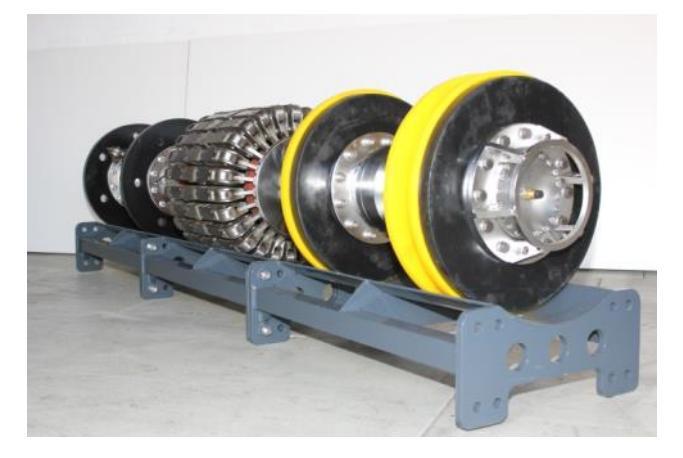
The application of versatile MFL tool and Datsurvey ® software to difficult-to pig pipelines

The Pipesurvey International tool combines tri-axial sensor technology and integrated sensors for discrimination of internal and external corrosion in flexibly suspended sensor pads. The measuring module will give full wall coverage and at the same time has the ability to collapse in smaller diameters and so it offers the possibility to inspect multi-diameter pipelines. The tool is bi-directional and will pass through shortradius 1.5D bends so it will be used not only in long distance transmission pipelines, but also in short lines like jetties, tank farms and offshore.

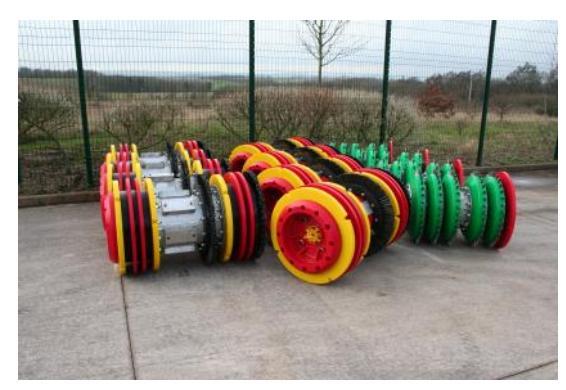
Pigtek's heavy duty cleaning pigs

The magnetic cleaning pig is based on a bi-directional pig design and is fitted with a combination of polyurethane guide and seal discs. High power magnetic packages are also fitted to the central pig body for recovery of any ferrous debris. The packages provide a very strong magnetic field over a large surface area to ensure efficient debris pick-up and hold capabilities. Carbon steel pencil type brushes were also fitted to the central pig body and rear of the pig to provide additional cleaning.

The Pigtek dual module HDR pin pig is designed for cleaning pipelines that contain hard wax and/or scale. The pig incorporates steel pins having tungsten carbide tips, which are profiled for cutting into hard pipeline debris. The pins are fitted into heavy-duty carrier cups mounted on the trailing pig. The arrangement of pins in each cup is offset to provide 360 degree cover to the internal pipewall and the aggressiveness of the HDR pin pig can be controlled by altering the number of pins fitted to each cup.

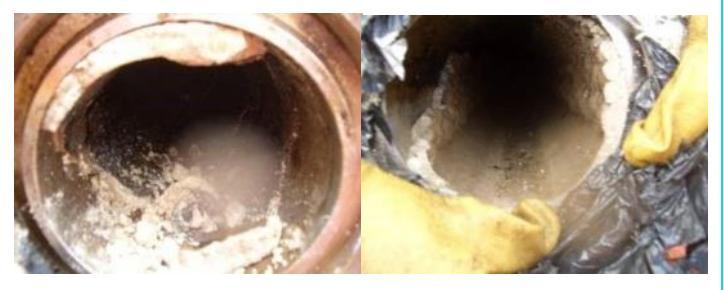
Barium sulphate hard scale deposits

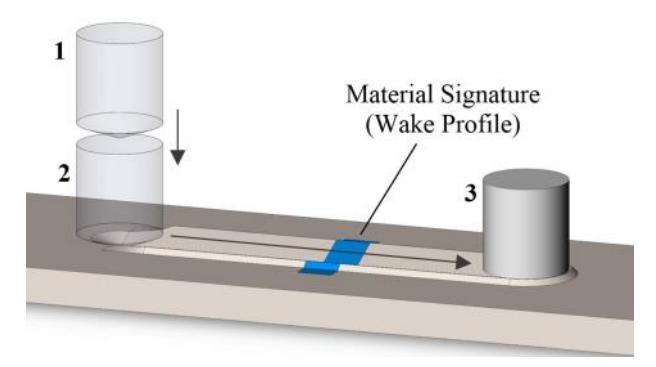
Schematic of frictional sliding process and resulting feature

The relationship between the profiles obtained and mechanical properties obtained through tensile tests was initially validated academically using a single stylus, but has since been expanded for even more accuracy to include multiple styluses of different geometries that contact the surface simultaneously. They induce different amounts of strain to correlate with specific points on the stress strain curve.

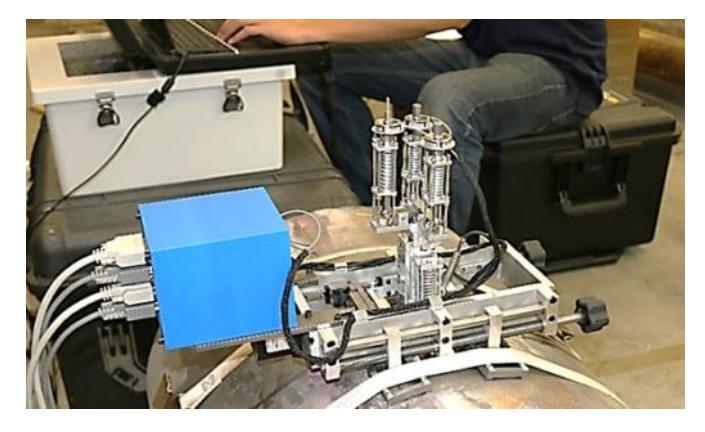
HSD Tester (patents pending)

The HSD Tester includes self-guiding to maintain the alignment of the stylus with the curved surface of a pipeline. It is both fast and accurate. MMT's testing procedures are being validated using a large range of materials relevant to existing steel pipelines.

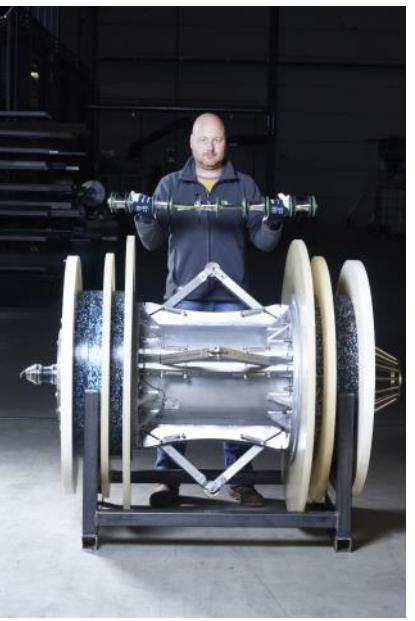
A.Hak's new 3 inch ultrasound Piglet®
