ADDRESSING THE PROBLEMS OF AGEING PIPELINES USING THE MOST RECENT ULTRASONIC IN-LINE INSPECTION TOOLS

By Dr. K. Reber & Dr. M. Beller

NDT Systems & Services AG, Stutensee, Germany

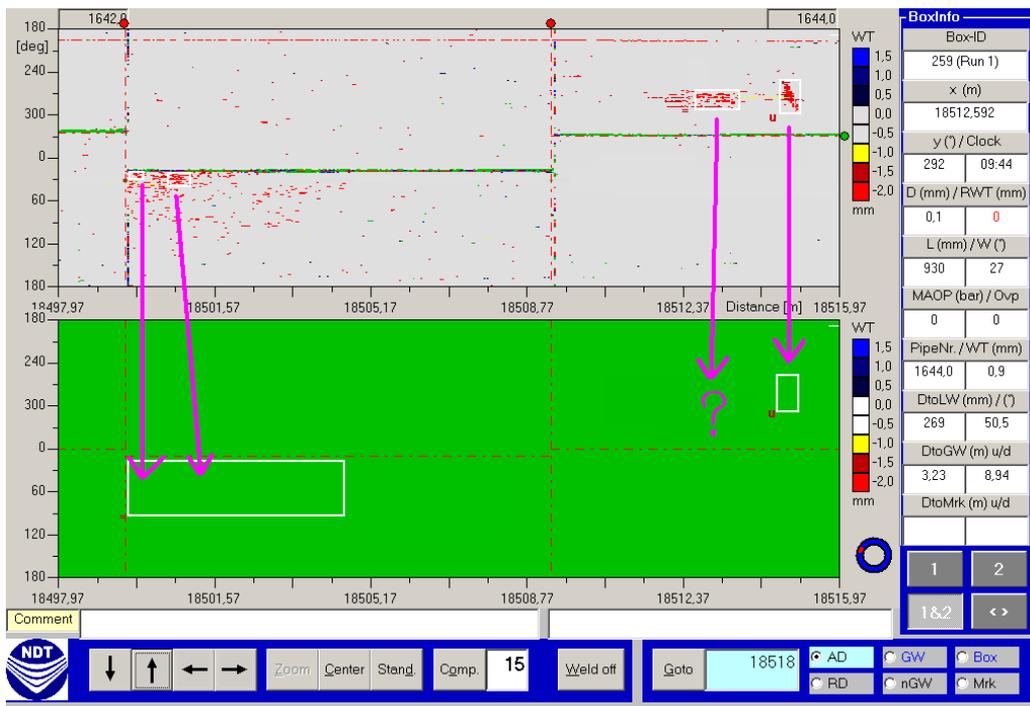
Figure 1: A sample screenshot of the RunComparison Function of NDT's analysis Software. The purple (dark grey) arrows indicate what correspondences can be found.

Figure 1 shows a screenshot of the RunComparison Function of NDT's Analysis Software PIXUS. Note that the girth welds are depicted by dashed red (grey) lines and are located at exactly the same position. Feature locations are depicted by white boxes.

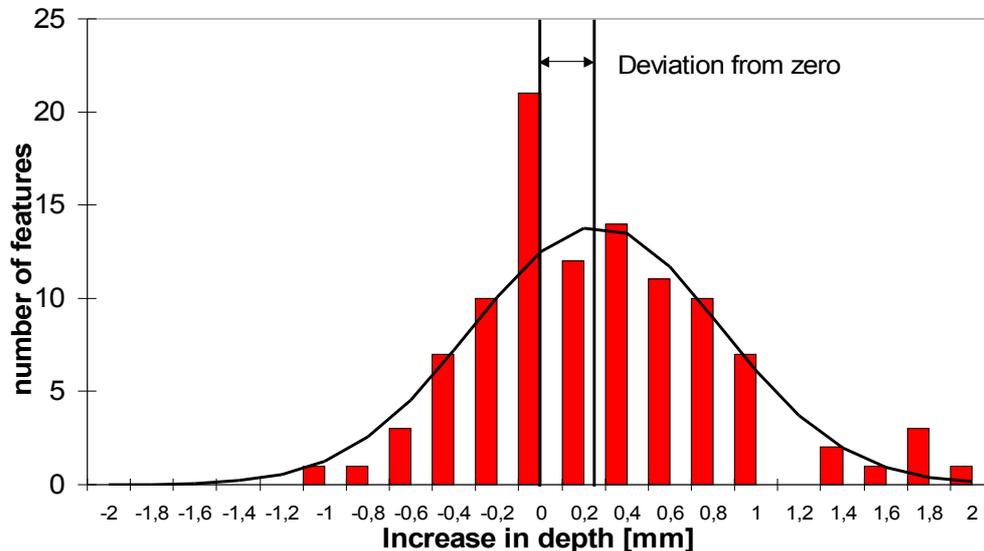
Figure 2: The increase in depth for 104 sample pairs of metal loss features as a histogram. There is a deviation of the mean from zero, that cannot be explained by the pig measurement uncertainty alone.

same for most defects, the changes in depth can be used as several measurements of the same corrosion rate. The relevance of the result will thus depend on the number of pairs and the accuracy of the two tools. A sample histogram of changes in depth is shown in Figure 2. It would be an oversimplification to assign a single growth rate to a pipeline altogether. Areas of active corrosion would be hidden if the average is taken over all parts of the line that are potentially no affected.

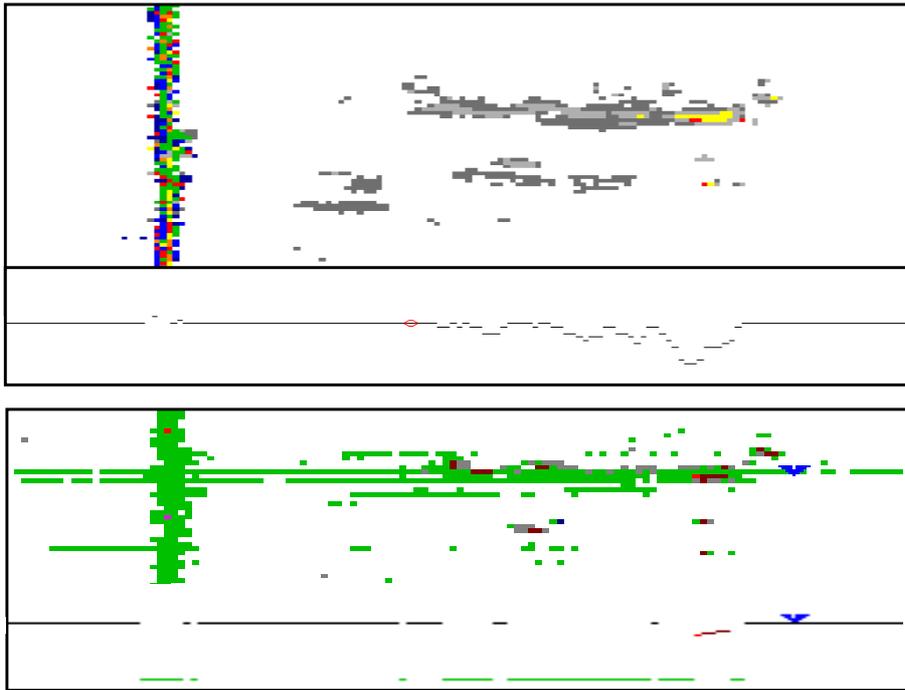
Figure 3 A defect seen by two inspections with different UT-tools. The lower inspection is over 12 years old. The upper picture show the defect as it was seen recently by an NDT pig.

Because ultrasonic data has no intrinsic ambiguity, it is also much more valuable long-term. Archived MFL data that is older than 10 years is often not used for Run Comparisons. While for UT data advancements in technology have also improved the overall value of the measurement data, even very old data is still directly comparable to data of very recent UT pigs. Figure 3 shows a metal loss defect as recorded by two inspections. The lower part shows the result of an earlier inspection that is about 12 years old. The upper part shows the recent results as they were obtained by NDT. The upper diagram in each box is the C-Scan the lower one a B-Scan with the deepest point.

The data of the earlier inspection was governed by echo loss. It is shown in green (dark grey in black and white reprints). Except for some spots in the weld echo loss is missing in the recent data. The effect is also seen in the B-Scans. In the earlier measurement the profile is basically flat at 0 mm (which is the conventional way of indicating echo loss in the data). Only a few points with a wall thickness deviating from the nominal wall thickness can be observed. In the recent measurement the full profile is revealed.

The presence of echo loss has an effect on the reported depth. In the first inspection the defect was reported with a depth of 2 mm. The deepest point is now measured as 3 mm. Based on a simple feature to feature comparison one may be tempted to conclude that active corrosion has been present (or still is). The analysis of the actual data, however, reveals that it is much more likely that the deepest point was masked by echo loss, thus leading to a shallower depth.

- Echo loss is the most problematic adaptation. Echo loss can also be interpolated, but this generates defect profiles that have not really been measured. It would be better to neglect areas with echo loss altogether. In the example in Figure 3 only the shape can be compared.

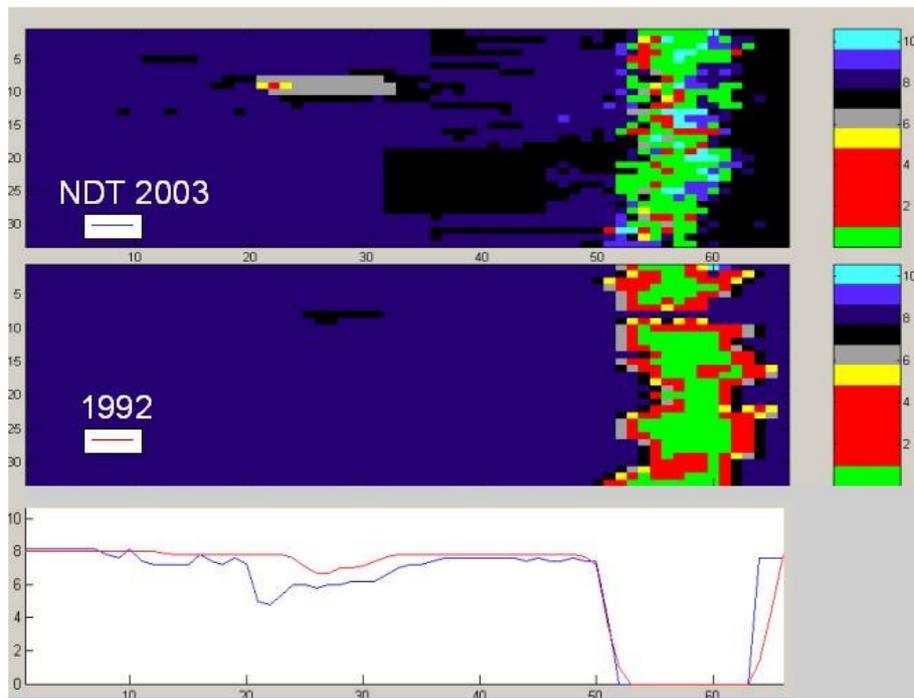
Figure 4: Pixel-by-pixel comparison of a metal loss defect. No change is found.

Figure 4 shows a sample comparison of two matrices of wall thickness values. Both data values are displayed with the same colour code. The sizes have been adapted to show the same area of the pipe surface. In the lower part the river bottom profile is shown for the two measurements. There is a relevant deviation between the two indications – a growth of the metal loss.
